# YOUR ONESURVEY HOME REPORT

16 Blackwood Avenue  
Newton Mearns  
Glasgow  
G77 5BA

# SINGLE SURVEY

# Single Survey

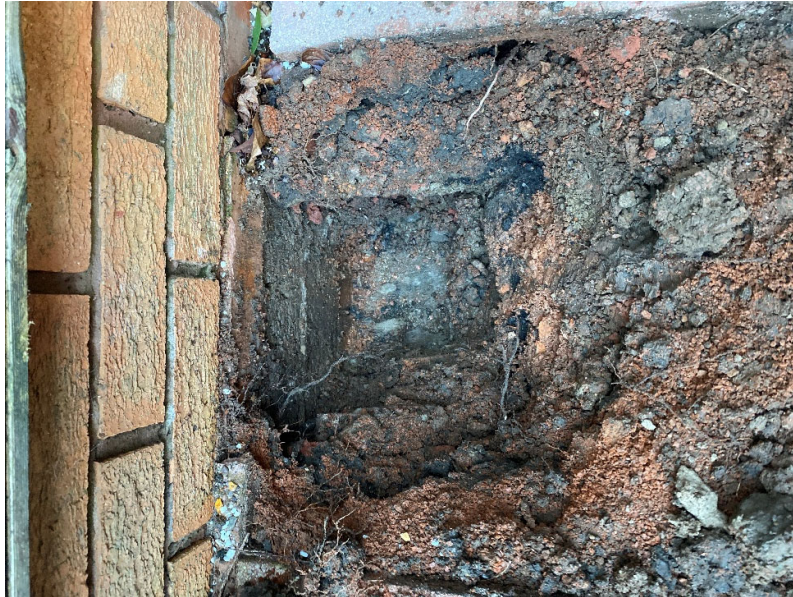
To confirm the geometry of the foundations a small trial pit was excavated down the side wall of the building. This showed the top of the concrete to be 380mm above the external ground level, project 200mm from the face of the external wall. The foundations were found to be at least 200mm thick. The soil below the foundations is a soft to firm sandy clay with an allowable bearing capacity of 75kN/m<sup>2</sup>.

The floor of the conservatory has been constructed using a suspended timber floor which appears to be well vented.

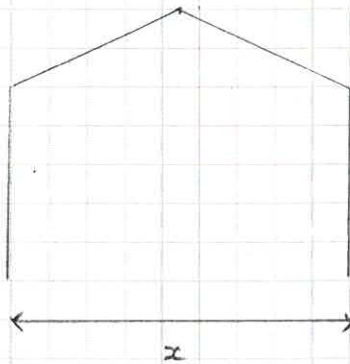
GEOMETRY

$$x = 3.3\text{m.}$$

EXPECTED FOUNDATION WIDTH = 0.65m.

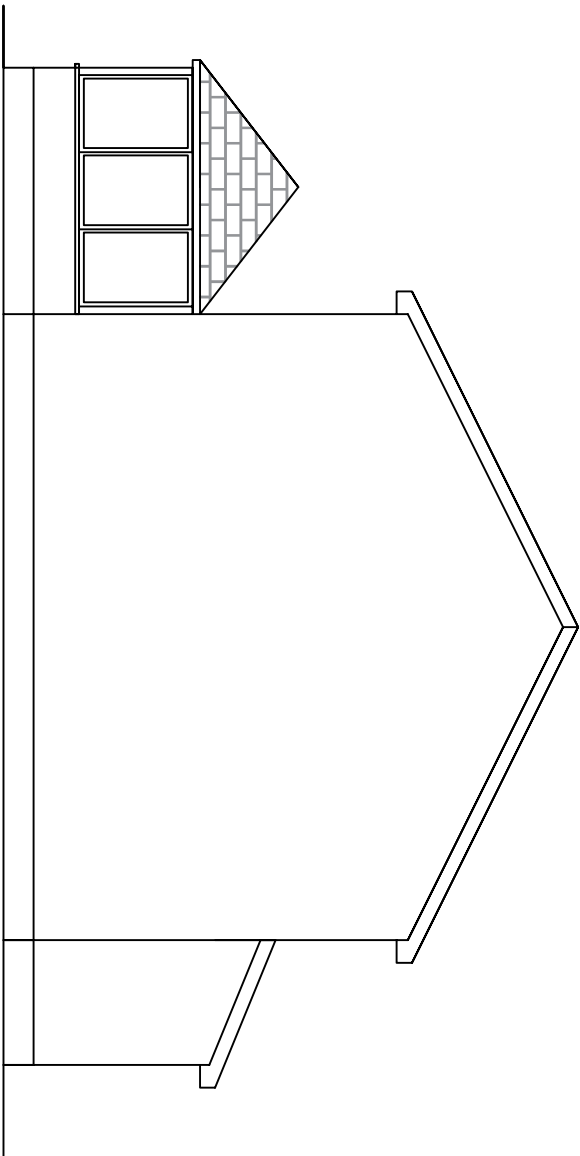
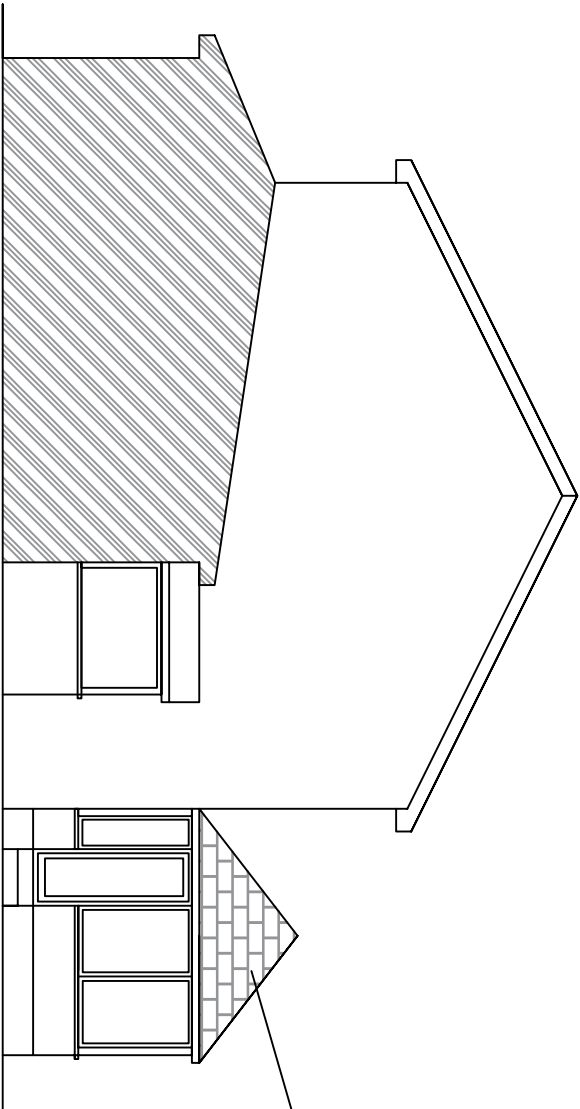
The conservatory was originally built in 2004 and had the roof replacement carried out back in 2018.

A structural survey has been completed in December 2025 and confirmed all is satisfactory with the structural integrity of the works

Existing conservatory roof to be removed in full and replaced with a pre-manufactured conservatory roof conversion.
