15 Springbank Crescent,  
Dunblane,  
FK15 9AP

# Home Report

## Survey Report on:

| <b>Date of Inspection</b> | 12th March 2026 |

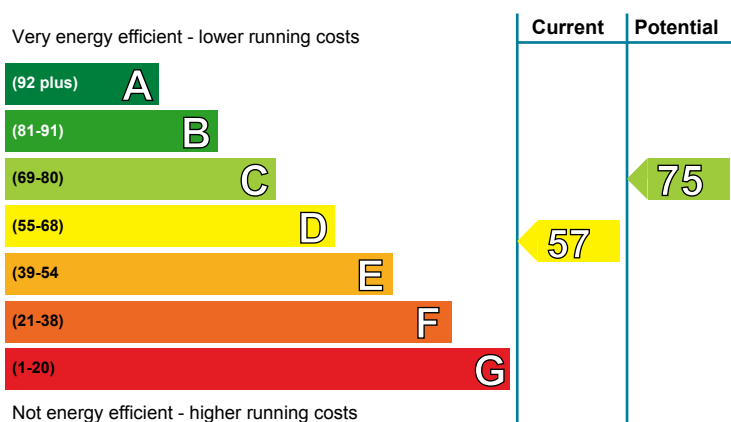
## Energy Efficiency Rating

Your current rating is **band D (57)**. The average rating for EPCs in Scotland is **band D (61)**.
