YOUR ONESURVEY  
**HOME REPORT**

Flat 0/2  
234 Bearsden Road  
Glasgow  
G13 1LA

# SINGLE SURVEY

<b>Surveyor Reference</b>	GG/1951
---------------------------	---------

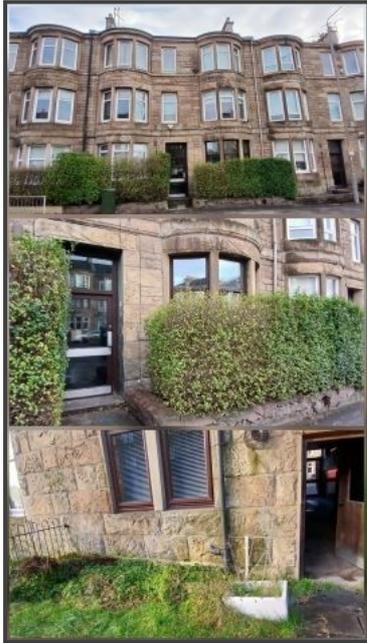
- Existing Remedial Damp Proof Course

Visual evidence of historic damp proofing works carried out to the front elevation, rear elevation and common close of the property was apparent.

With this being the case, we would suggest that you establish the extent (external and internal) of the historic damp proofing works, and if damp proofing Guarantees exist, and of course, if they are still valid.

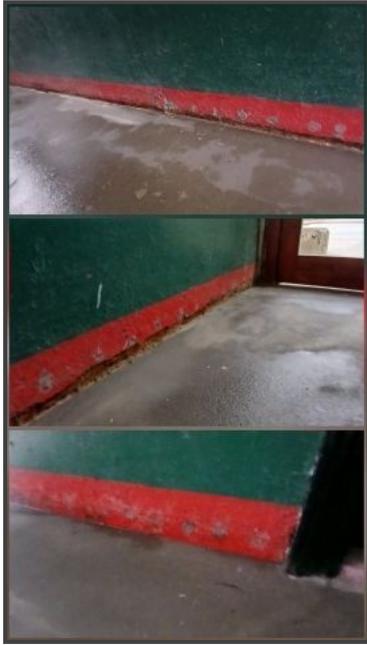
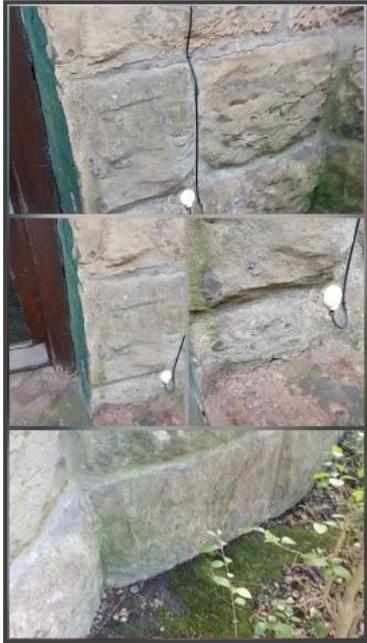
- The external ground level is below the internal floor level of the ground floor flat.

However, the openings air vents to the rear elevation of the property are partially blocked by plant growth. This will significantly reduce airflow, putting sub-floor timbers at risk from fungal decay.

We recommend, as essential regular maintenance, that the client arranges for air vents to the property to be cleaned out in order to maintain air flow to the sub-floor to extend the life span of the timbers.
