# Home Report

82 Dundonald Road  
Kilmarnock KA1 1TH

Date of Valuation: 15/04/2026

<b>Property Address</b>	82 Dundonald Road Kilmarnock KA1 1TH
<b>Customer</b>	Phyllis Carroll
<b>Prepared by</b>	Graham + Sibbald Property Consultants Limited
<b>Date of Inspection</b>	15/04/2026

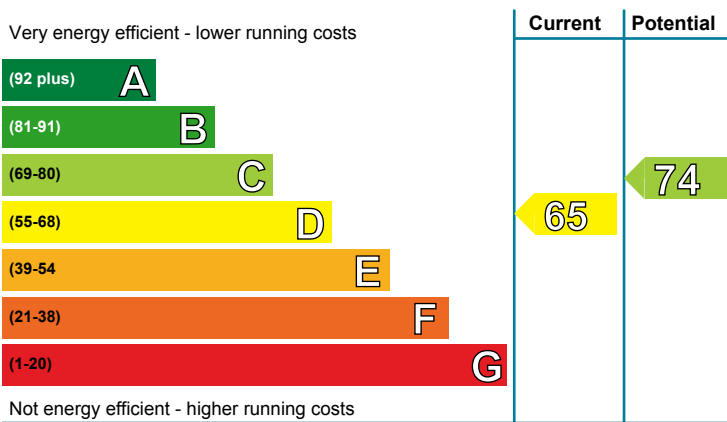
## Energy Efficiency Rating

Your current rating is **band D (65)**. The average rating for EPCs in Scotland is **band D (61)**.
