12 Thorn Avenue,
Coylton,
AYR,
KA6 6NL

Home Report

Single Survey

Property Address	12 Thorn Avenue, Coylton, AYR, KA6 6NL
Reference	1557973
Customer Name	Kathleen Mackay
Date of Inspection	30th April 2026
Surveyor's name, qualifications and office	Mark Rutherford MA (Hons) MRICS DM Hall LLP Chartered Surveyors Eldo House, Monkton Road, Prestwick, KA9 2PB Tel: 01292 286974 email: ayrshireresidential@dmhall.co.uk
Prepared By	DM Hall LLP

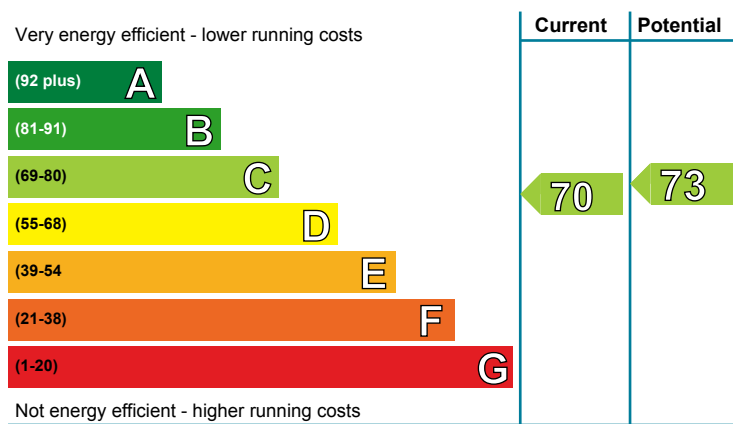
Energy Efficiency Rating

Your current rating is **band C (70)**. The average rating for EPCs in Scotland is **band D (61)**.
