Our Ref: 17775/KL

17th April 2025

72 Elmwood Crescent, Flitwick, Beds. MK45 1LJ - Structural Inspection

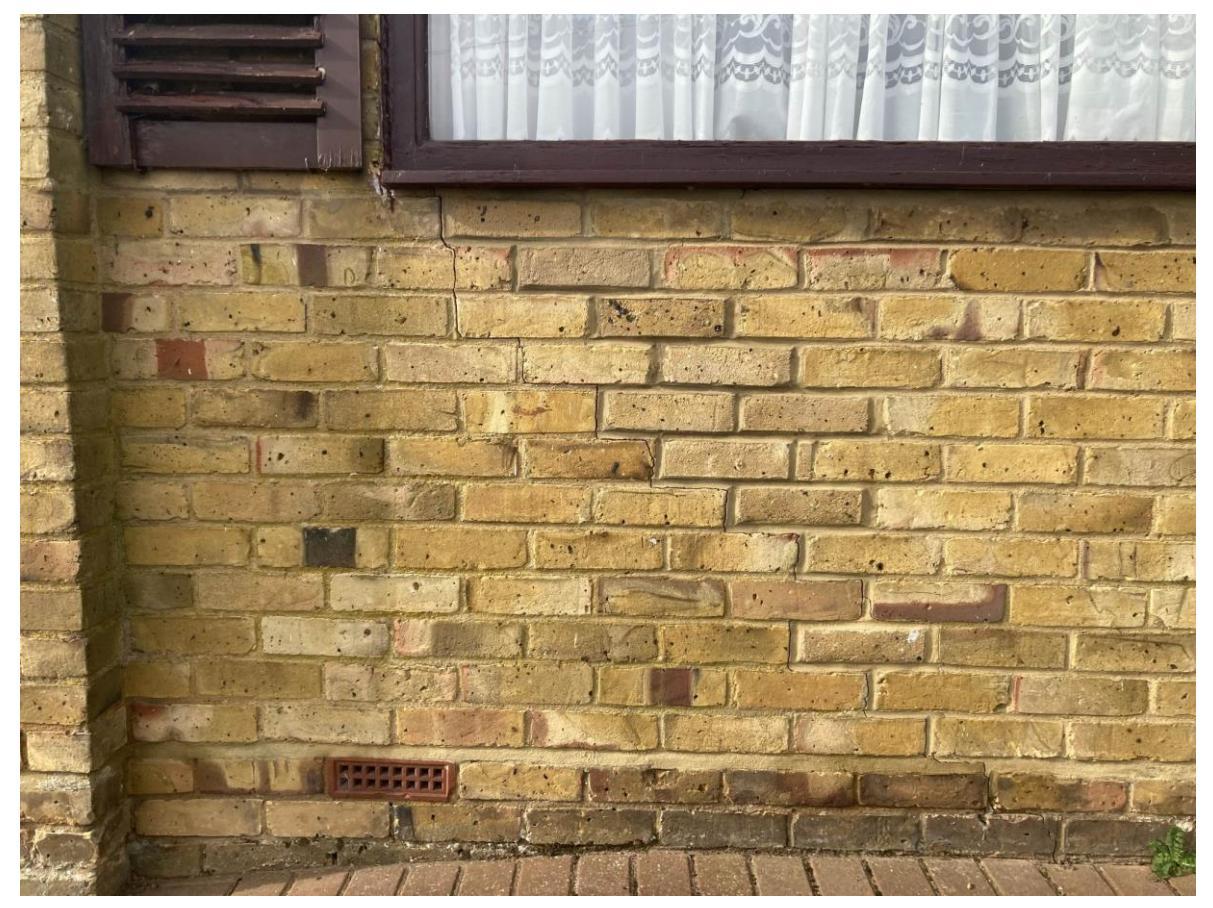
- 12. There is a stepping crack below the left-hand window. The crack is approximately 2-3mm wide.
- 13. There are areas to the right-hand side of the crack where some bricks appear to have been replaced or have been repointed.

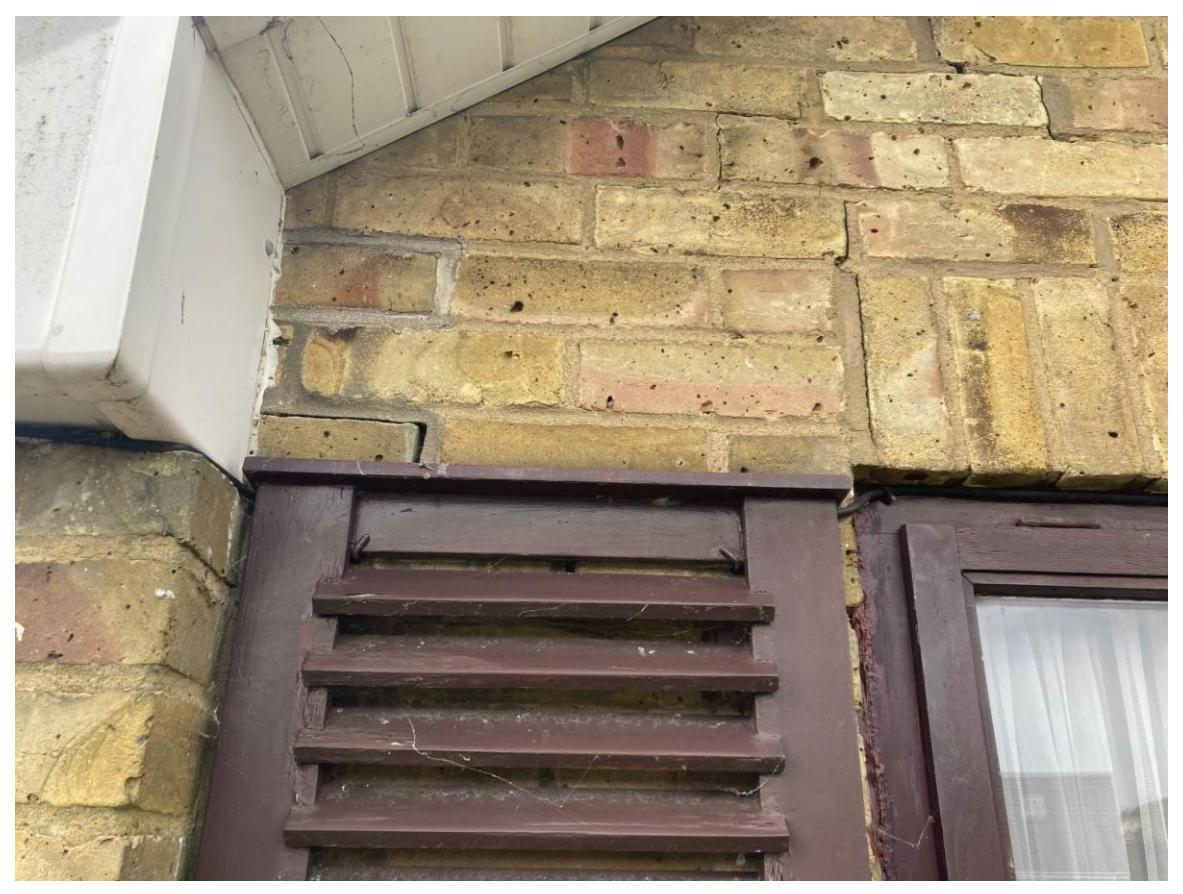
- 14. There is cracking to the top left corner of the left-hand window. The crack is hidden by the decorative shutters but appears to be above 5mm wide.
- 15. There is also some cracking to the left-hand side of the soldier course above the window.
- 16. The mastic joint to the left-hand side of the window is about 20mm wide and the brickwork at high level is uneven.

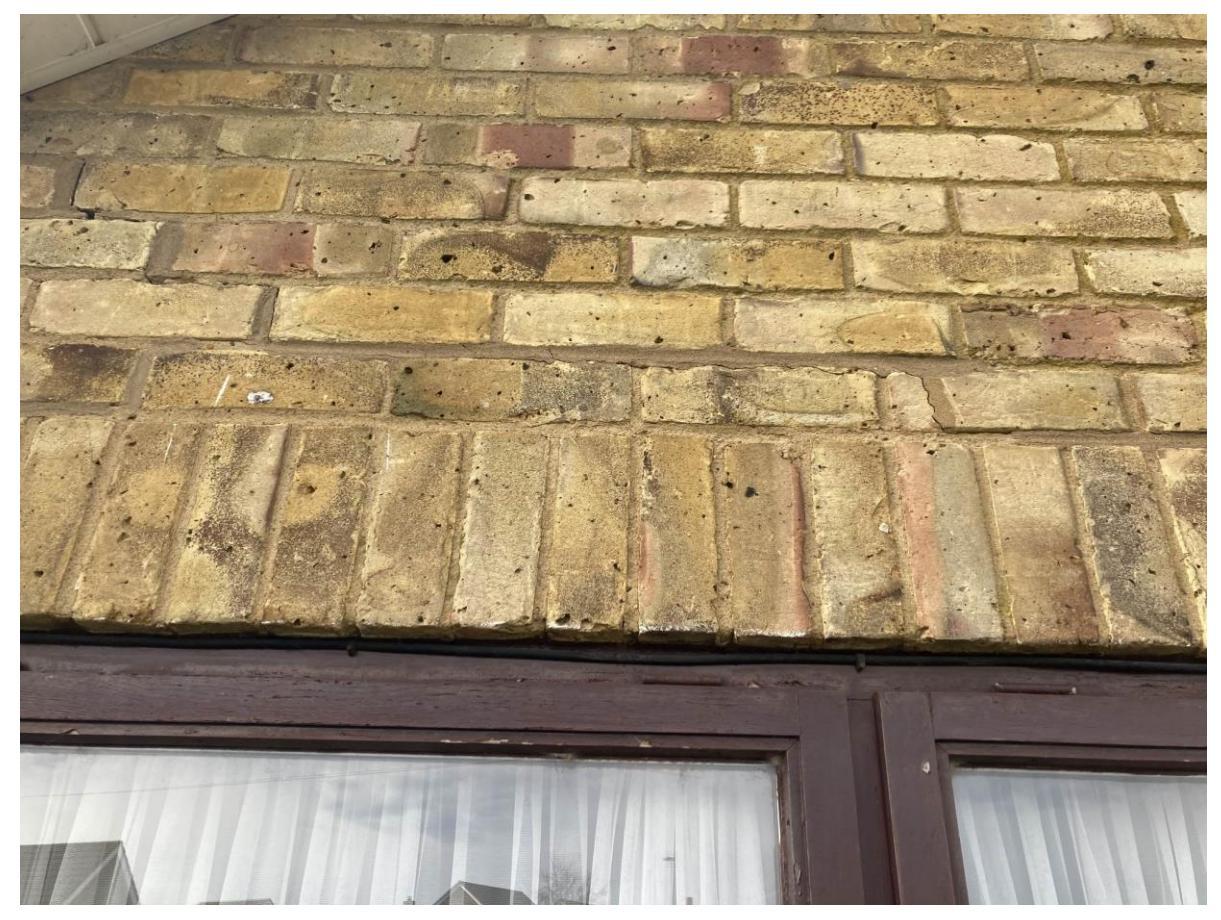
17. There are some cracks above the windows and areas that have been repointed.

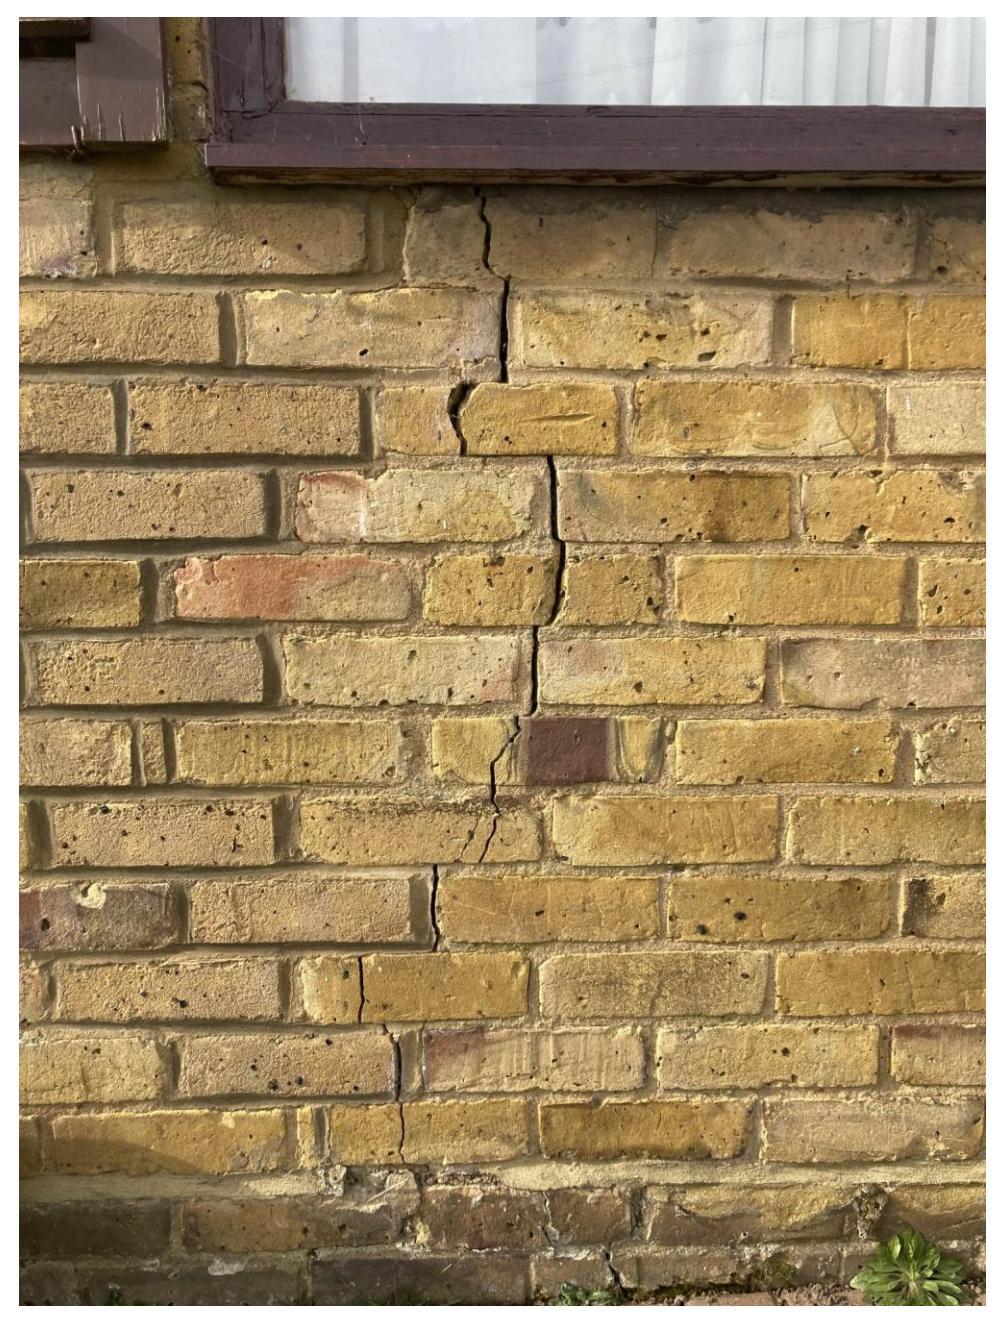
- 18. There is a vertical crack below the right-hand window. The crack is about 2mm wide at the bottom increasing to 7-8mm wide at the top.
- 19. There are areas to the left-hand side of the crack where some bricks appear to have been replaced or and areas have been repointed.

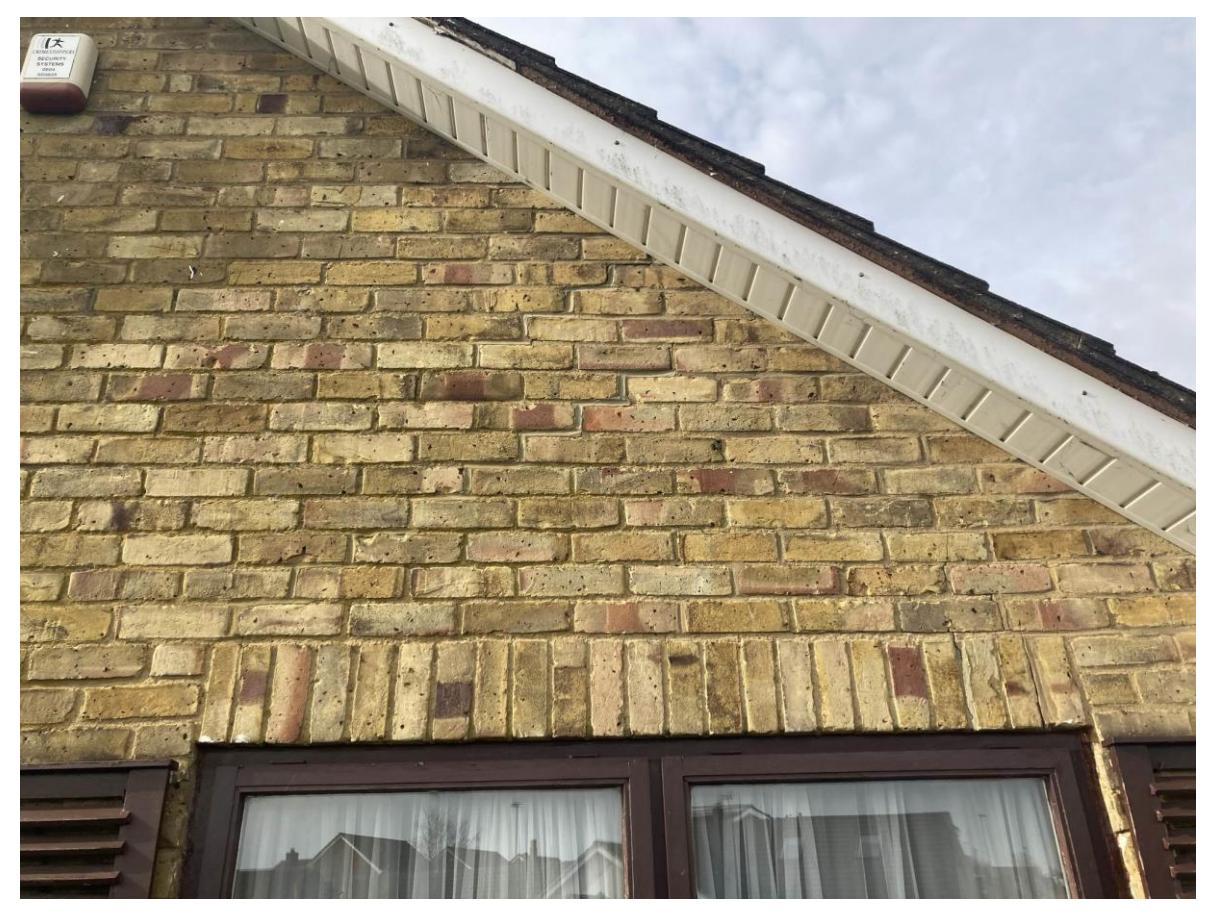
- 20. There is cracking above the window both sides ranging in width from 1-3mm.
- 21. Some repointing has been carried out over the window and the cracks have reopened by 1-2mm.

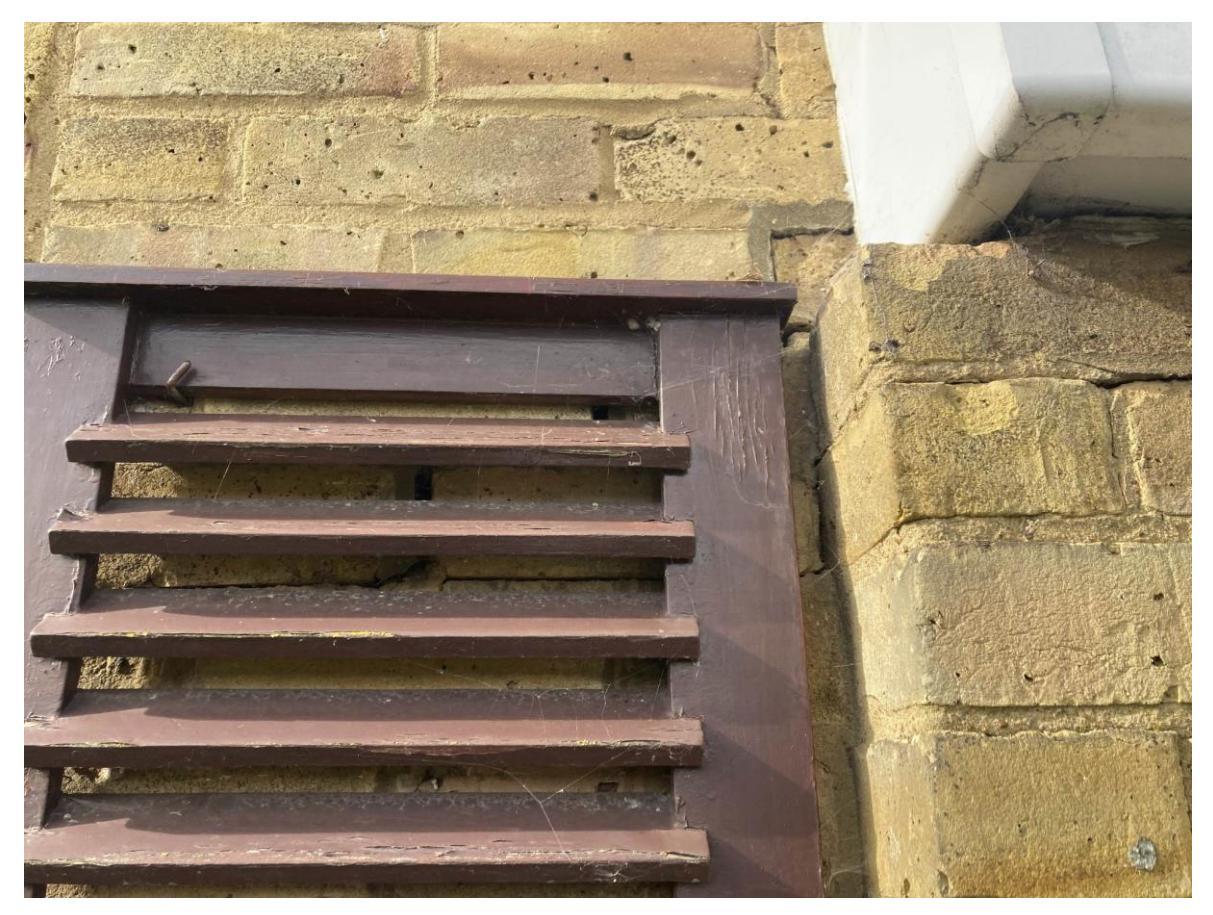
22. There is cracking to the top right corner of the righ-hand window. The crack is hidden by the decorative shutters but appears to be above 10mm wide.

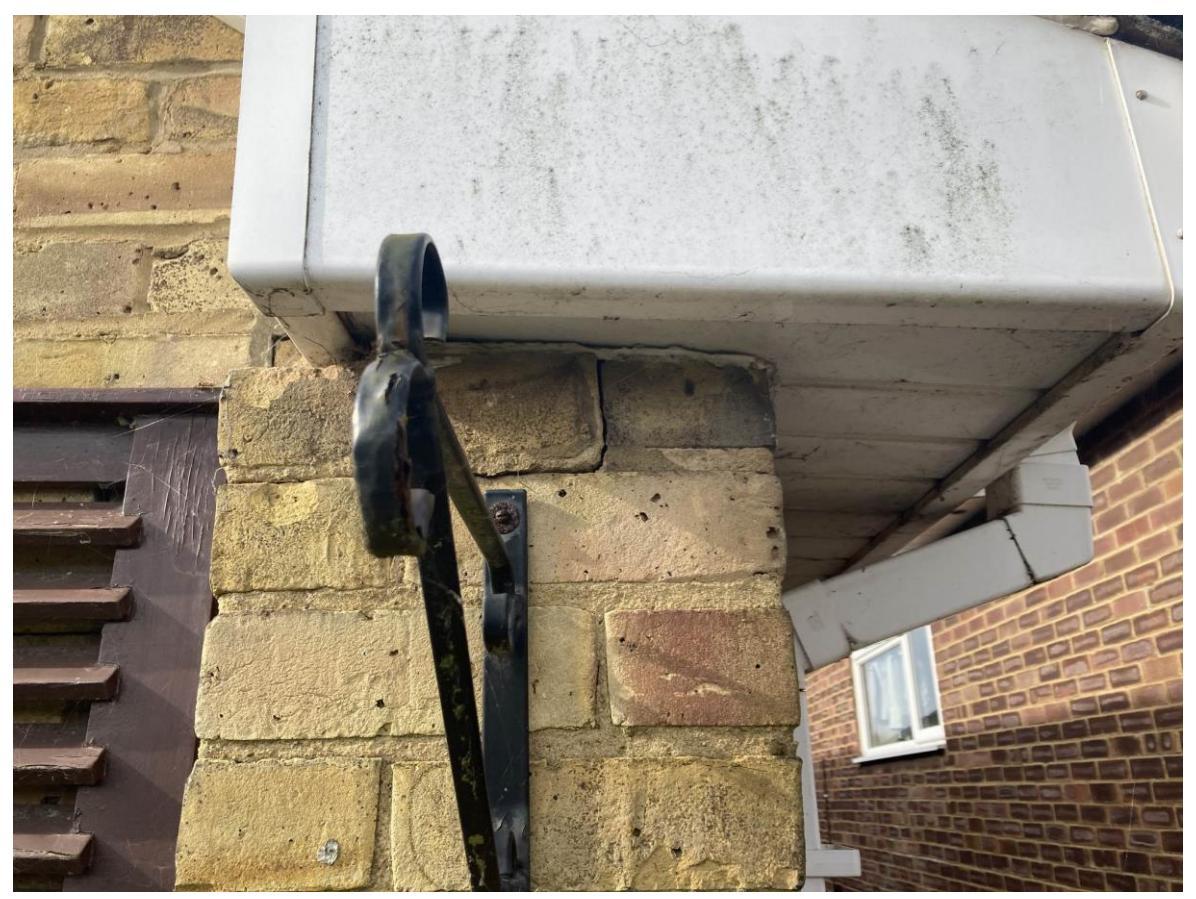
23. There is a loose brick to the pier to the right of the window.

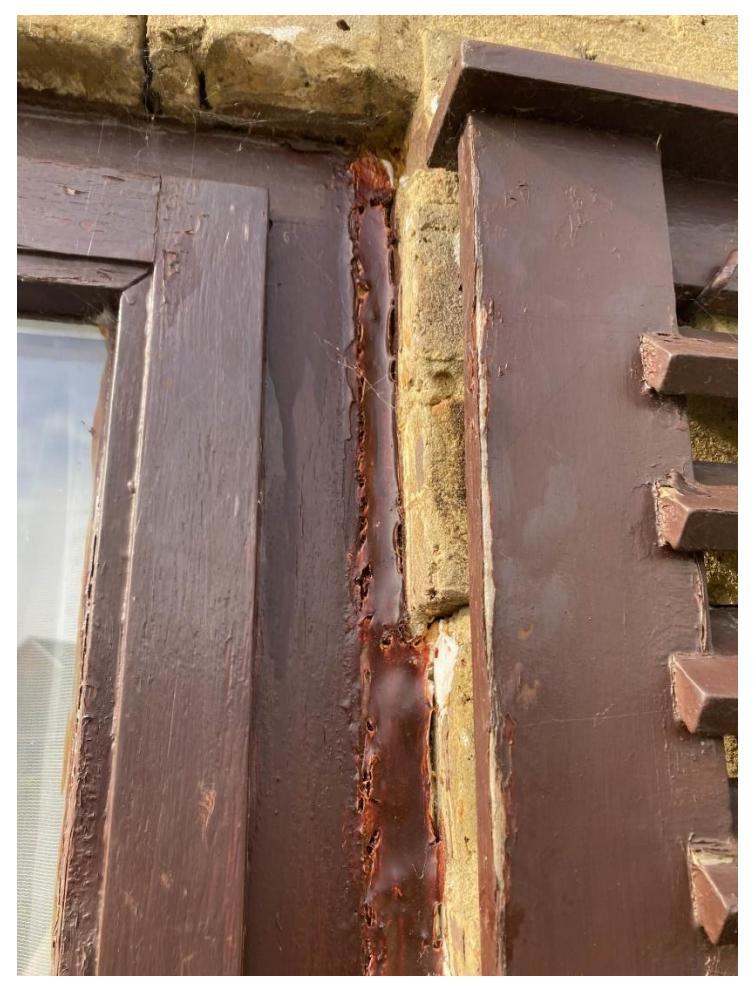
24. The mastic joint to the right-hand side of the window is about 25mm wide and the brickwork at high level is uneven.

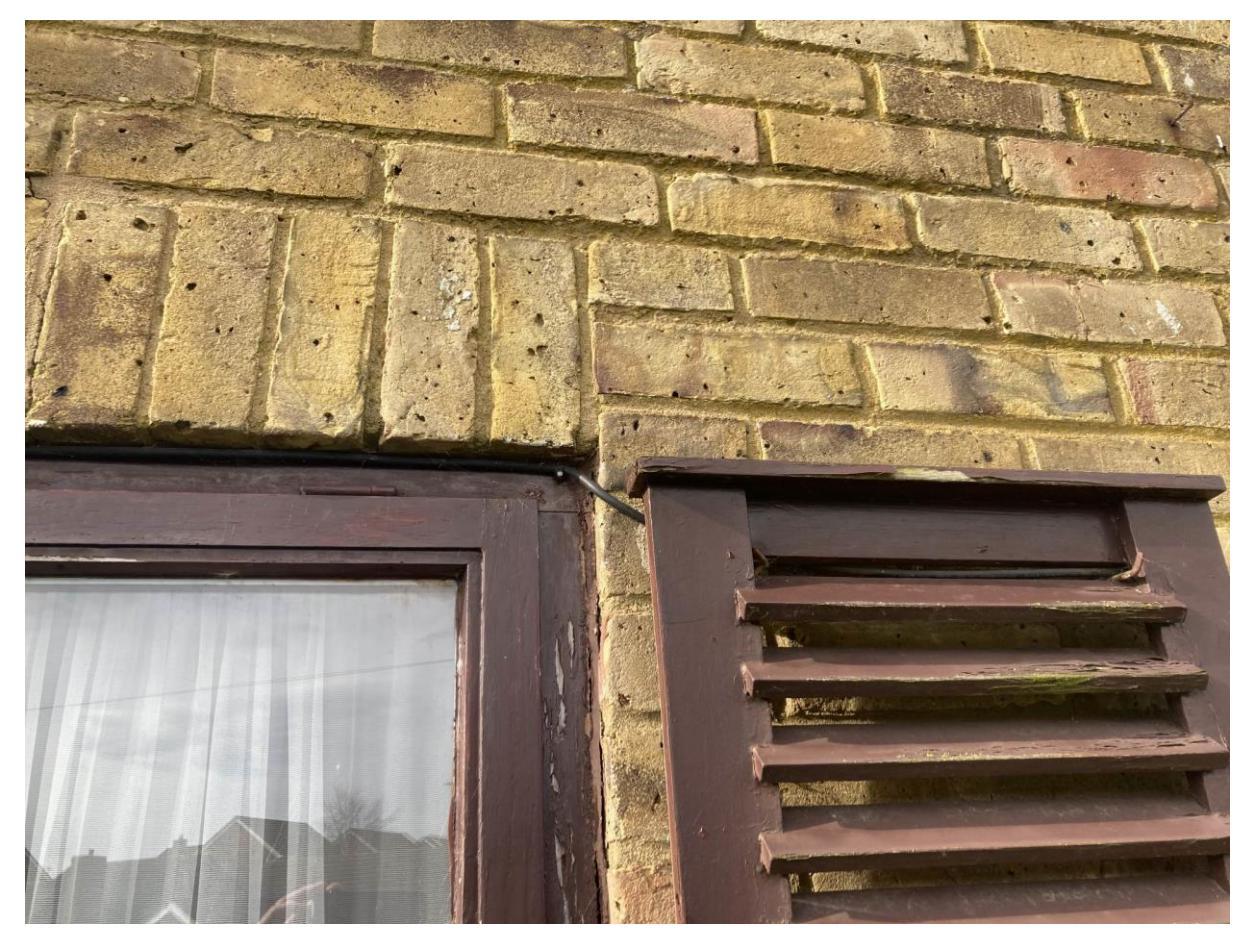
25. The bottom of the soldier course does not line through with the adjacent brick coursing indicating that there are no lintels to support the outer leaf of brickwork.

96. If the top of the window opening does not line up with a mortar bed joint, there is a high chance that there are no lintels supporting the outer leaf of the wall.

- 97. With properties of this era, the original window frames and mullions were often load bearing, with window frames built in as the bricks were laid and the frames then supported the outer leaf of brickwork.
- 98. The inner leaf carries all the roof and floor loads, and this used to have a lintel, so the building is structurally adequate.
- 99. The windows to this property are timber but I think it is unlikely that they are the original windows installed when the property was first built.
- 100. The timber windows fitted here, are non-load bearing and hence are unable to provide the same support as the original windows.

- 103. When new windows are fitted, the installation company should check the support and install new lintels if necessary. If they are not fitted then they can be fitted later by cutting out some brickwork over the window, installing a proprietary single leaf lintel and then re-bricking. This is likely to cost £300-£600+VAT per window. The wider the window the more it costs.

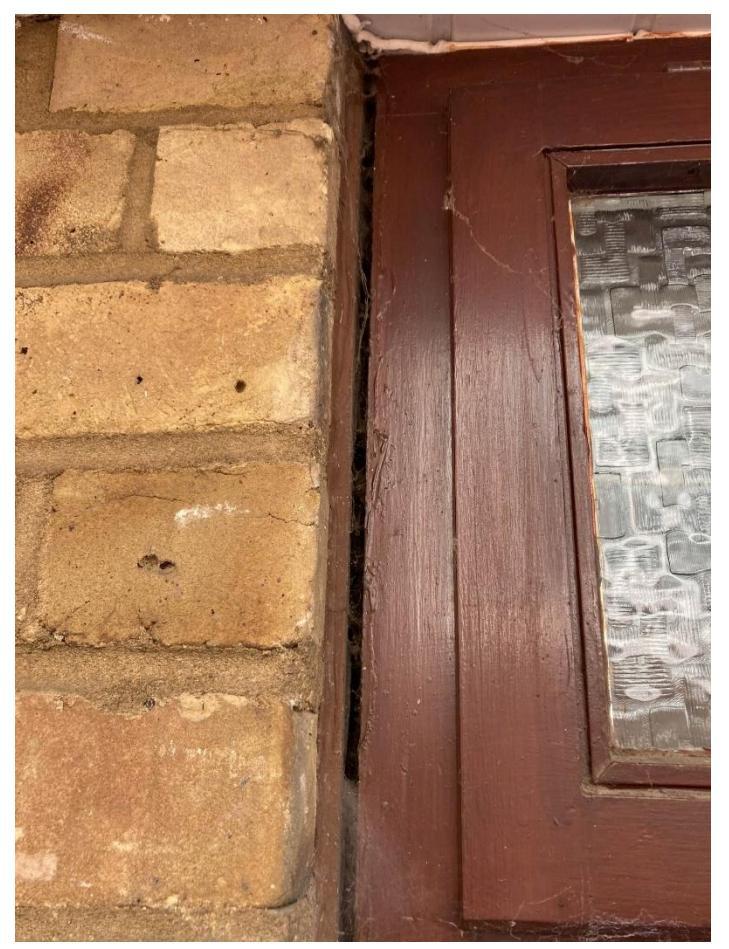
- 26. There is a gap of about 8mm between the left-hand side of the window frame and the wall to the window nearest the front of the property.
- 27. There is also a gap of 3-4mm to the right-hand side of this window.

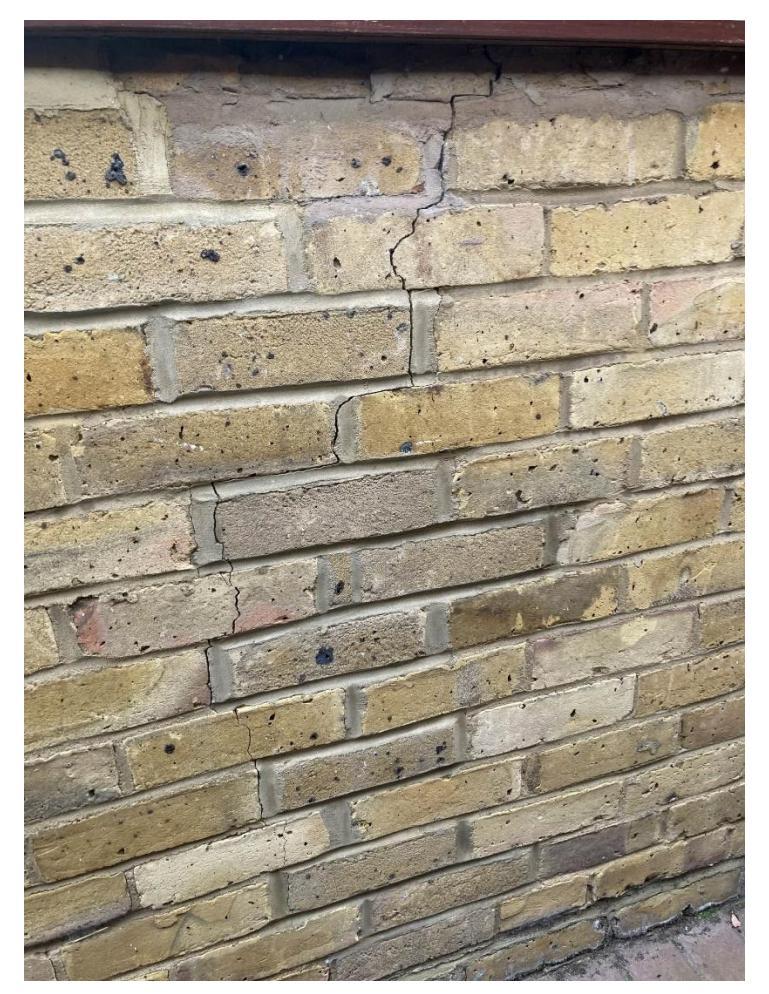
- 28. There is cracking below the window. The cracking is approximately 2mm wide at the top reducing to hairline at the bottom.
- 29. The crack has been repointed and had reformed. Some of the repointed perp joints are 25-30mm wide.

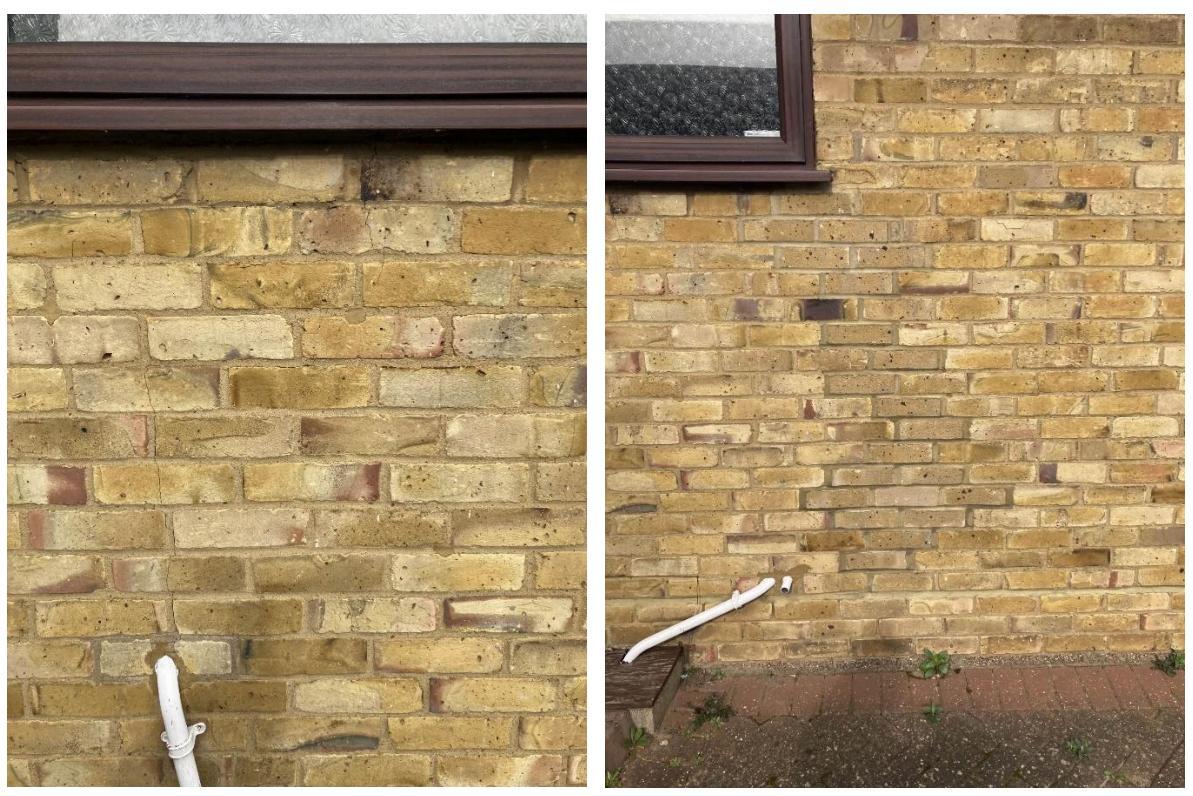
- 30. There is some hairline vertical cracking below the bathroom window.
- 31. An area of the all have been rebuilt and repointed.

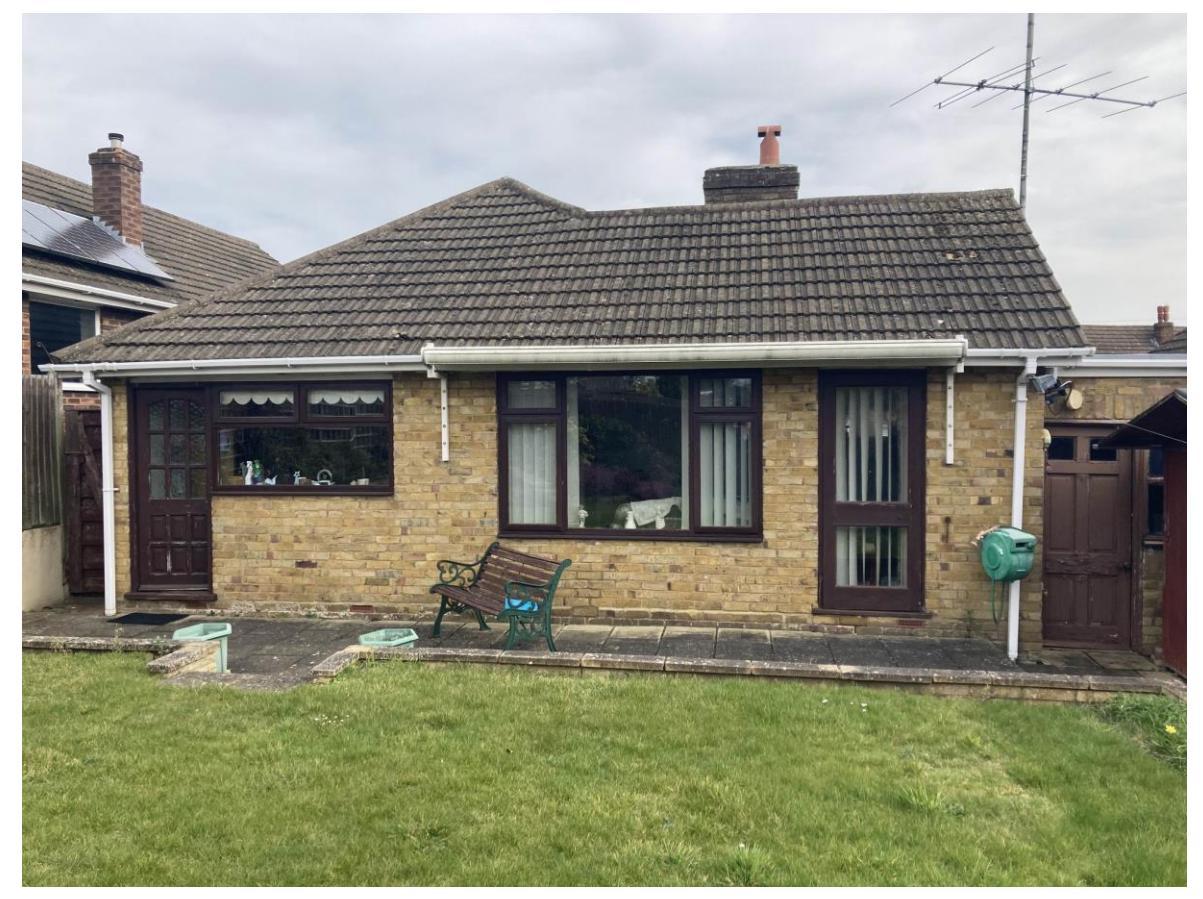
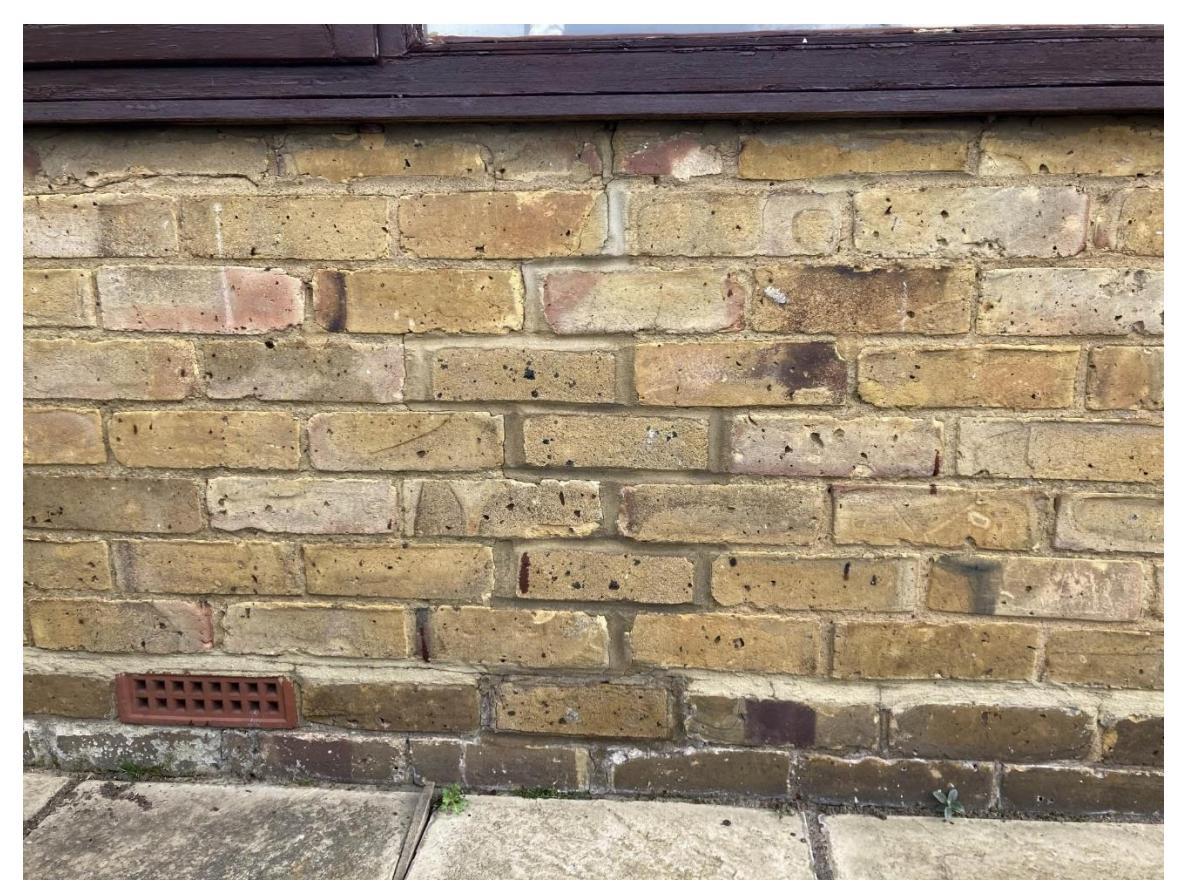
- 32. There is some signs of historic cracking below the living room window and these cracks are reforming. Some of the repointed perp joints are 25-30mm wide.
- 33. With the exception of the points noted, and considering the age of the property, the brickwork was generally straight, acceptably plumb and in reasonable condition.

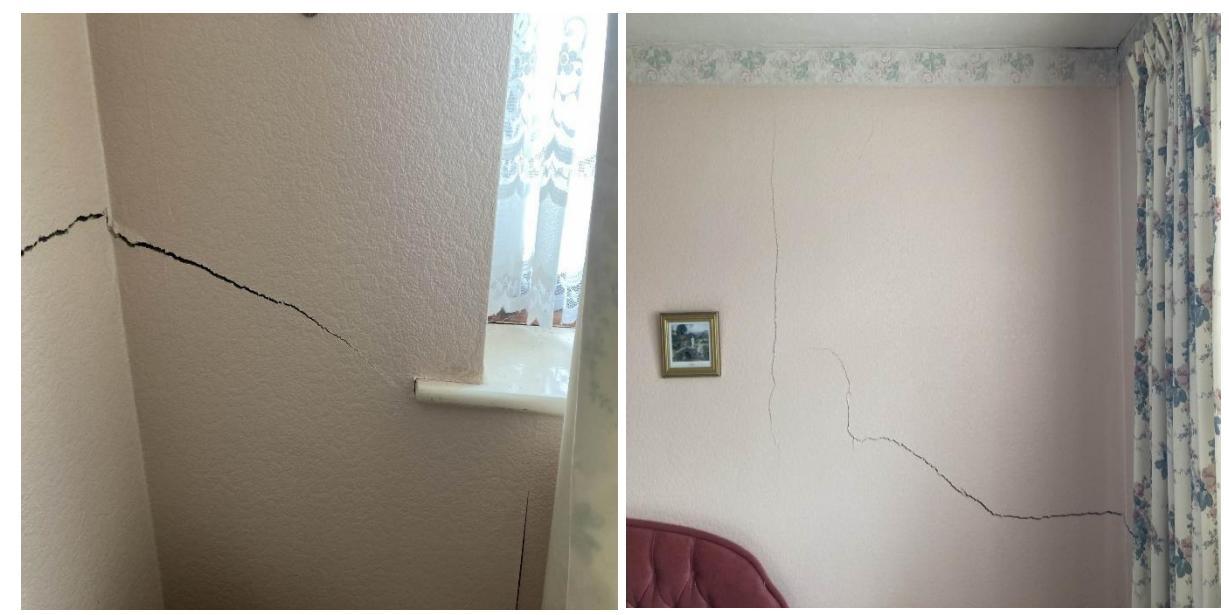
Front Right hand bedroom

35. There is a horizontal crack 4-5mm wide at the corner which runs from the bottom corner of the front window and continues around the corner into the side wall of the property where is meets a vertical crack in the side wall.

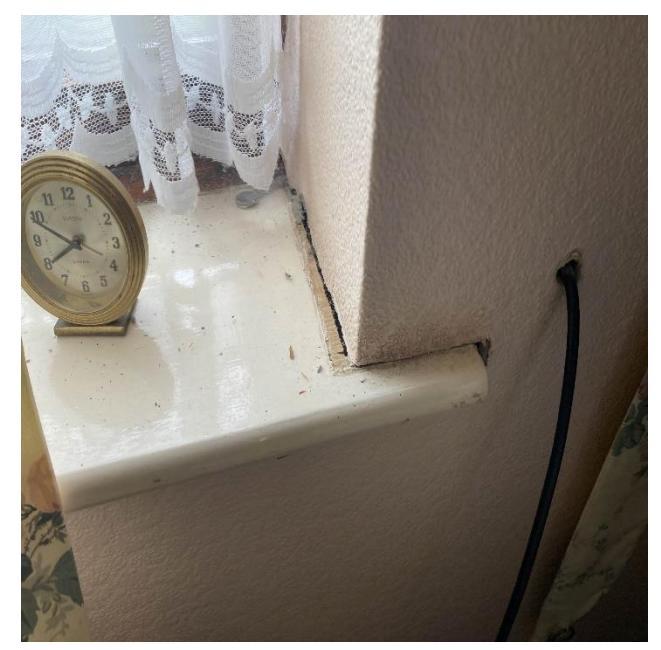
36. The right-hand side window cill has pulled away from the wall and there are gaps.

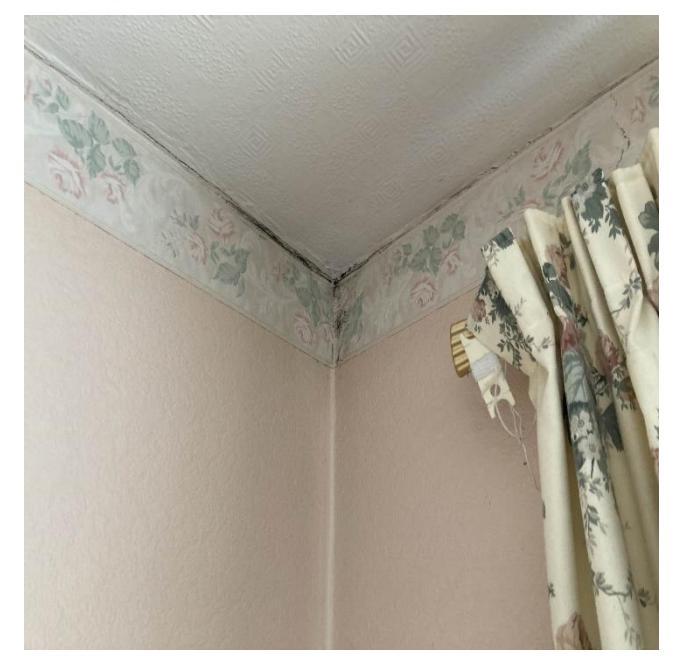
37. There are slight signs of mould growth in the corner of the room.

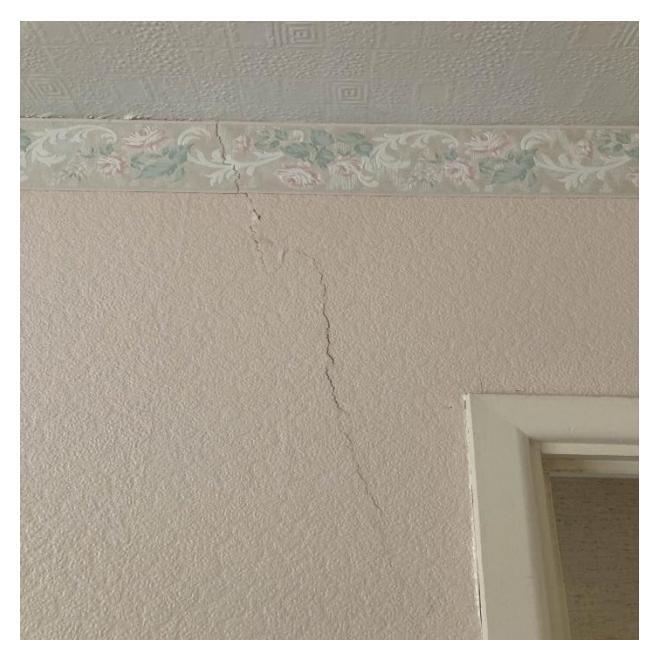
38. There is a crack to the left-hand side of the entrance door. There is also some stretching of the wallpaper at the wall/ceiling junction.

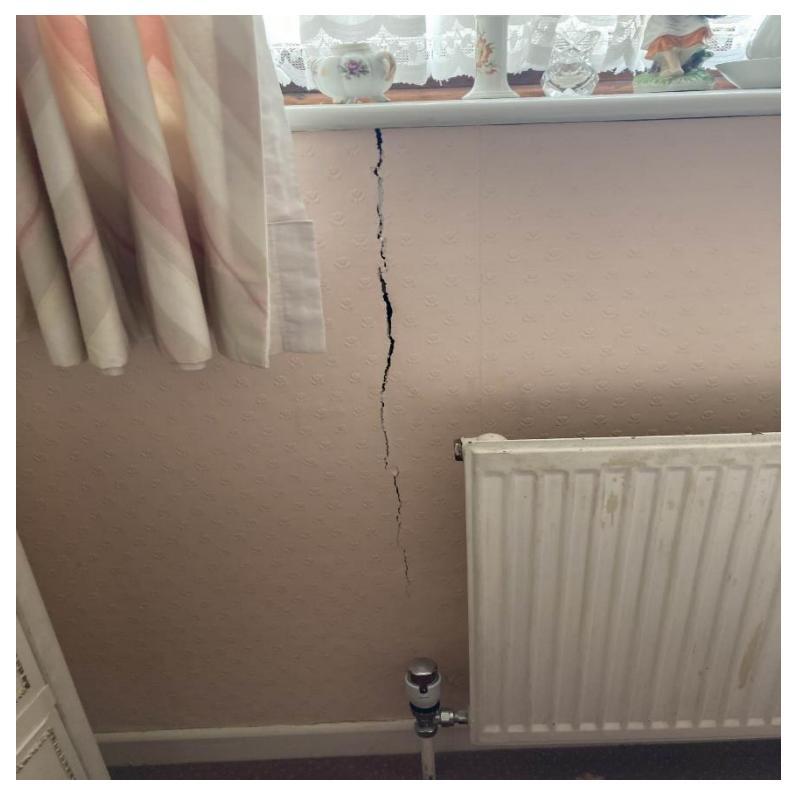
Front Left hand bedroom

39. There is a vertical crack below the front window. The crack is 5-6mm wide at the top reducing to hairline at the bottom.

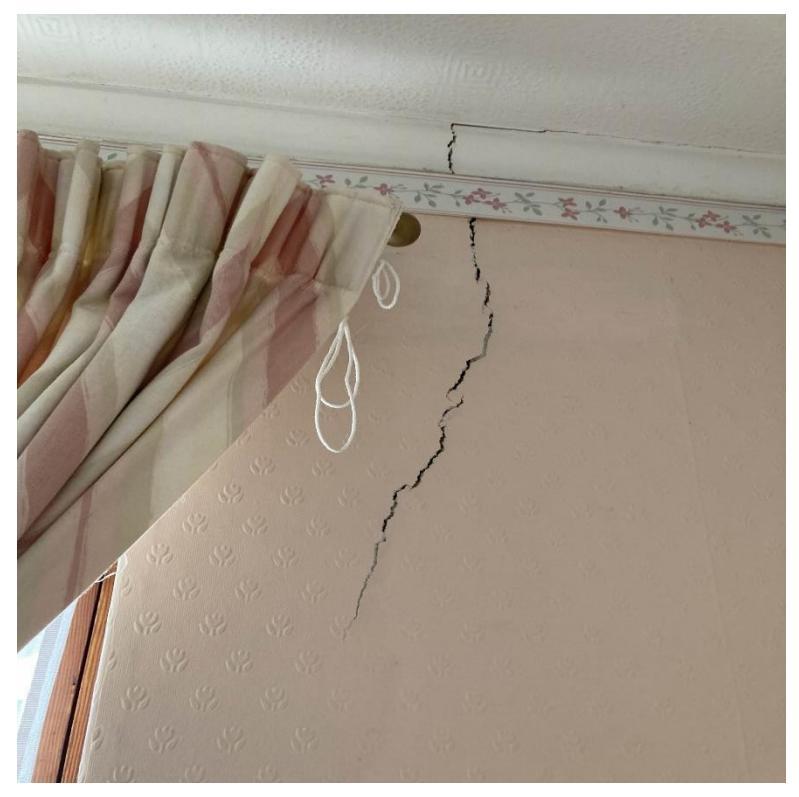
40. There is a crack 3-4mm wide at the top to the right hand side of the window.

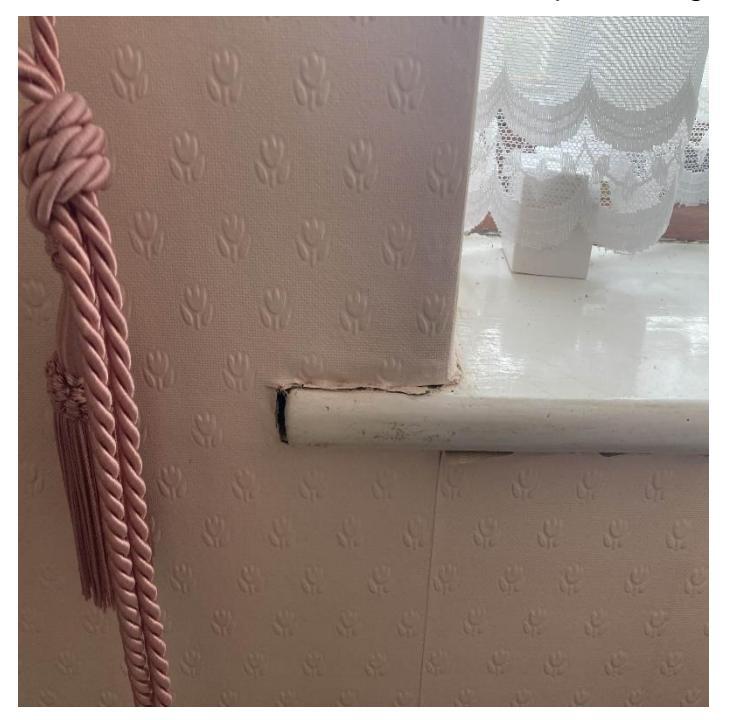
- 41. There are signs of movement to the left side of the window cill and there are gaps between the cill and the wall.
- 42. There are also signs of movement where the coving meets the wall.
- 43. The roof structure was not examined/ because of a lack of access/ not examined in detail but in the absence of reported damage and obvious defects, a detailed inspection did not appear justified.

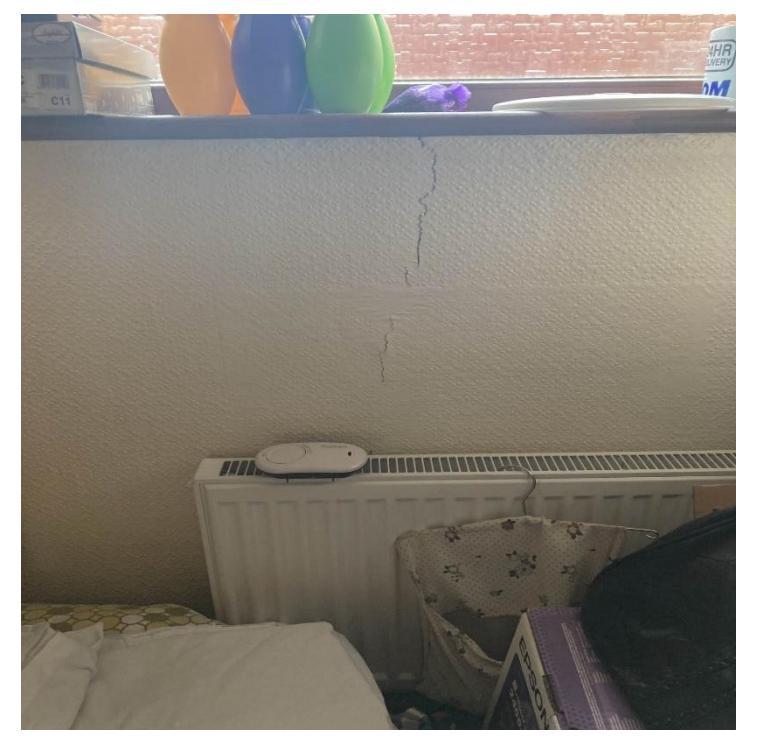
Middle Bedroom

45. There is a vertical crack below the window.

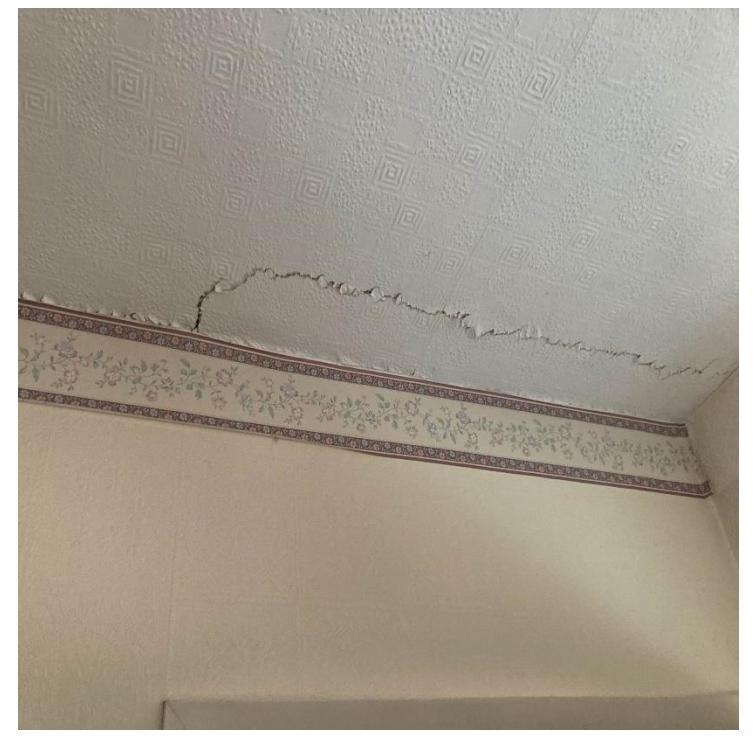
46. There is some cracking to the ceiling over the door to the cupboard that houses the boiler.

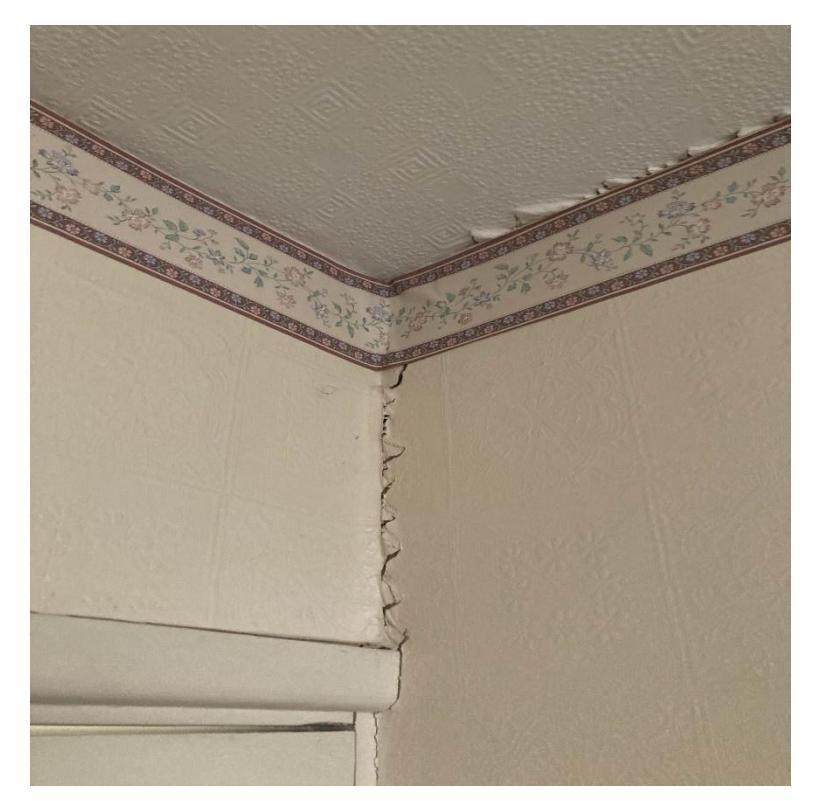
47. There is a vertical crack in the corner over the entrance door and some signs of movement where the wall meets the ceiling.

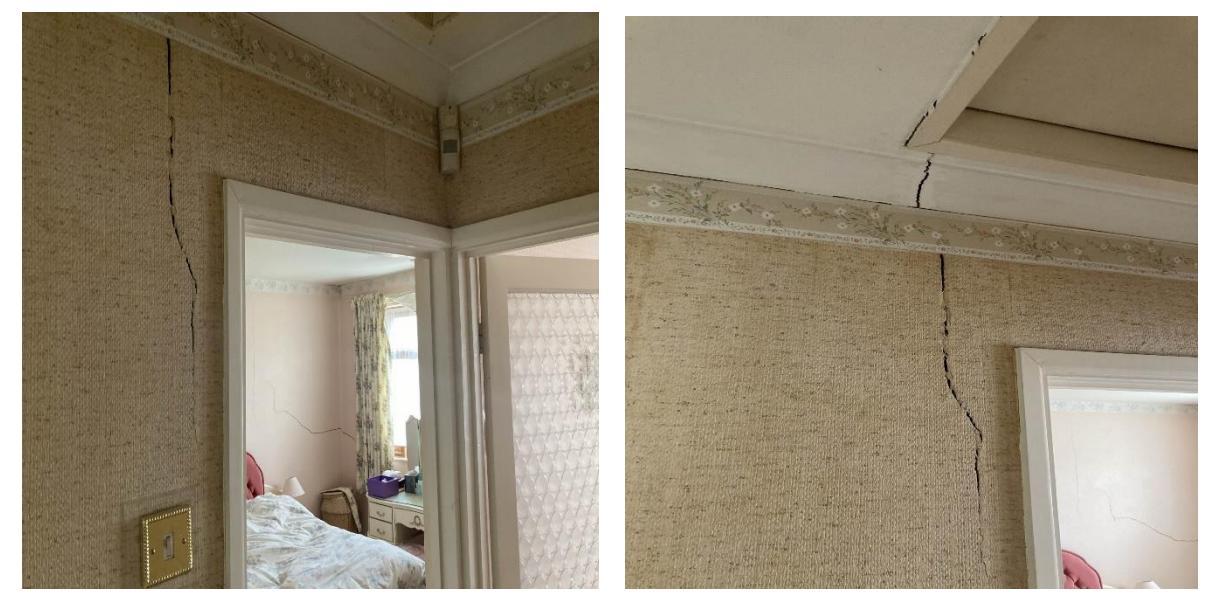
48. There is a vertical crack to the left-hand side of the entrance door to the front right hand bedroom. The crack measures approximately 5mm wide at the top reducing to hairline at the bottom. The crack extends up the wall and through the coving.

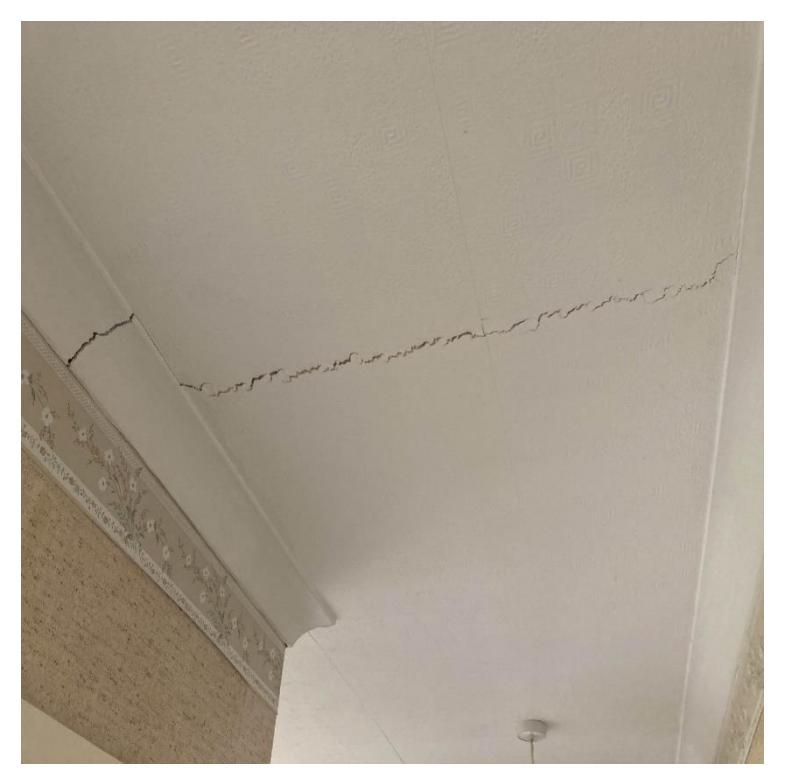
- 49. There is a crack in the ceiling that extends through the coving roughly in the middle of the hall close to the entrance to the WC.
- 50. There are other less significant cracks to the entrance hall ceiling.
