Our Ref: 17775/KL

17th April 2025

72 Elmwood Crescent, Flitwick, Beds. MK45 1LJ - Structural Inspection

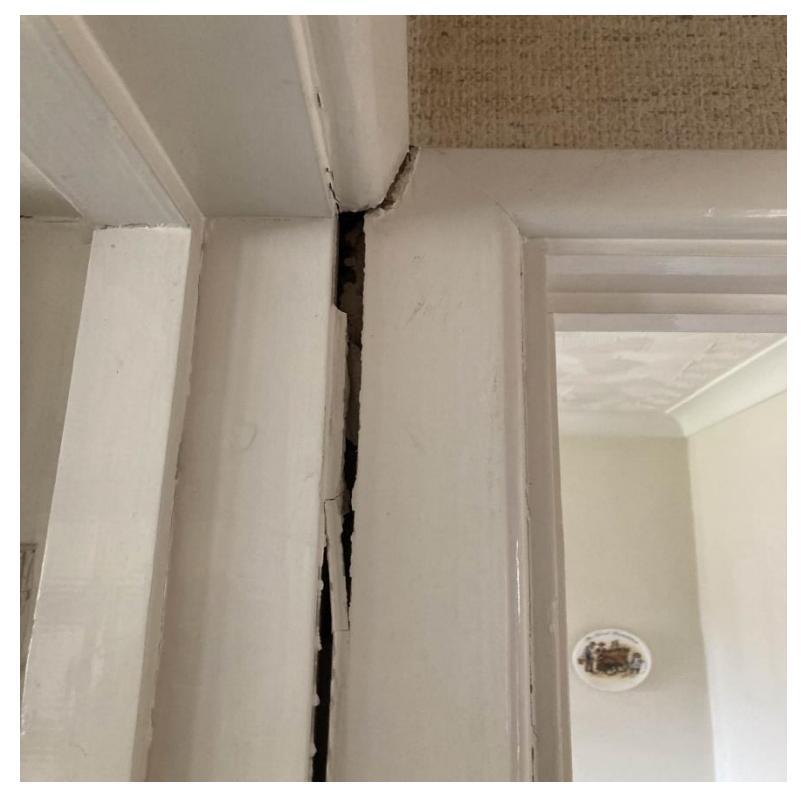
51. There is a gap of approximately 10mm where the architrave to the kitchen entrance door has pulled away from the entrance door to the living room.

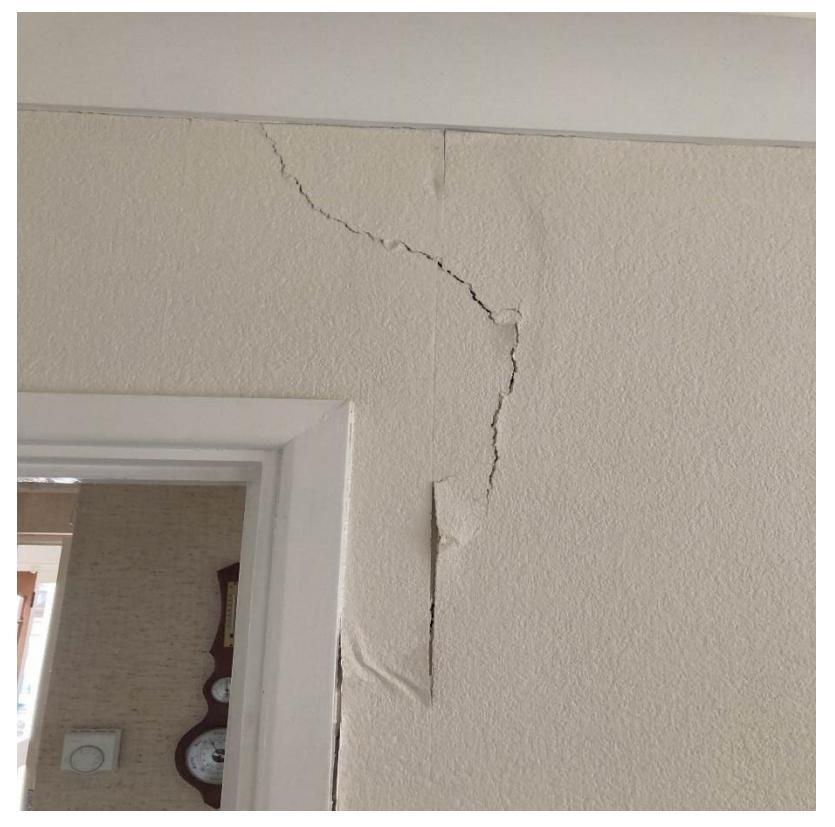
Kitchen

53. There is cracking to the right-hand side of the entrance door to the kitchen.

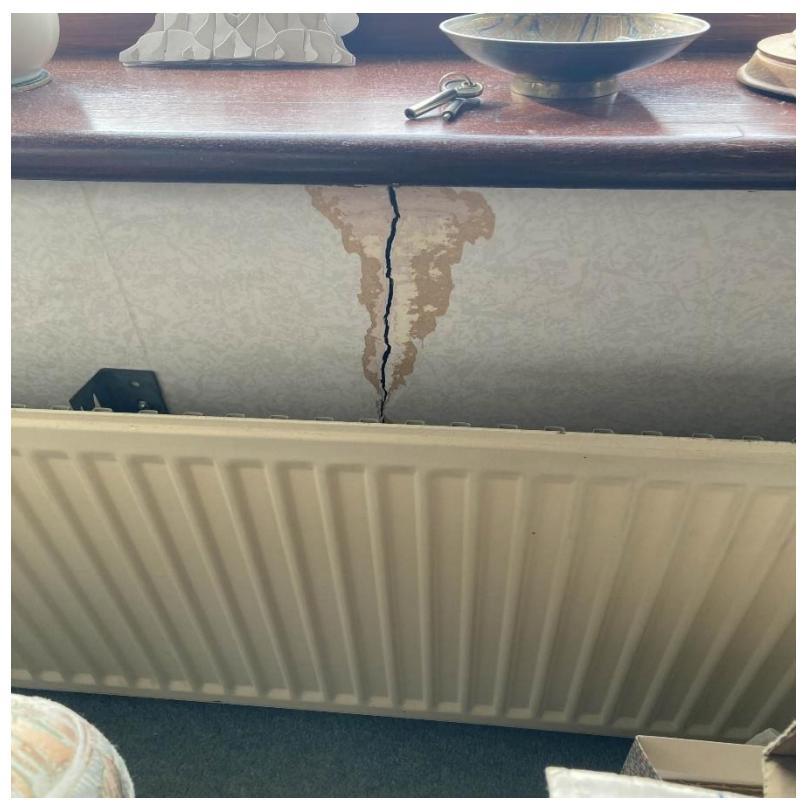
Living Room

54. There is a crack to the rear wall below the window. The crack is 3-4mm wide at the top reducing to hairline at the bottom.

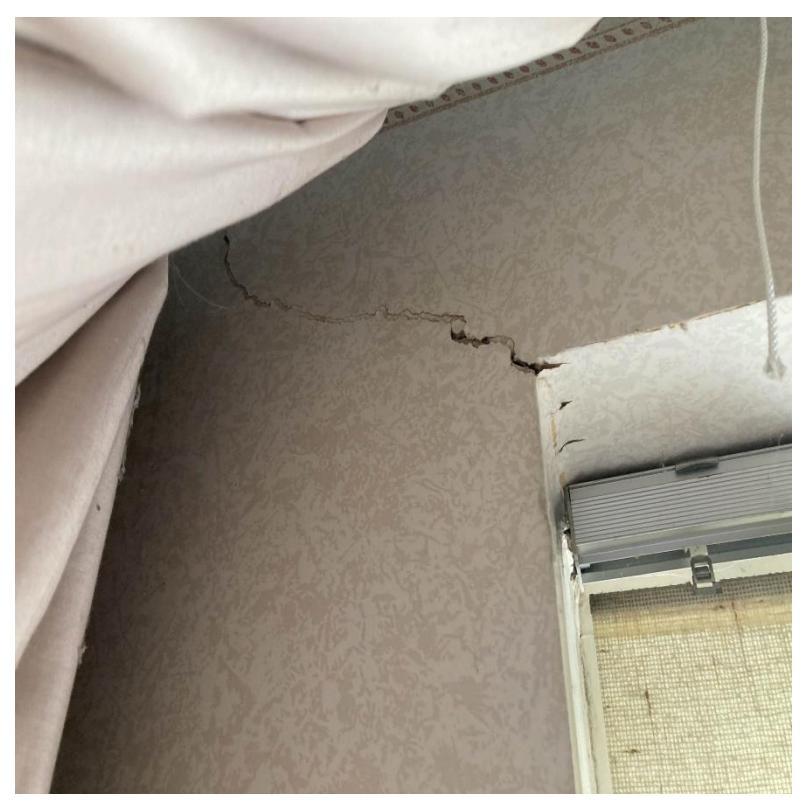
55. There is a tall window on the rear wall of the living room. There is a crack running from the top left-hand corner of this window up to the ceiling.

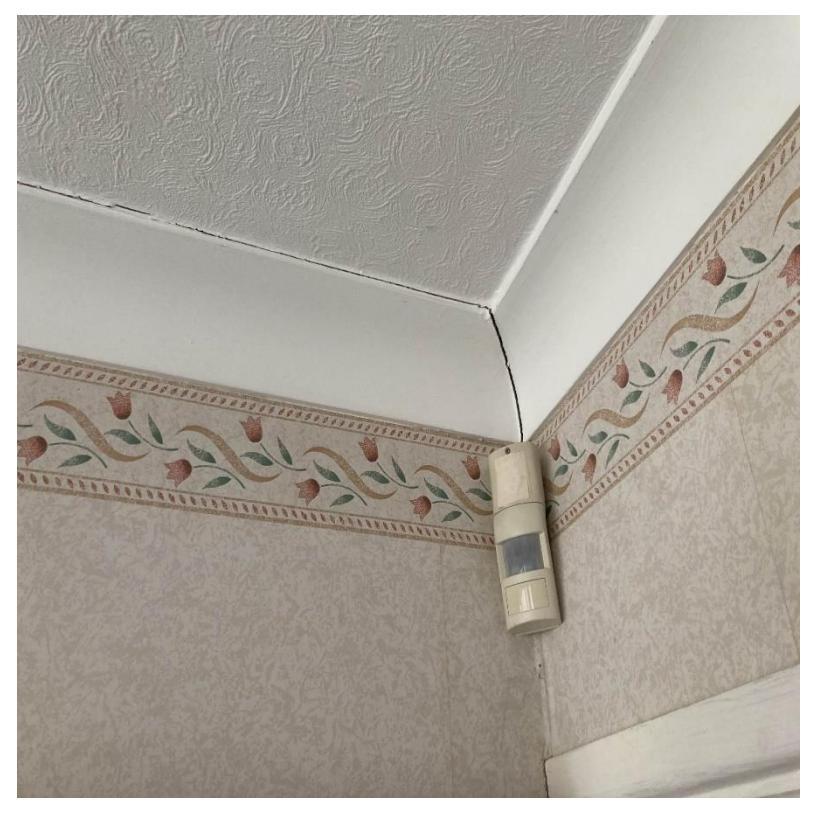
56. There is some cracking at the coving/ceiling junction above the entrance door to the living room.

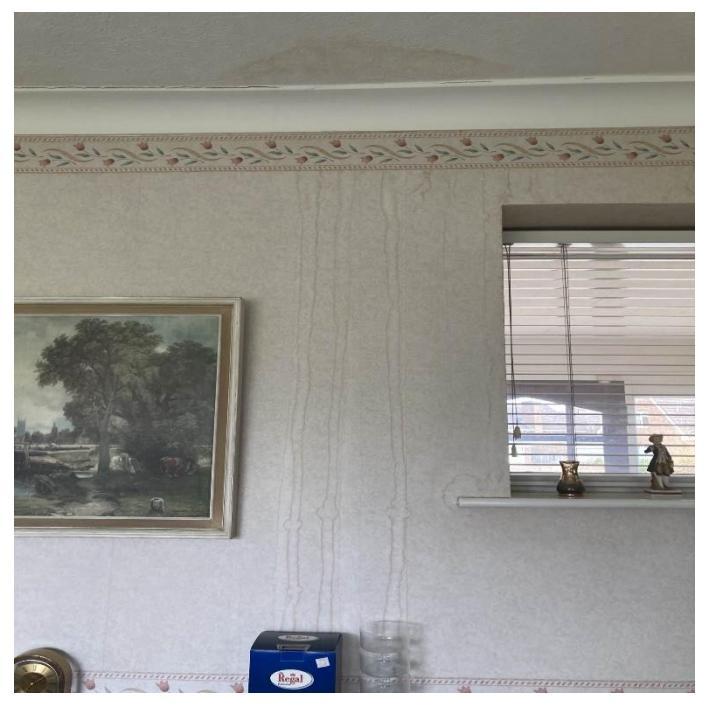
57. There is some water staining to the ceiling and wallpaper to the front wall of the living room.

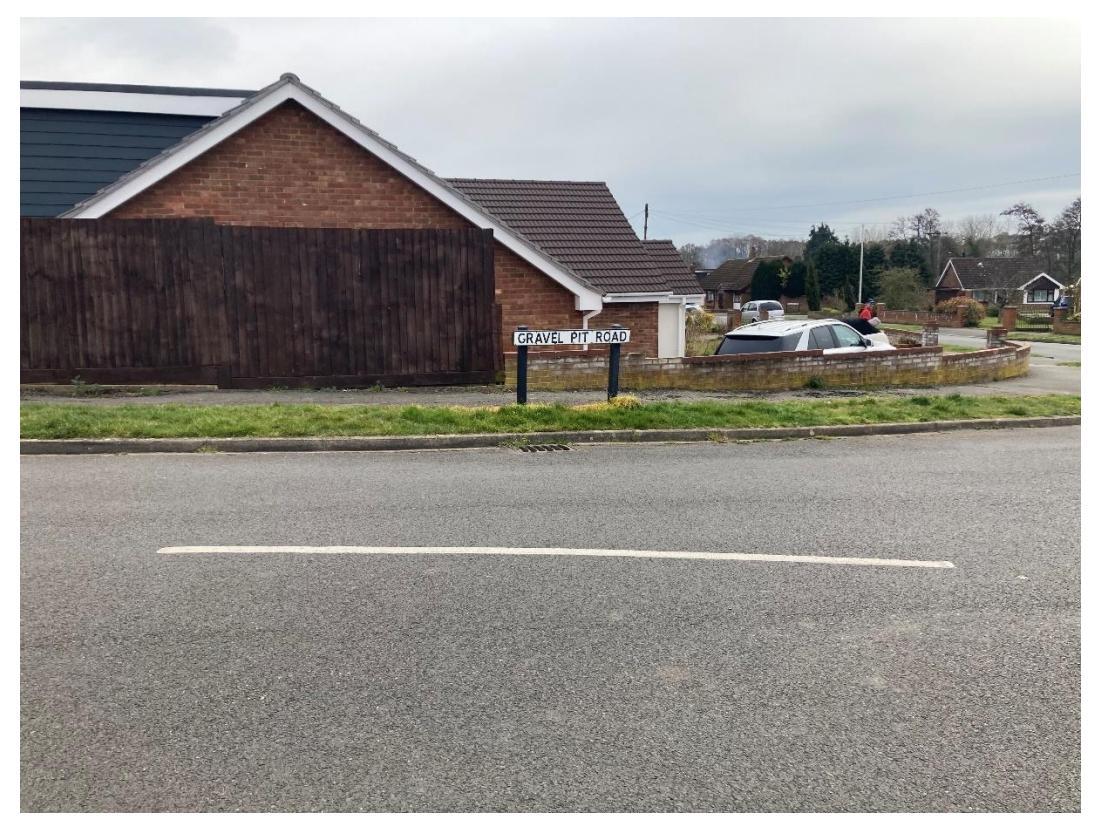
- No 74 has some cracking to the side wall. I spoke to the owner while I was on site and they said that they had the crack repaired in 2006-2007 and it has not reopened.
- The neighbour told me that No. 70 had a history of cracking, and these were also repaired in 2006-2007.
- No. 78 has some slight cracking to the side elevation.
- No. 66 is a very similar property to this property and appears to have been constructed with the same bricks. Cracking was noted to the front of this property in similar positions and there are signs that historic repairs have been carried out.

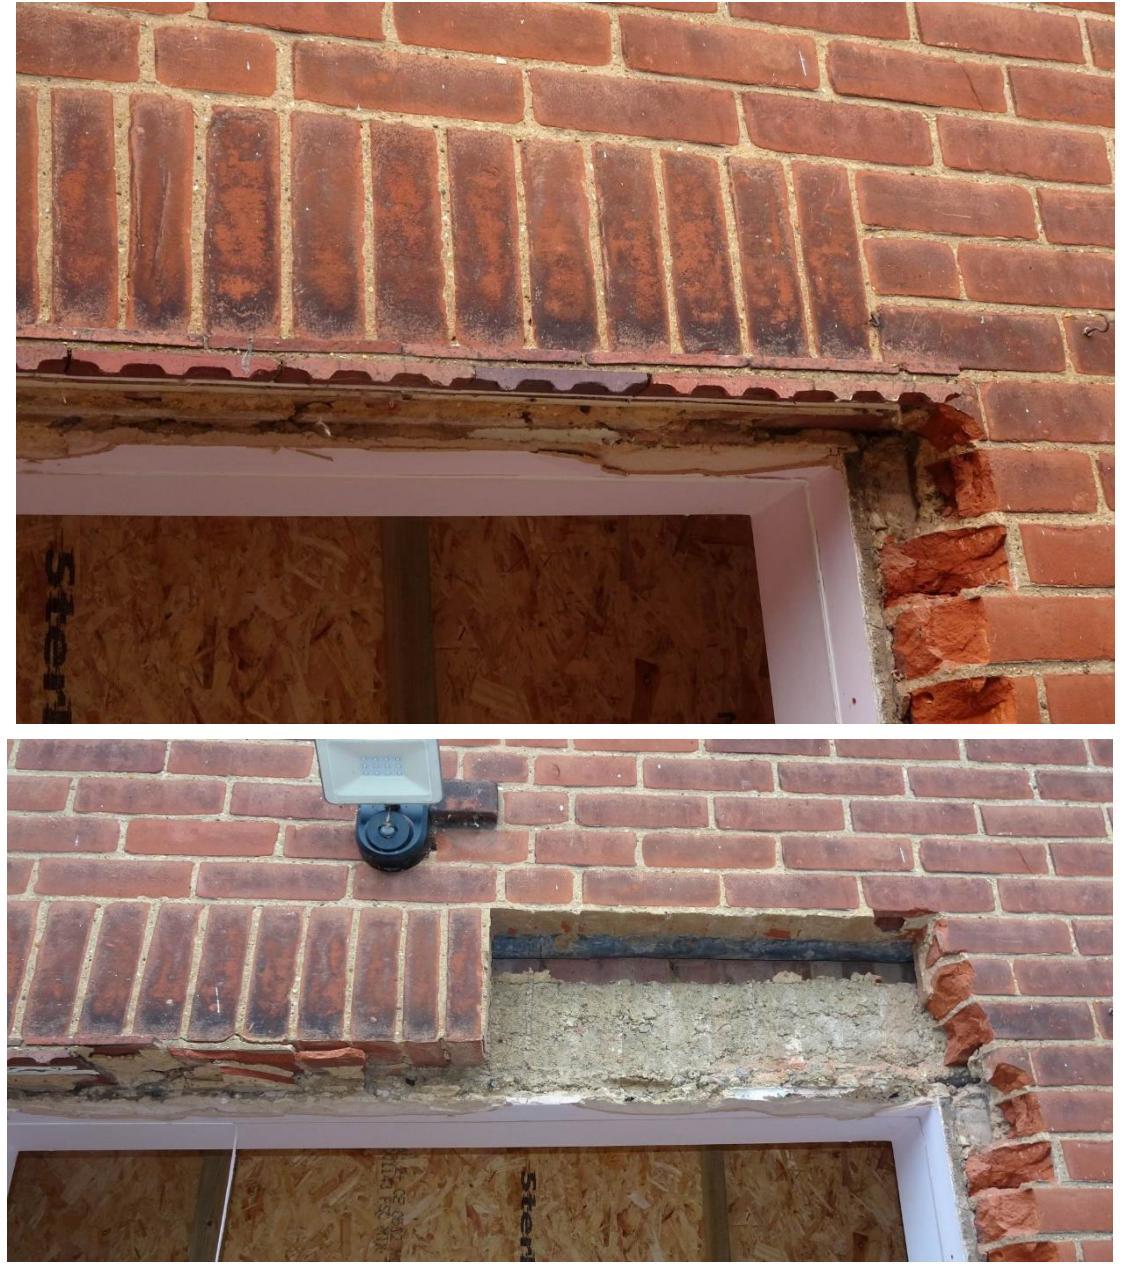
- 107. In the above photographs, the concrete lintel was cast against the soldier course but there were no ties joining the brick to the concrete with it just relying on the concrete 'sticking' to the back of the bricks. This detail does not adequately support the brick above.
- 108. In this case there is some cracking over the soldier course which suggests that the lintel is not a composite lintel.
- 109. The mastic seals to the windows, particularly to the front and side windows are very large. It may be advisable to remove the mastic, foam fill the gaps and install some trims to cover the gaps. The trims can then be sealed with mastic to provide a weather tight junction.
- 110. There are visual signs of water ingress to the front wall of the living room. This could mean that the roof is leaking, and this will need to be investigated by a roofing contractor and repaired if necessary.
