Combined Fire/Health & Safety Risk Assessment

Site / Development: Rede House, 63-75, Corporation Road, Middlesbrough, TS1 1LY

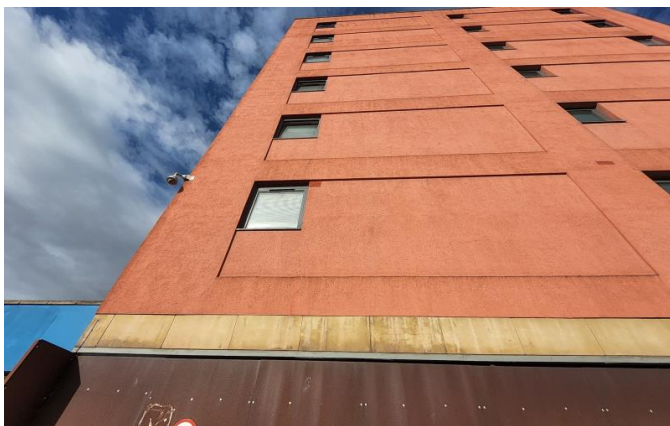
T# 2025-309582 Advice For External Wall Systems / Cladding / Balconies

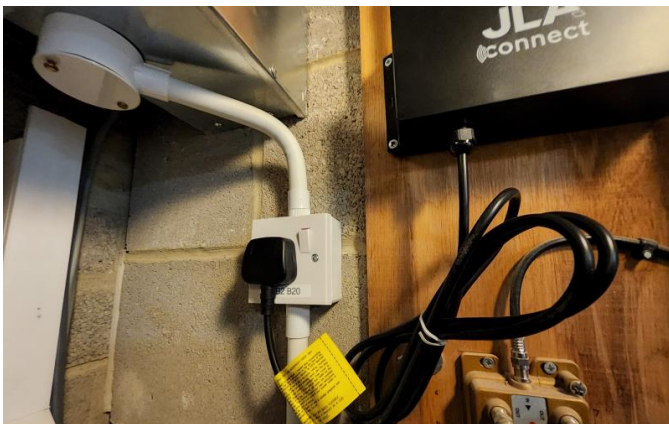
Example of un-tested AV equipment in the riser cupboards.

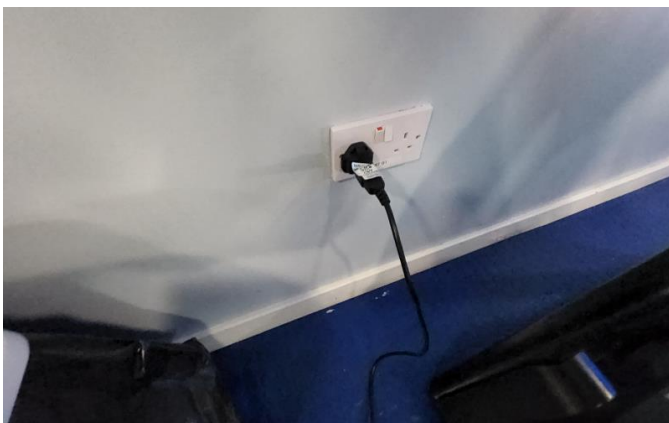
Example of a PAT label on the gym equipment.

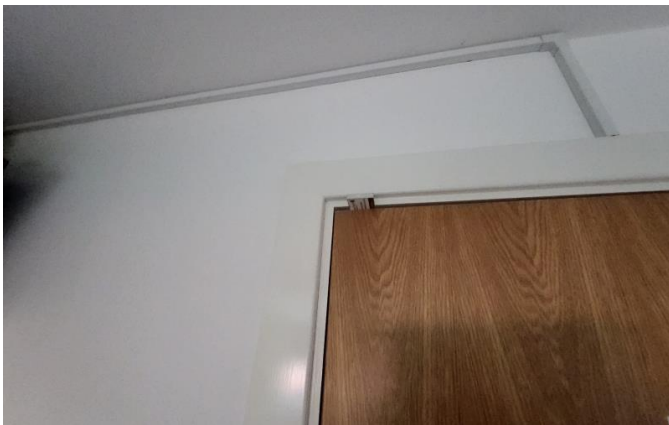
Example of plastic electrical conduit above flat 06-01's front entrance door.

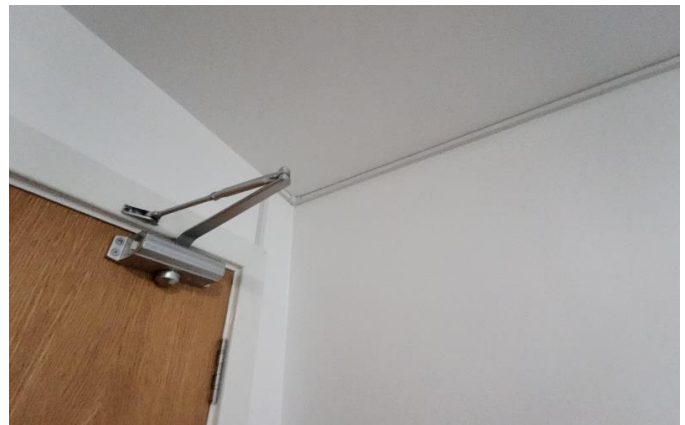
Example of plastic electrical conduit above flat 02-39's front entrance door.

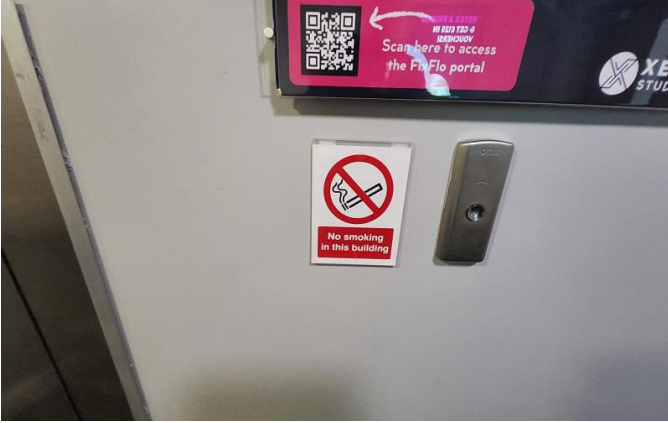
No-smoking signs in the common areas.

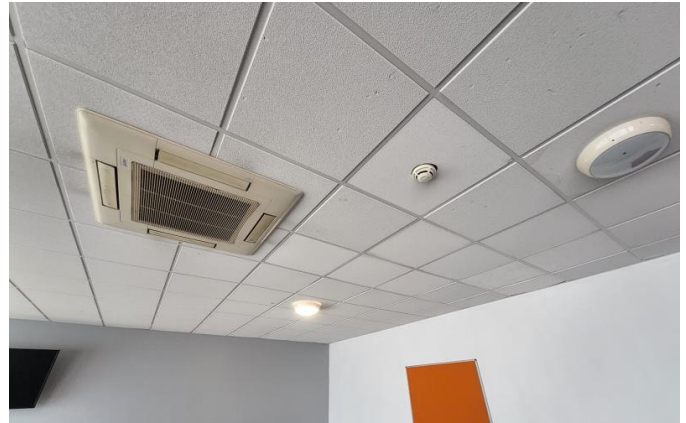
Example of an air-conditioning system in the communal areas.

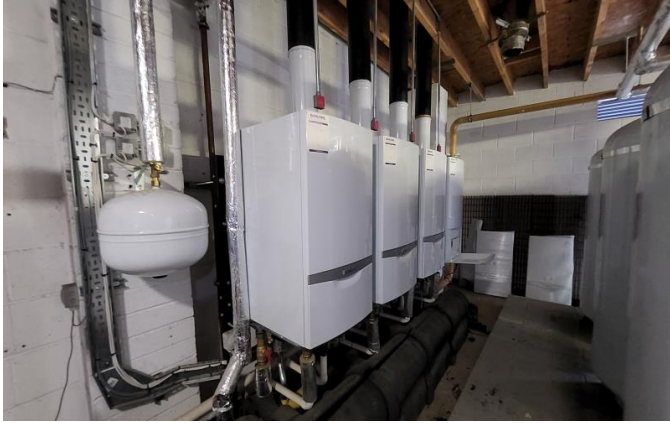
Gas combi-boilers in the plant room.

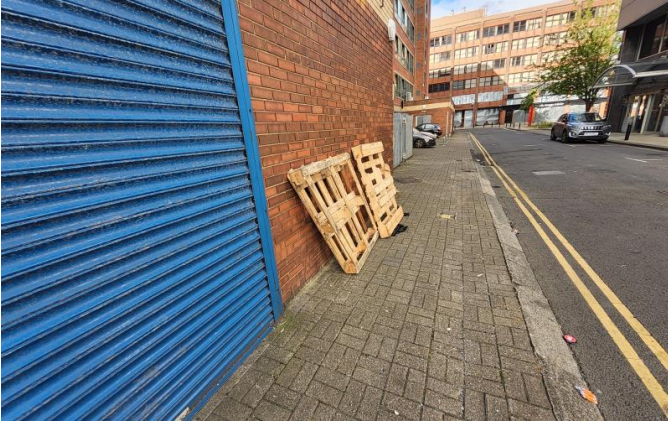
Wooden pallets to the rear of the building.

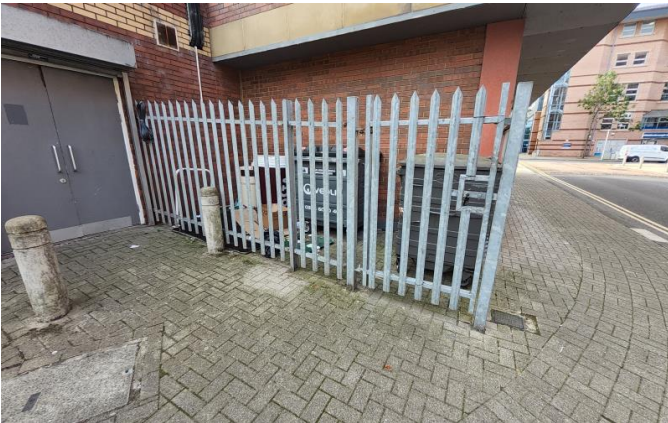
External bin storage area to the rear of the building.

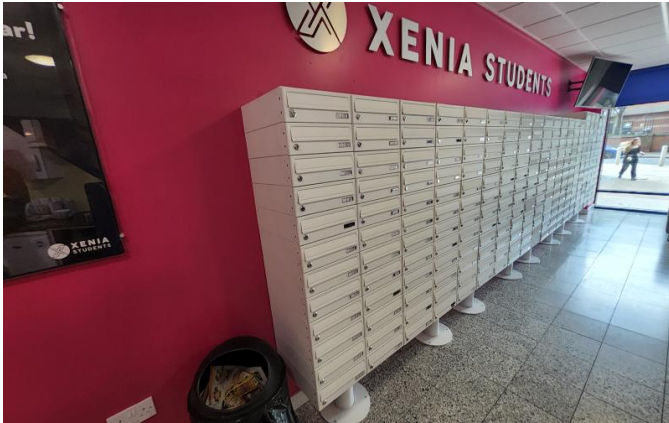
Internal, individual, residents' postboxes.

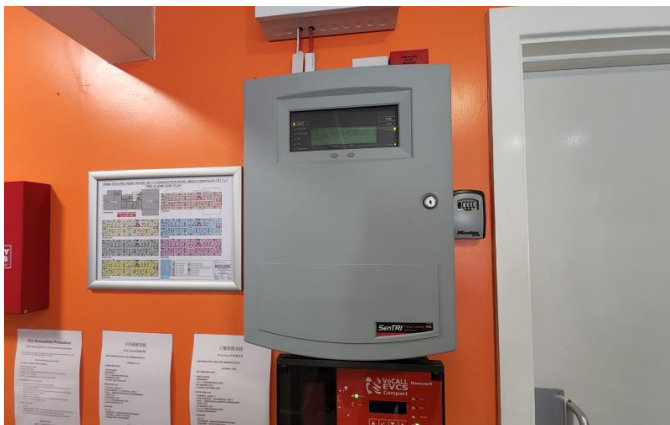
Fire alarm panel with no faults at the time of the assessment.

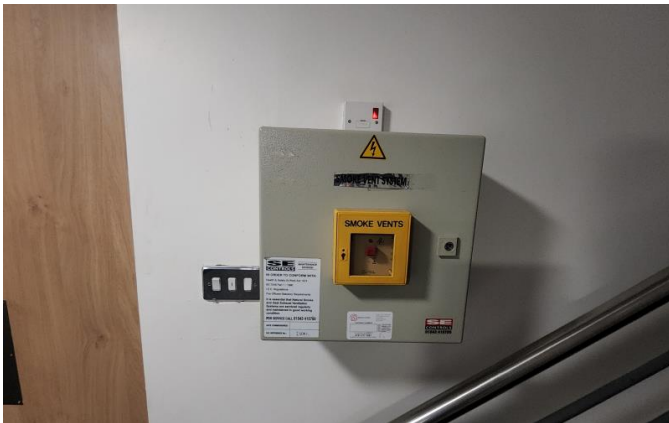
Smoke Vent Swich Control Panel.

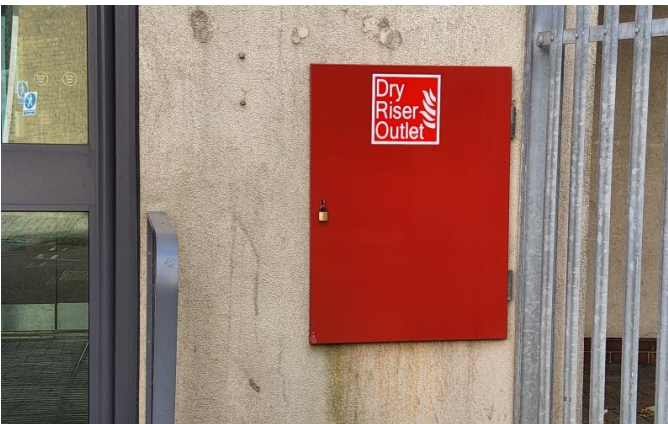
[T# 2025-310592 Fixed firefighting installation other](#)

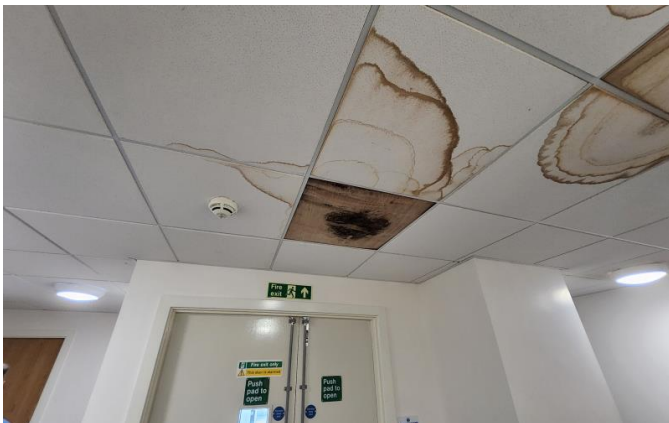
Damaged ceiling tiles in the common corridors.

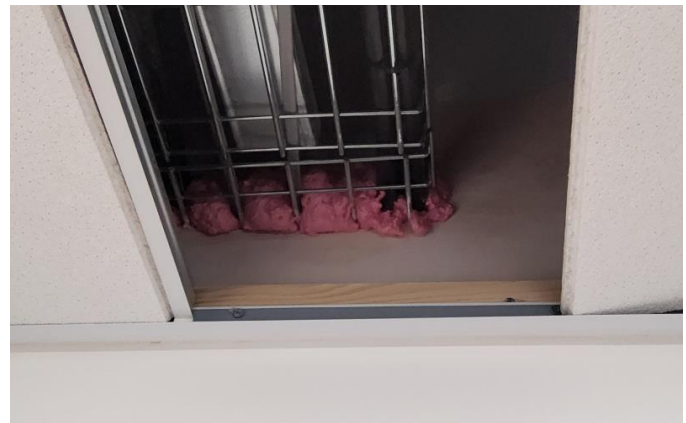
Expanding foam used to fire-stop gaps between compartments.

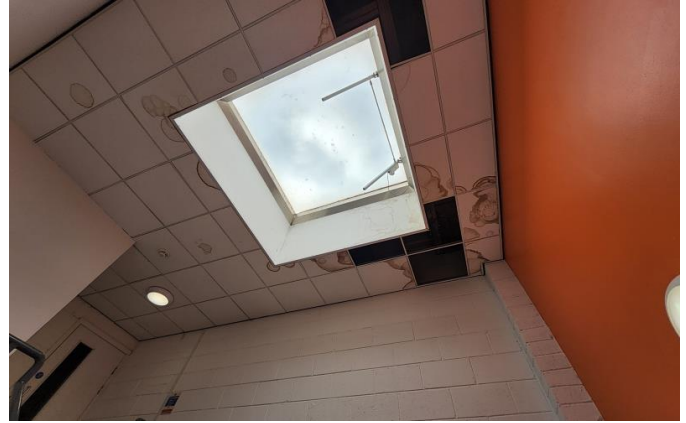
Damaged and missing ceiling tiles in the protected stair.

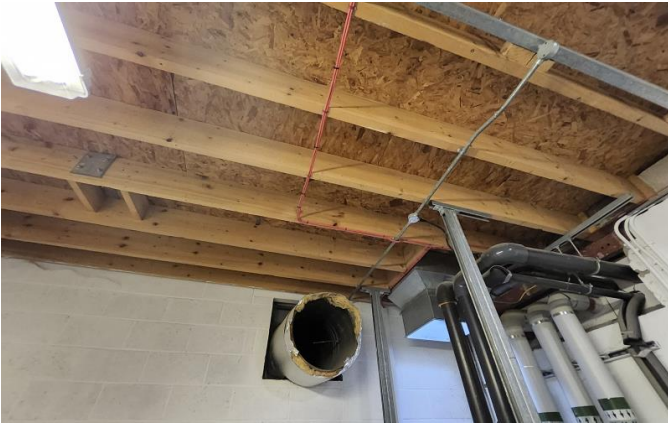
Incomplete compartmentation with exposed beams in the water tank room.

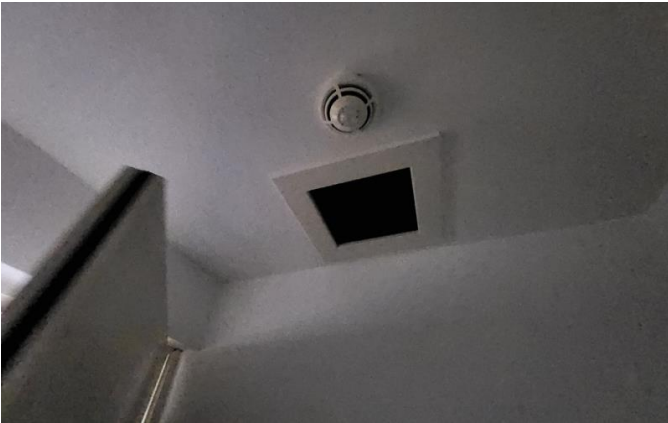
Missing access hatch in the 5th floor storeroom.

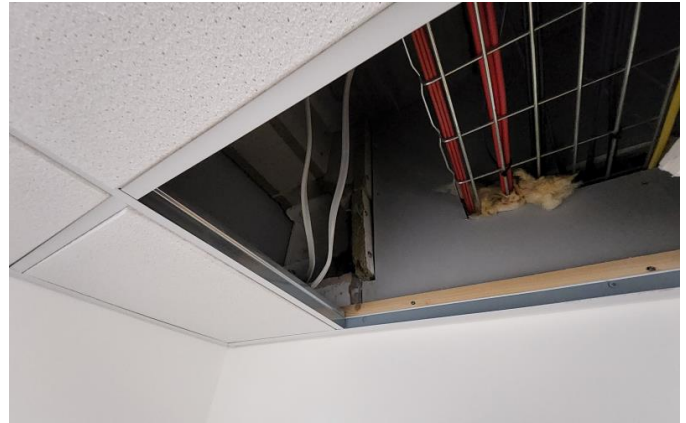
Incomplete compartmentation above the cross-corridor door.

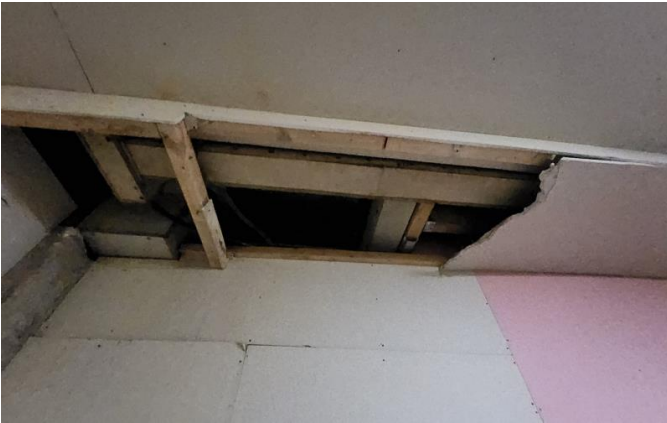
Damaged ceiling in the bike store.

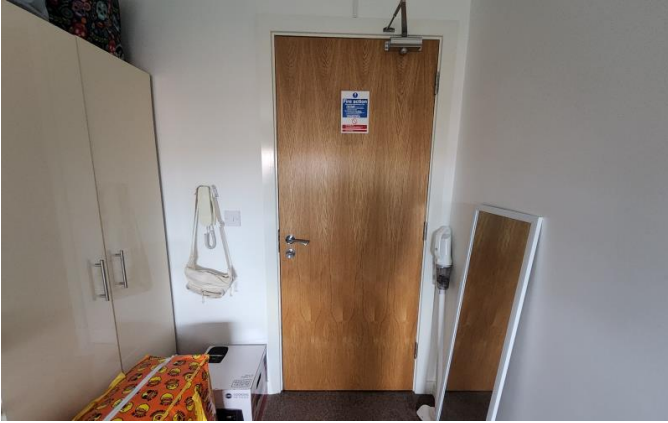
Room 6-01's front entrance door.

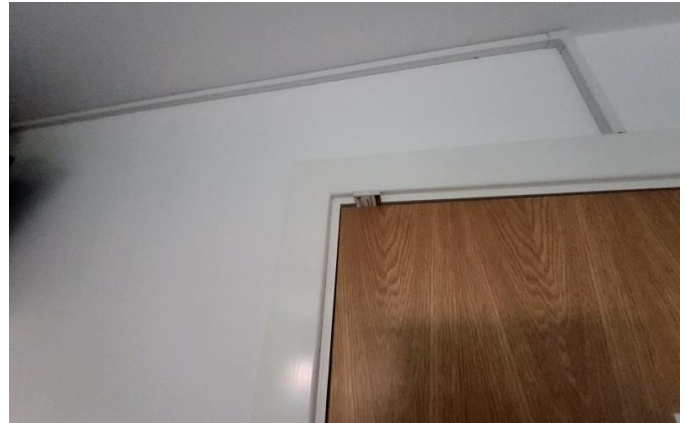
Room 6-01's front entrance door with gaps that exceed the recommended tolerances.

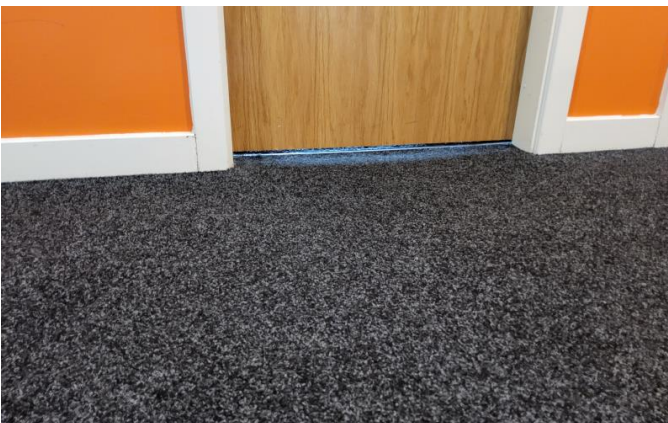
Room 6-01's front entrance door with gaps that exceed the recommended tolerances.

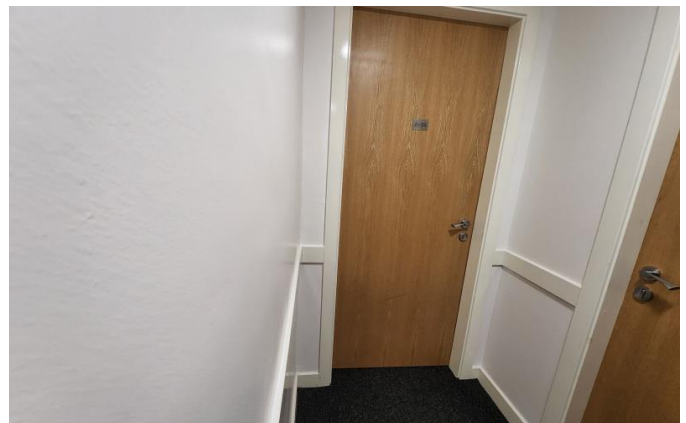
Room 2-39's front entrance door.

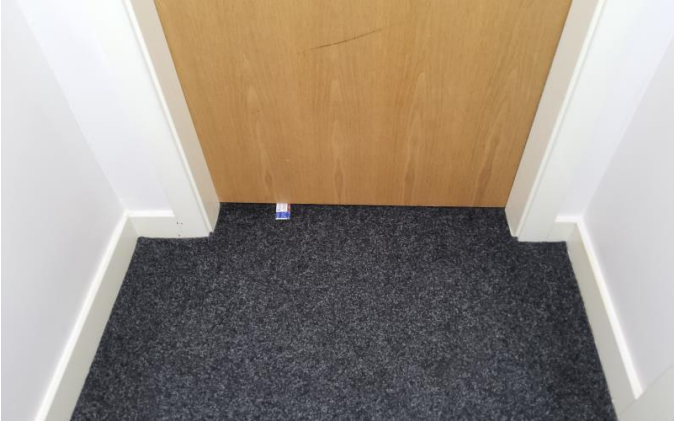
Room 2-39's front entrance door with gaps that exceed the recommended tolerances.

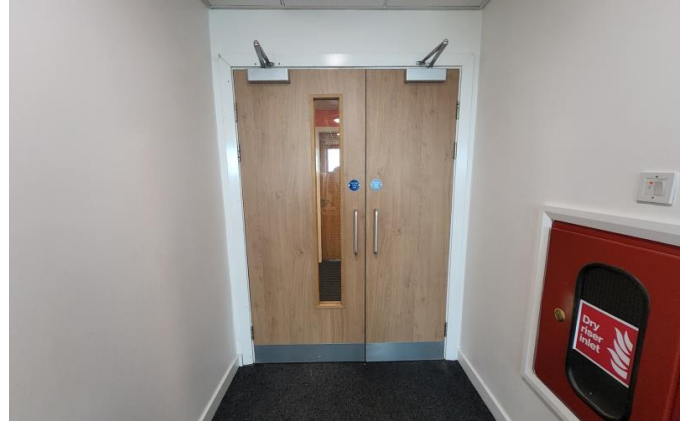
Example of a fire-rated lobby door.

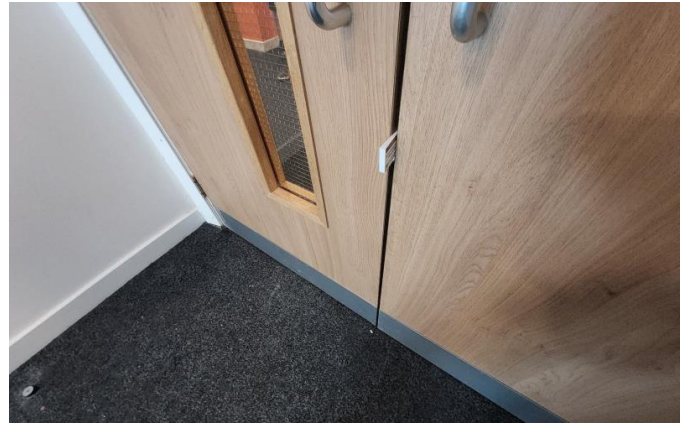
Example of a lobby door with gaps that exceed the recommended tolerances. .

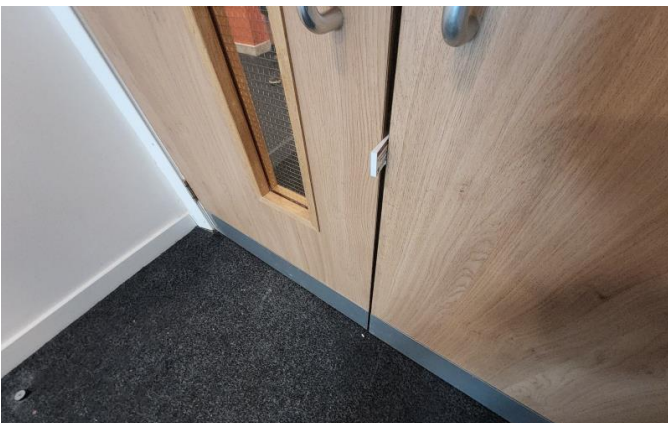
Example of a fire-rated lobby door with gaps that exceed the recommended tolerances.

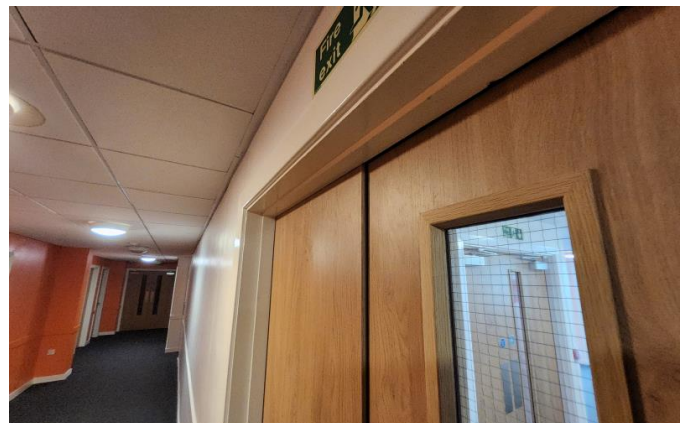
Example of a lobby door that doesn't close fully.

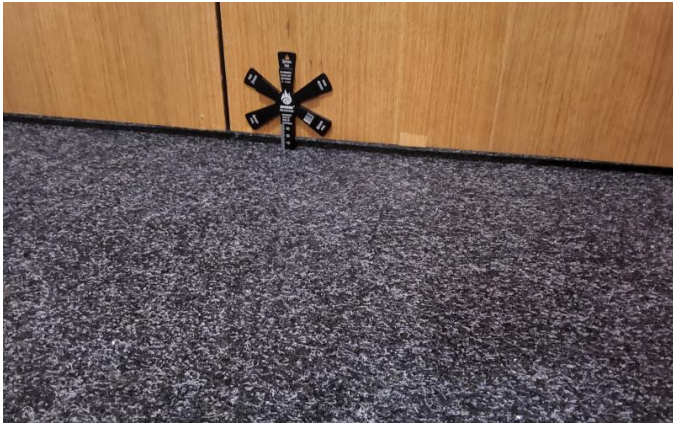
Example of a lobby door with gaps that exceed the recommended tolerances.

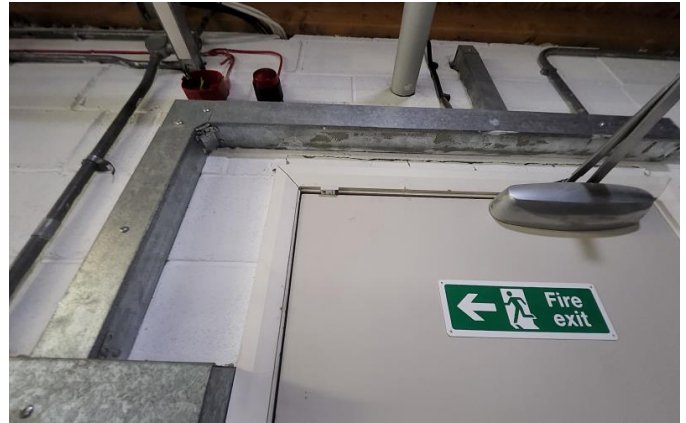
Example of a plant room door with gaps that exceed the recommended tolerances.

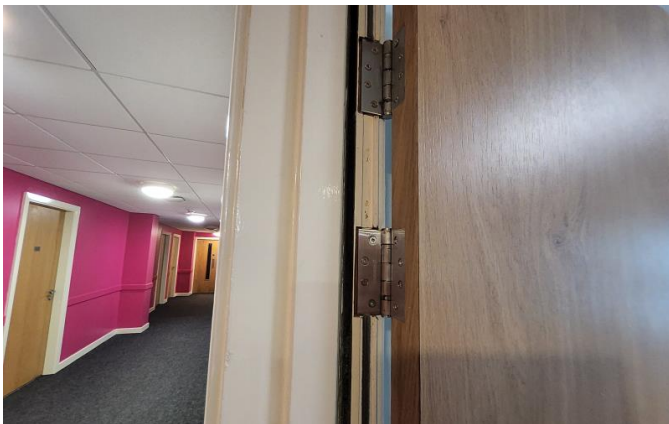
Example of a lobby door with seals missing.

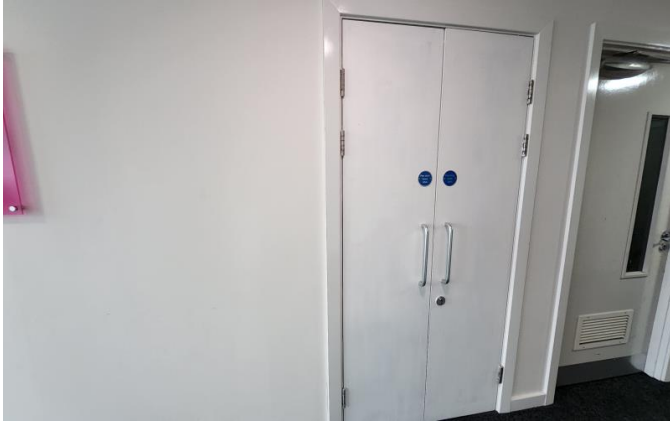
Example of a riser cupboard door.

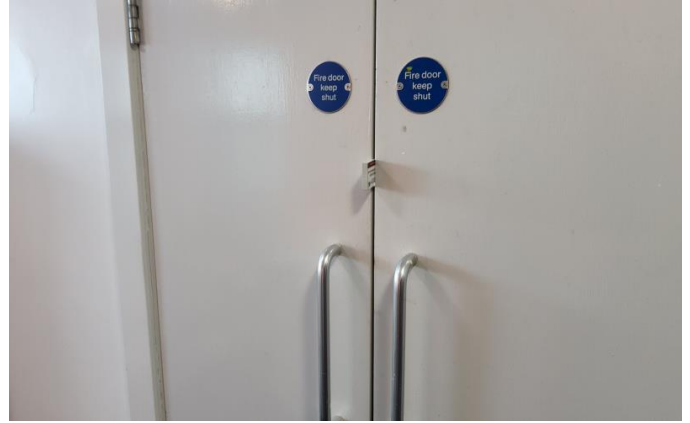
Riser cupboard door with gaps that exceed the recommended tolerances.

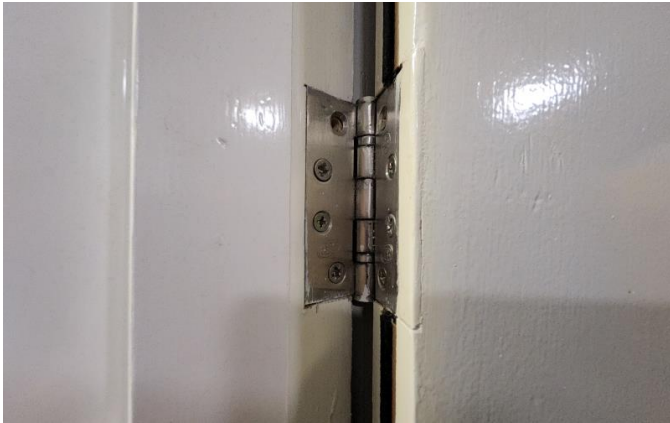
Example of a riser cupboard door with screws missing from the hinges.

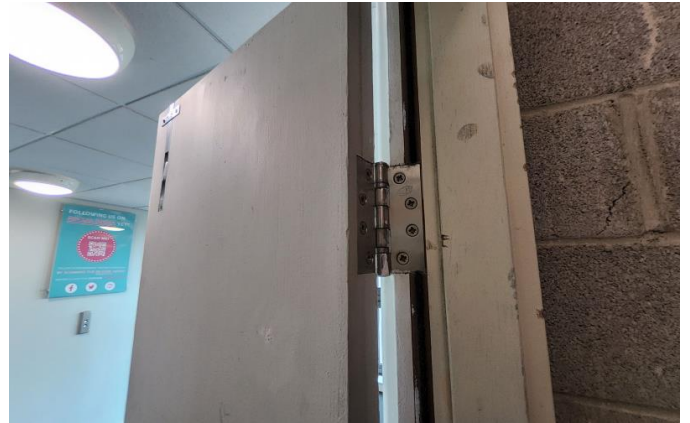
Example of a riser cupboard door's fire-rated hinges and combined intumescent strips with cold smoke seals.

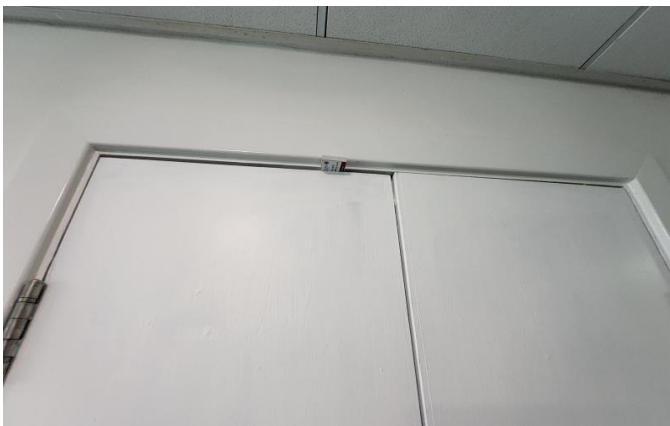
Riser cupboard door with gaps that exceed the recommended tolerances.

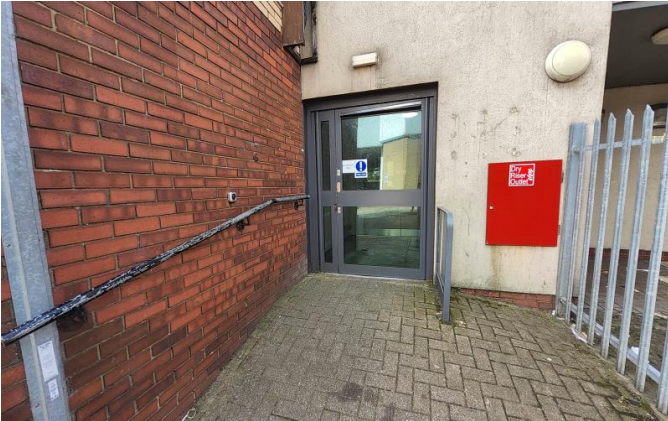
Fire exits are missing the 'Fire exit keep clear' sign on the doors.

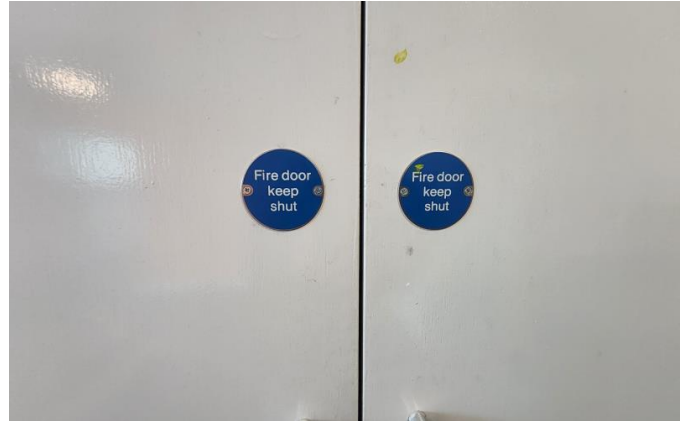
Incorrect signs on the riser cupboard doors.

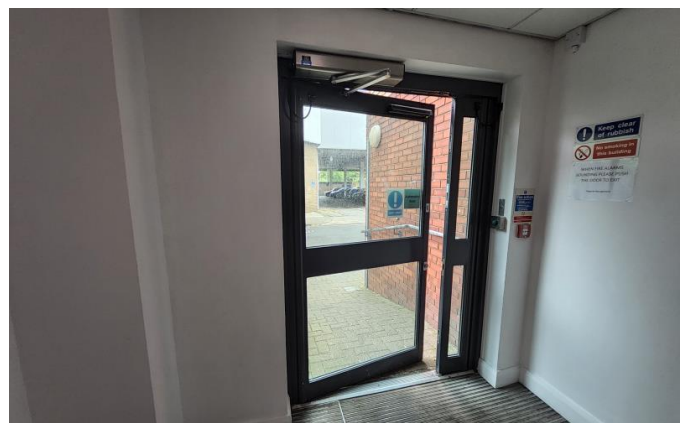
Fire exit signs are missing from above the final exit doors.

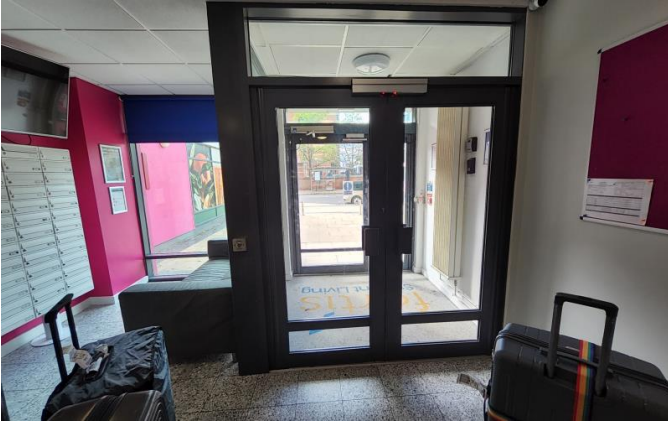
Fire exit signs are missing from above the final exit doors.

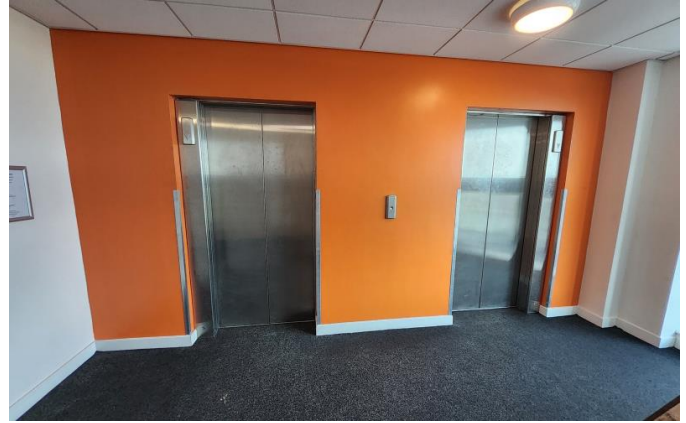
Example of a lift in the common areas missing a "Do not use life is event of fire' sign.

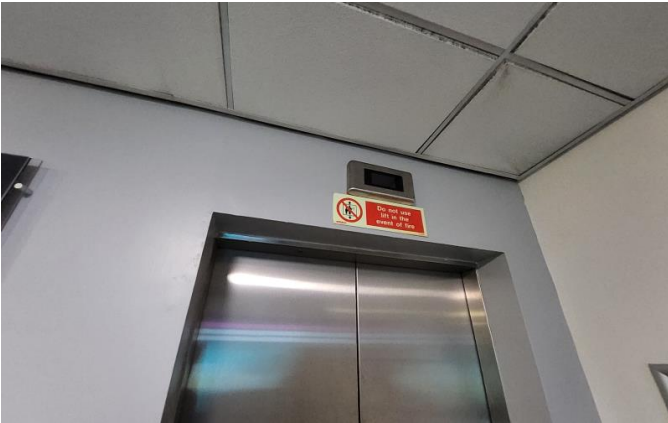
Example of a lift warning sign on the ground floor lifts.

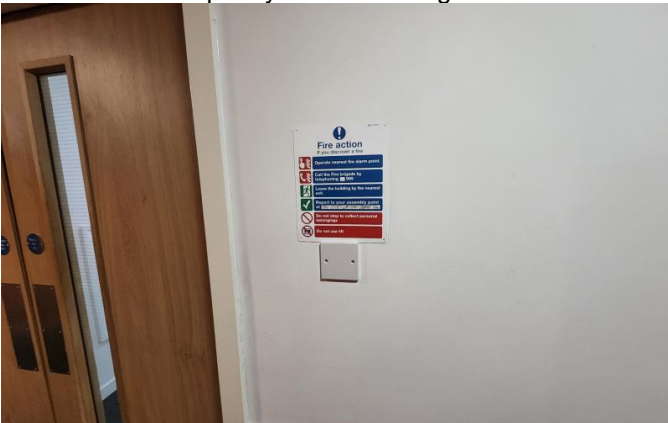
Simultaneous fire action notices.

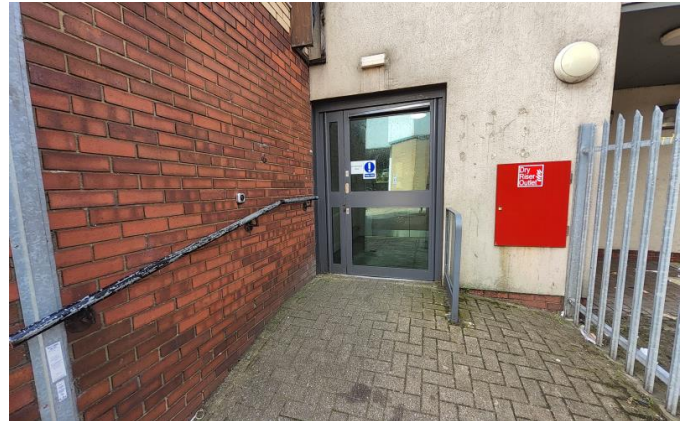
External emergency lighting.

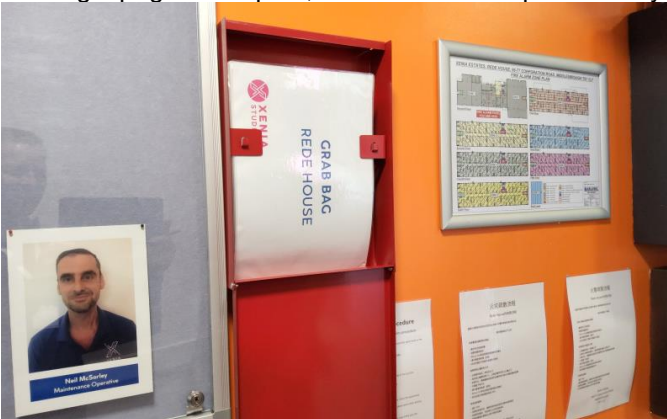
- The UK contact details.
- The UK contact details of any other person who has the facilities to and is permitted to access the building as the responsible person considers appropriate.
- Copies of the building's floor plans, which identify specified key firefighting equipment.
- A single page block plan, which identifies specified key firefighting equipment.

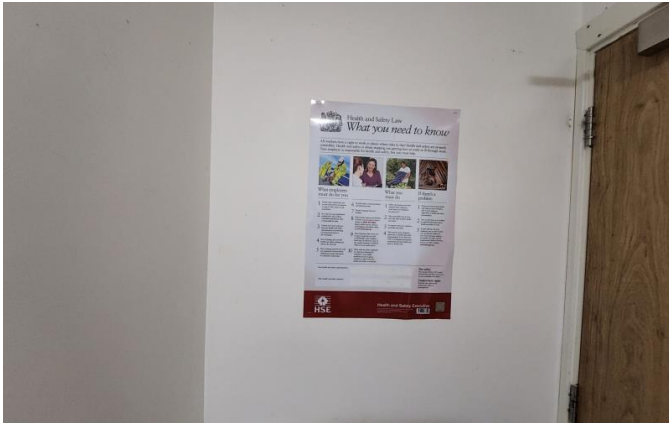
Health and Safety poster.

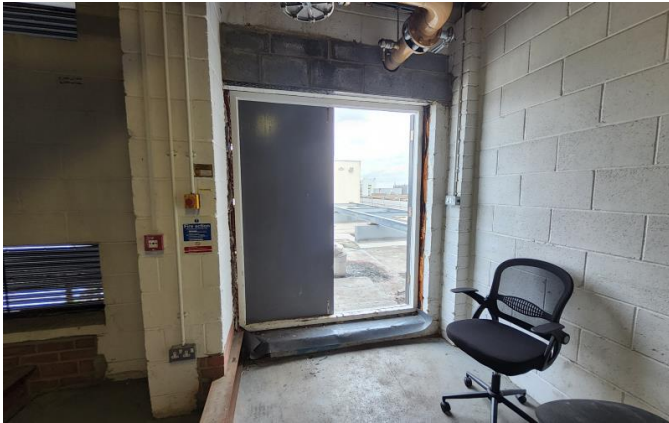
Roof access door was unlocked.

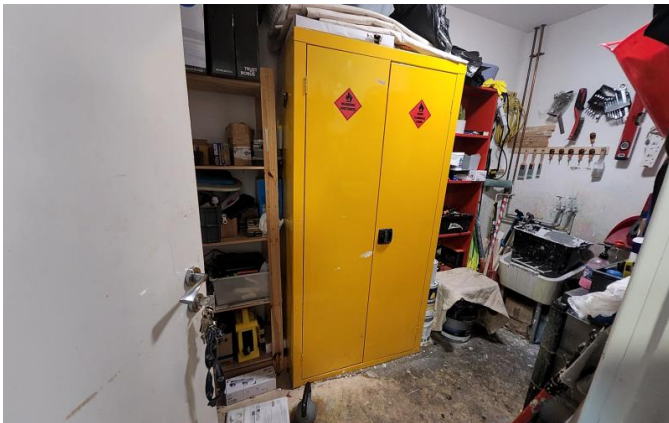
COSHH cupboard with relevant information kept in the locked maintenance manager's storeroom.

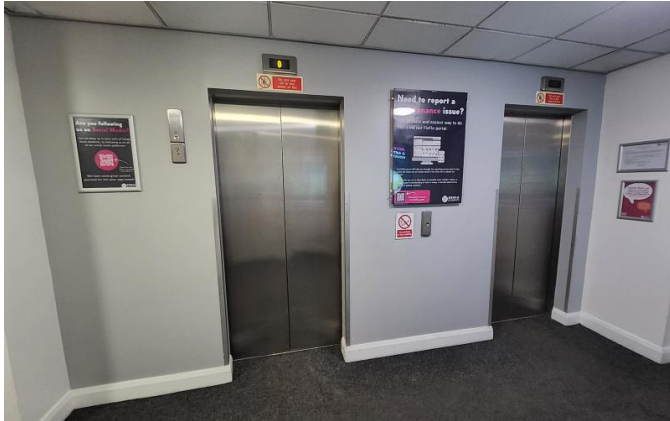
All statutory inspection certificates for the lifts and/or lifting equipment are held centrally or on site.

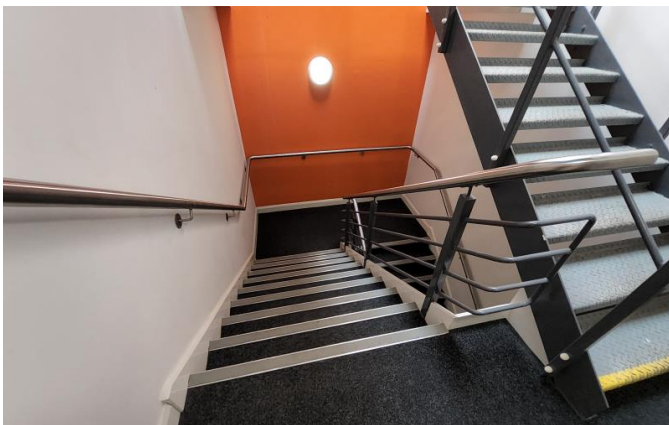
Anti-slip nosings are fitted to the internal stairs.

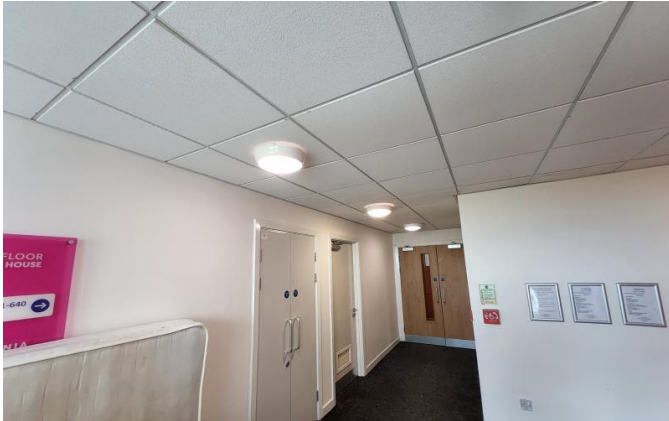
Artificial lighting.

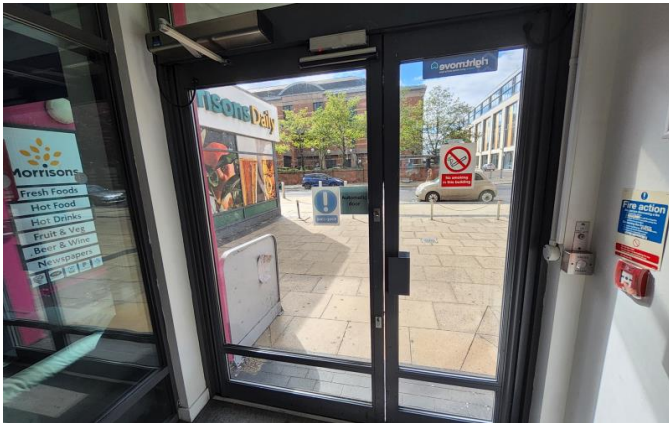
Glazing systems are marked.

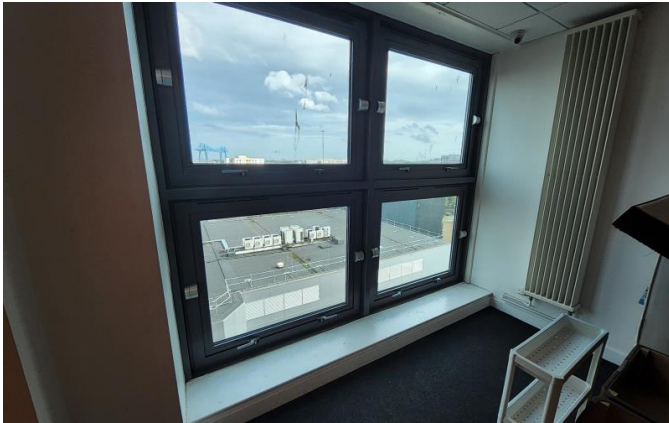
All on-site glazing appears to be in good condition.

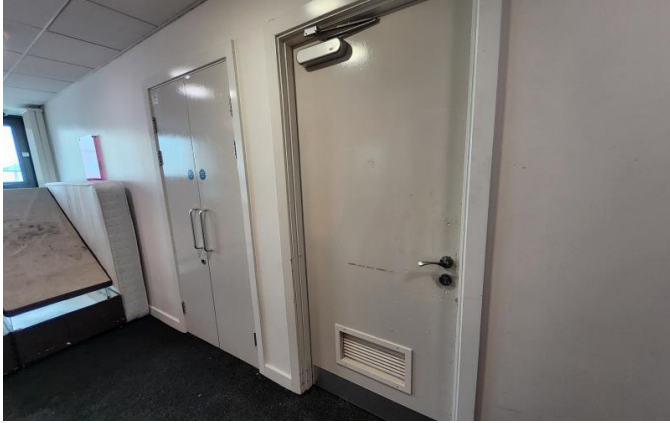
Maintenance manager's storeroom door.

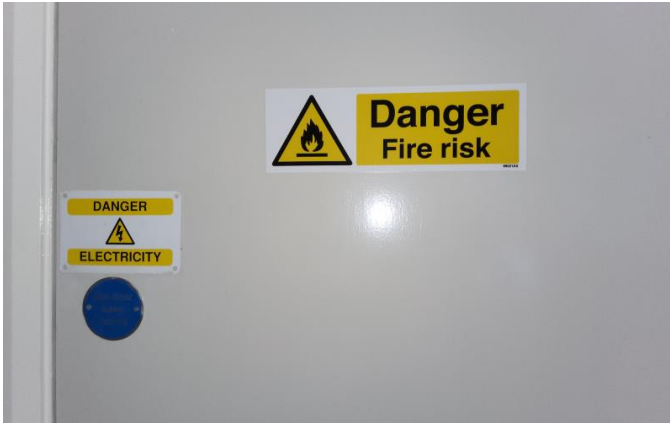
Electrical hazard signs.

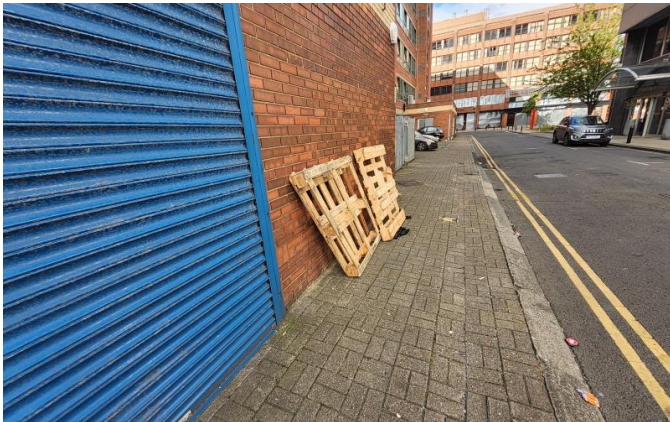
Pedestrian footpaths.

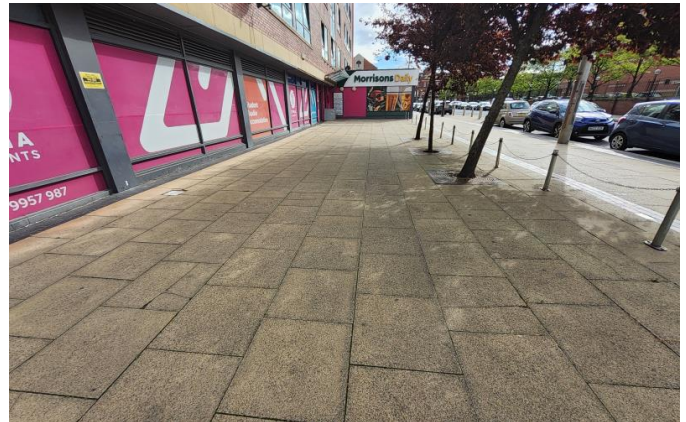
Pedestrian footpaths.
