Home Report

Single Survey

Property address	Flat 1 Ness House Ness Road Fortrose IV10 8SD
Customer	Emma Cameron
Customer address	Flat 1 Ness House Ness Road Fortrose IV10 8SD
Prepared by	Shepherd Chartered Surveyors
Date of inspection	29/04/2025

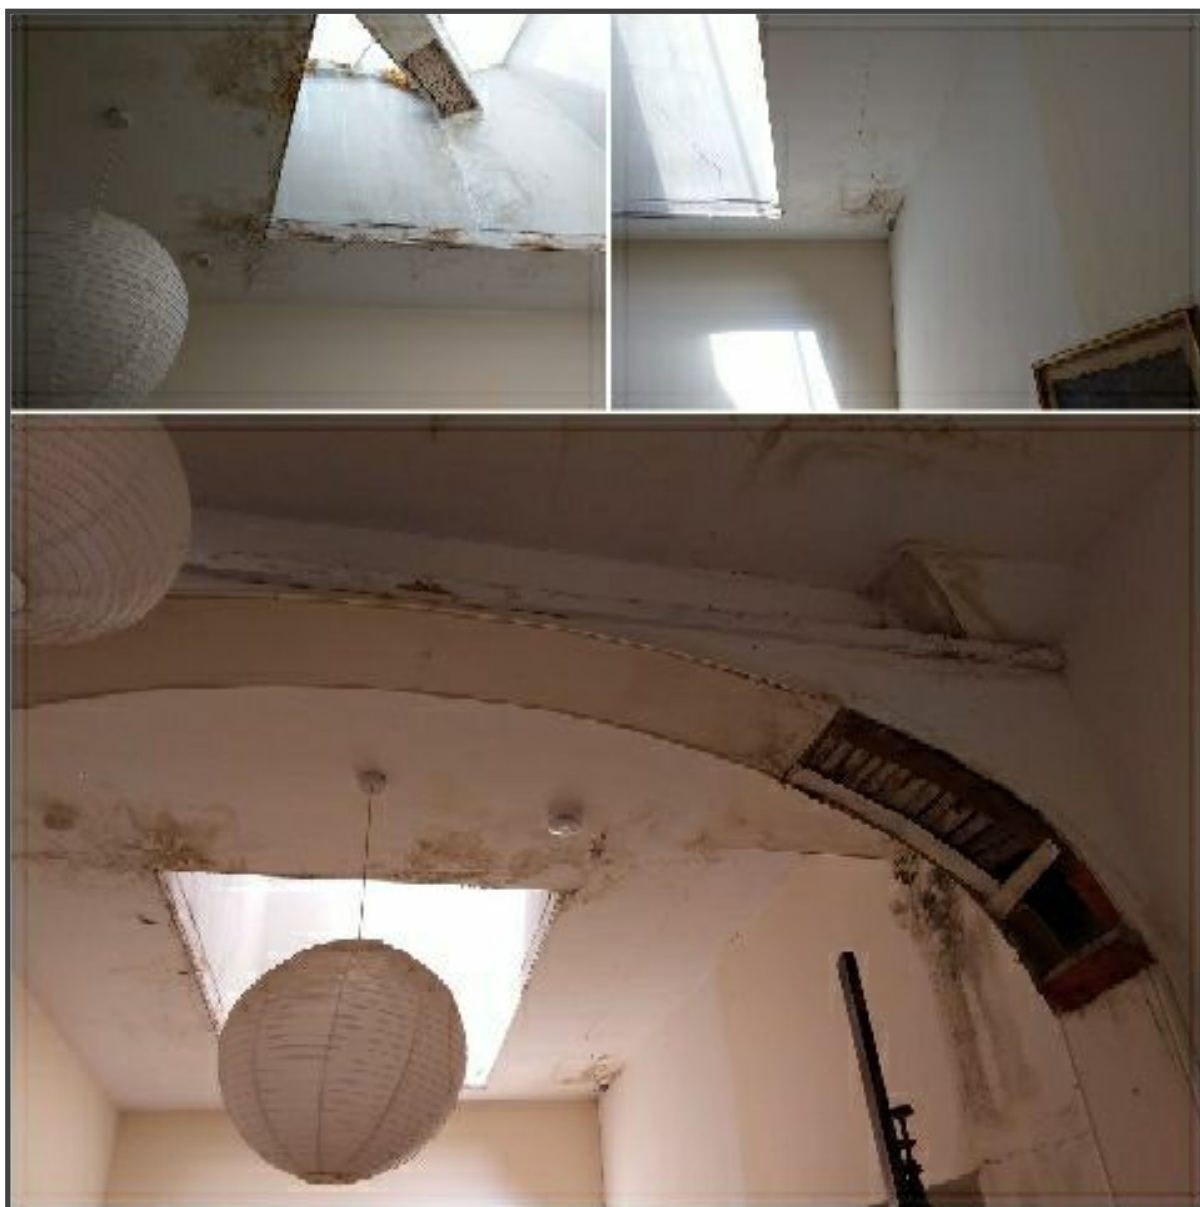
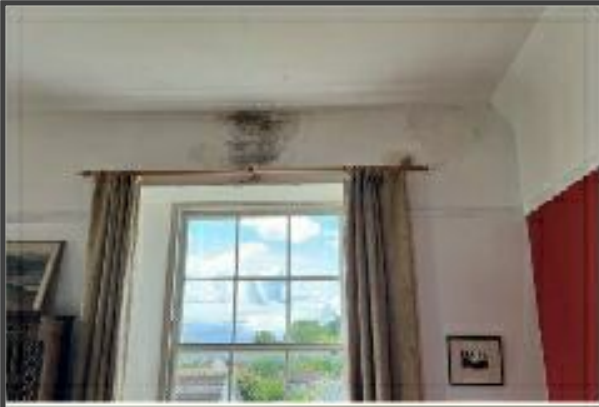
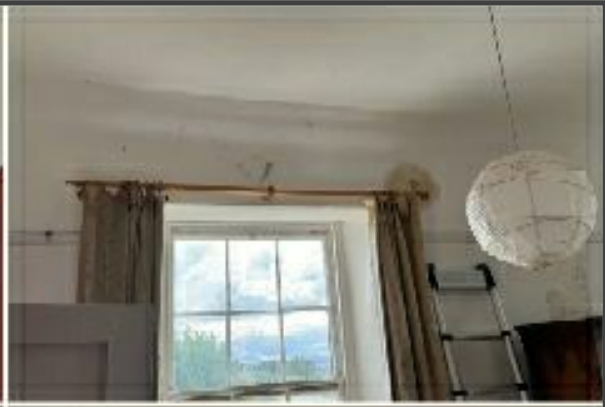
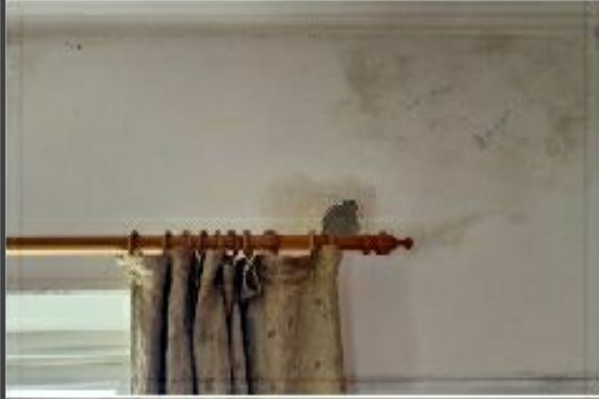
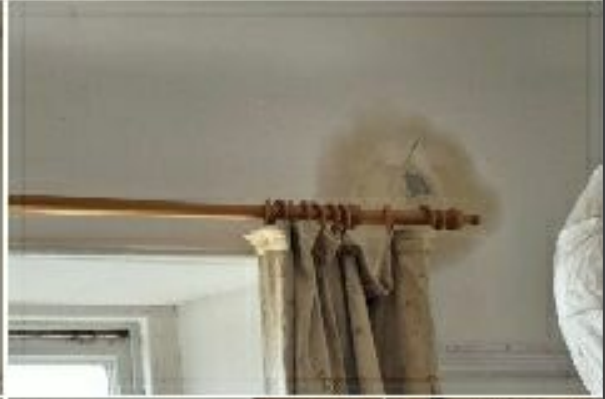
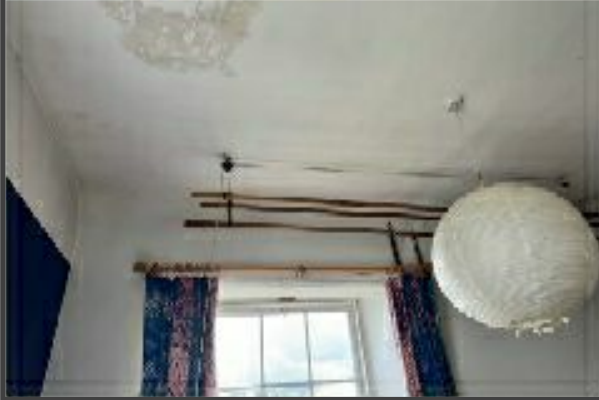
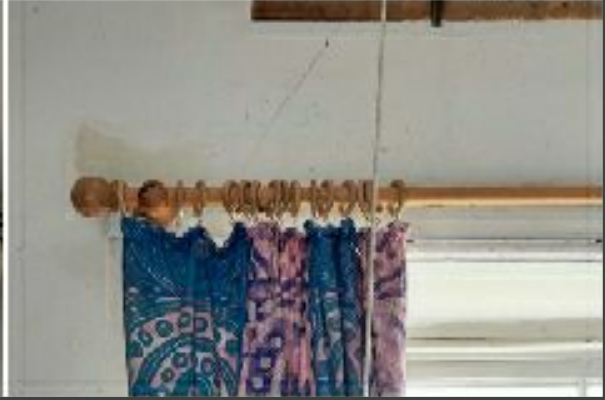
Our inspection of the internal ceiling & wall surfaces of the property was carried out by a visual inspection and by the use of an electrical conductivity meter; As highlighted in the first three sets of collage photos above, this indicated penetrating damp to be present in the ceiling of the Hallway & the walls of the Lounge, Kitchen and rear left Bedroom designated for treatment on our enclosed sketch plan.

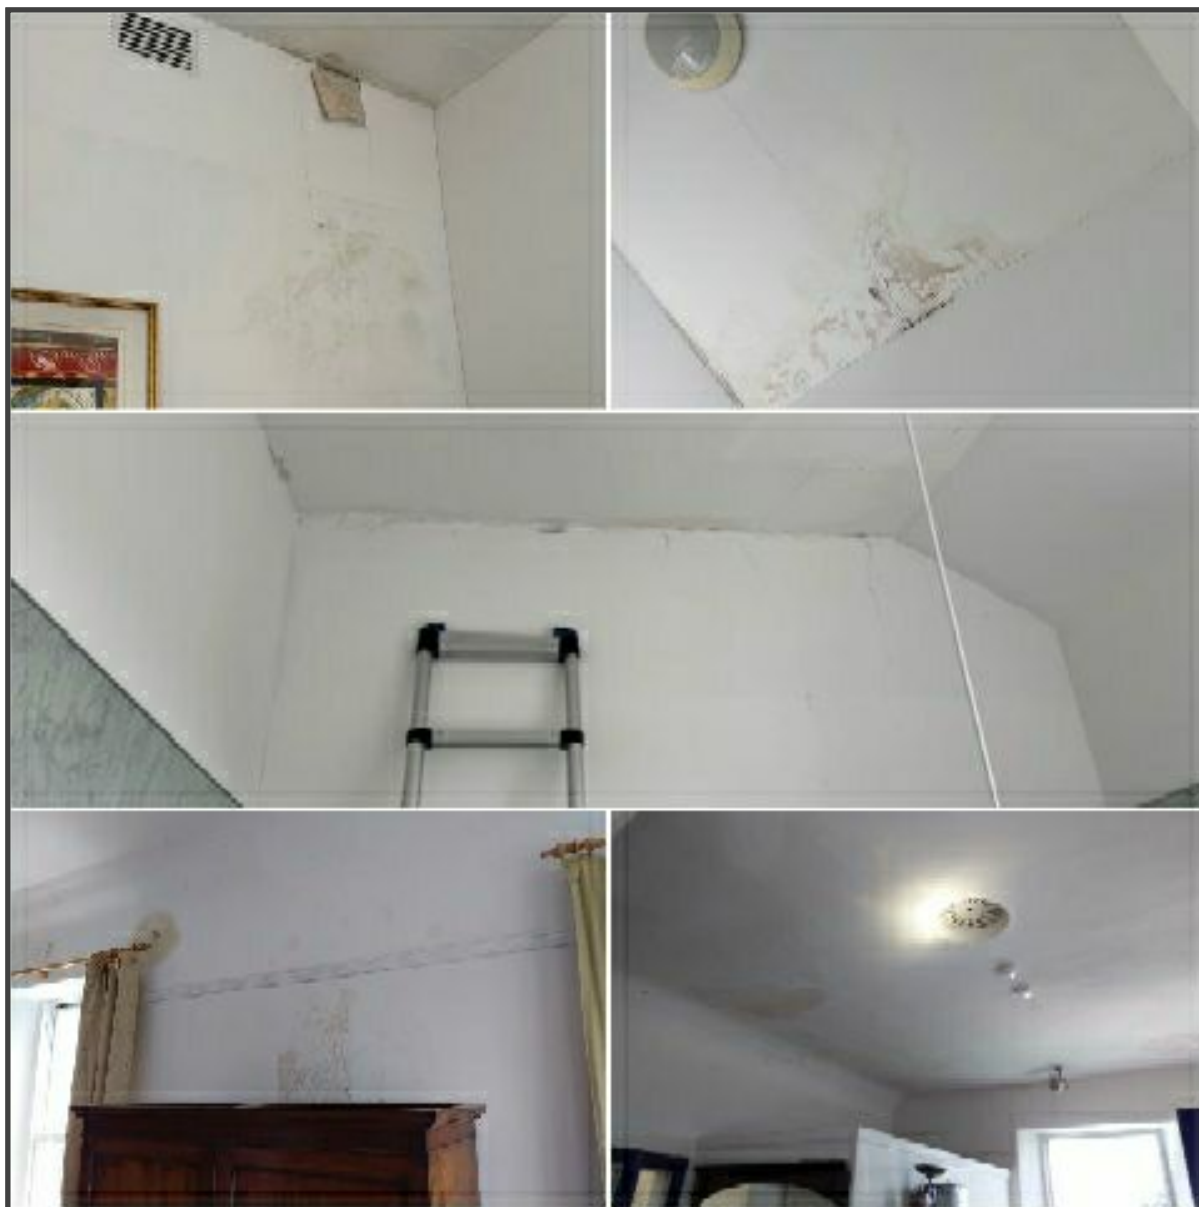
Damp staining was noted to areas of ceiling plaster and wall surfaces throughout the property as can be seen in the fourth set of collage photos above, when tested these areas were found to be dry and appeared historic (plaster repairs works may be required to these areas by the clients own contractor prior to any decoration being carried out).
