# Renovation of 17 Green Walk SK8 4BN

| Project name | 17 Green Walk SK8 4BN |
| Address | 17 Green Walk, Gatley, Cheadle, Storbritannia |
| Conducted by | Farhad Hamahusseini, 15.11.2024 21:34:55 |

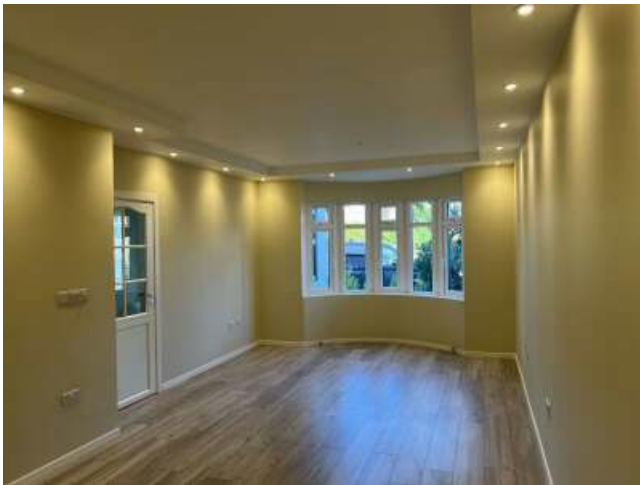
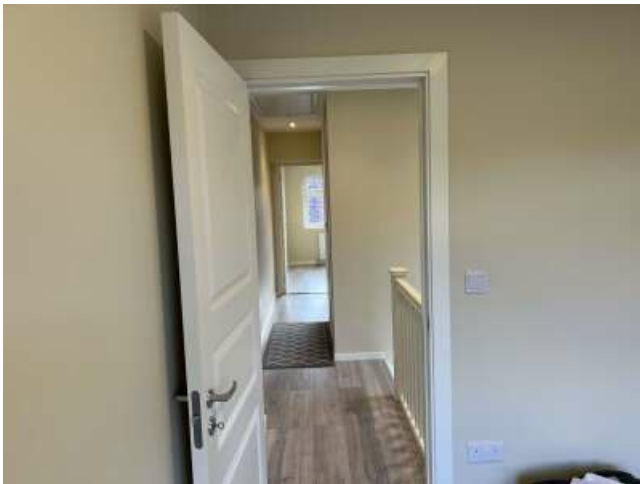
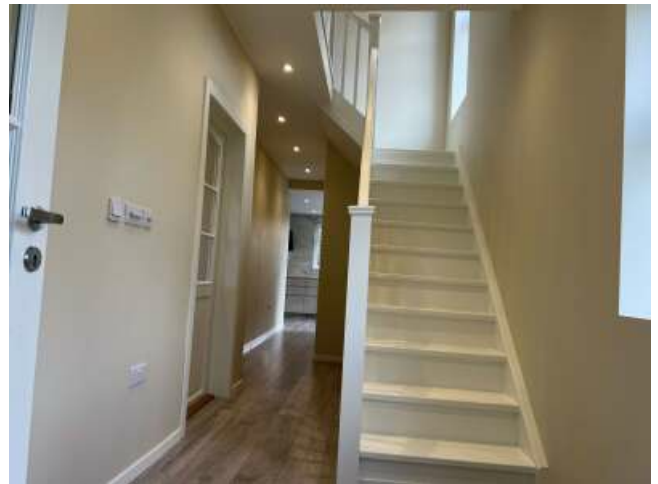
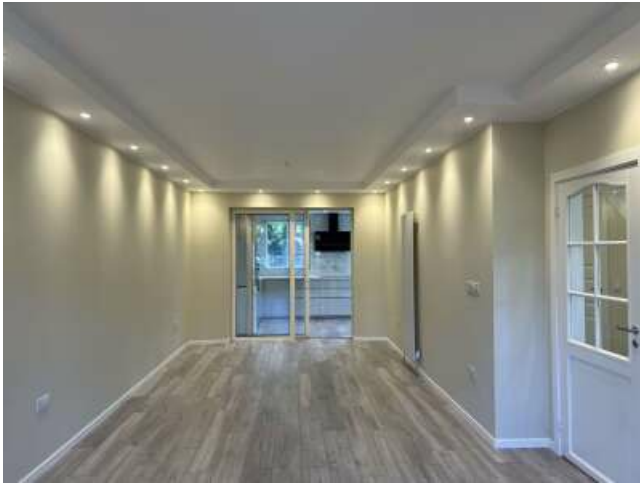
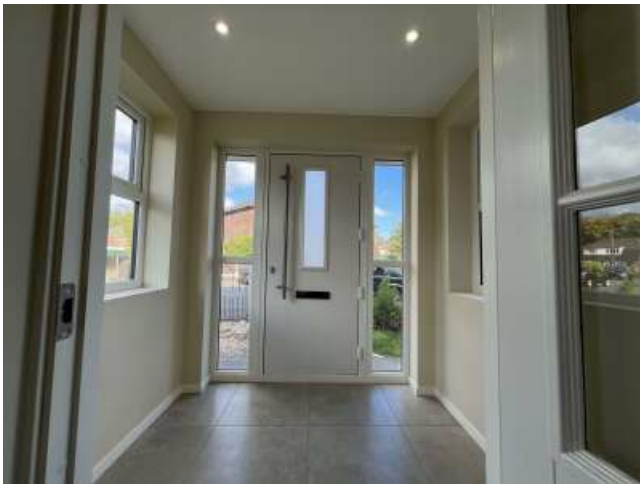
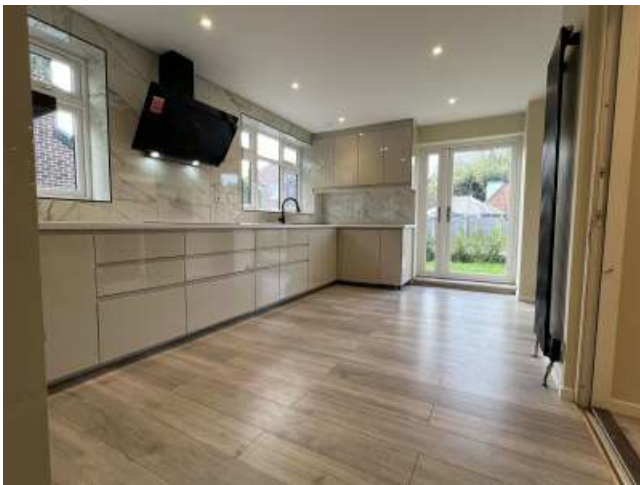
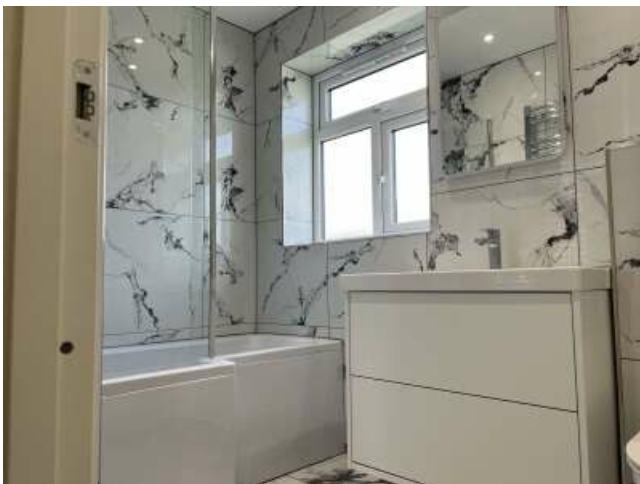
| Pictures of the house's new interior | The pictures show the completed renovation of the interior of the house, including the living room, hallway, porch, bedroom, and kitchen. | ✓ |

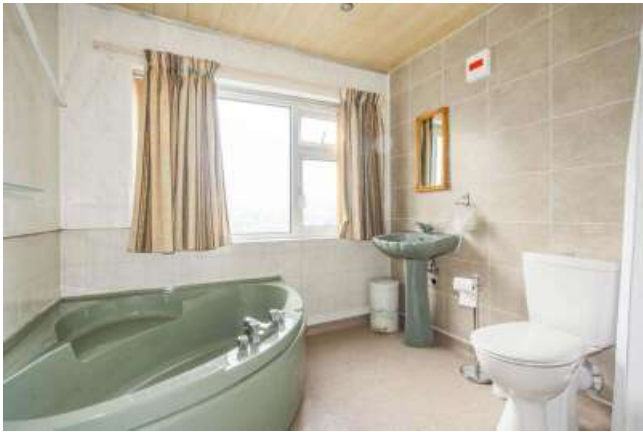
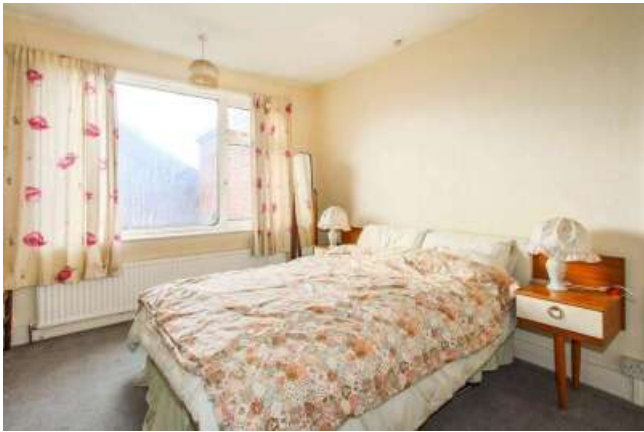
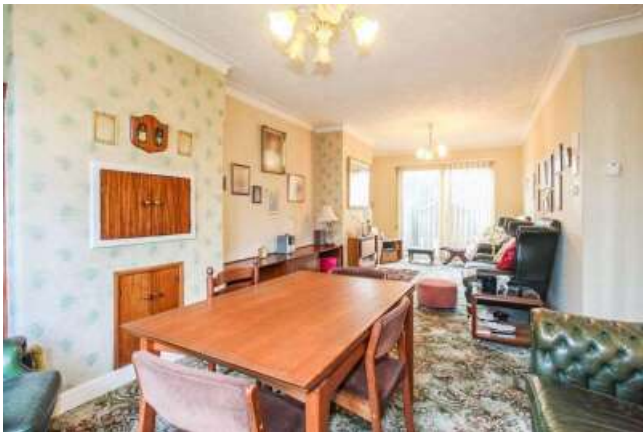
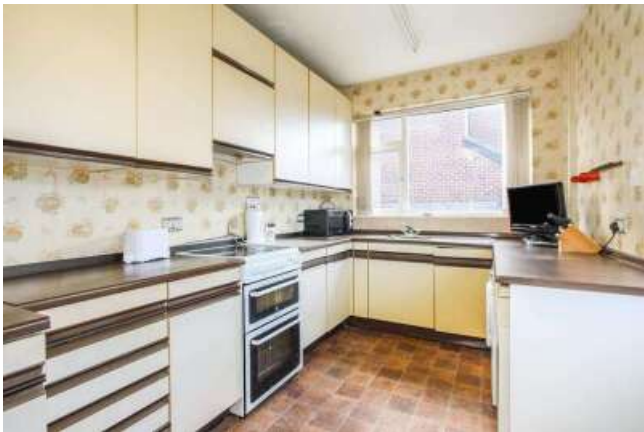
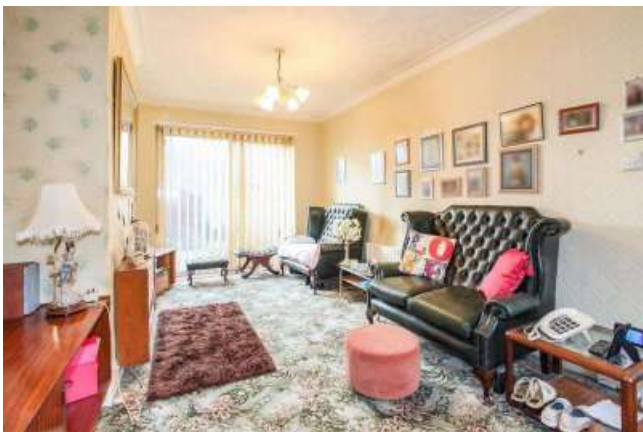
| Pictures of the house's old interior | The pictures show the old interior, including the living room, bedroom, kitchen, and bathroom. | ✓ |

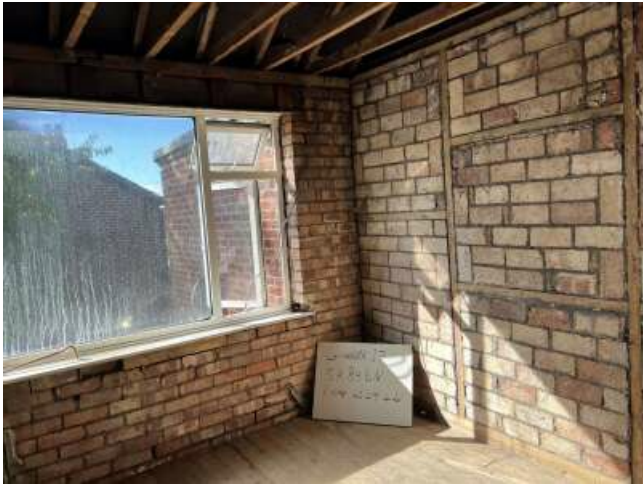
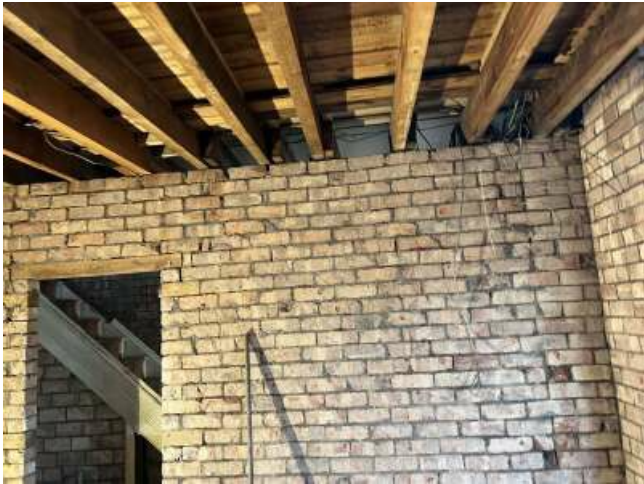
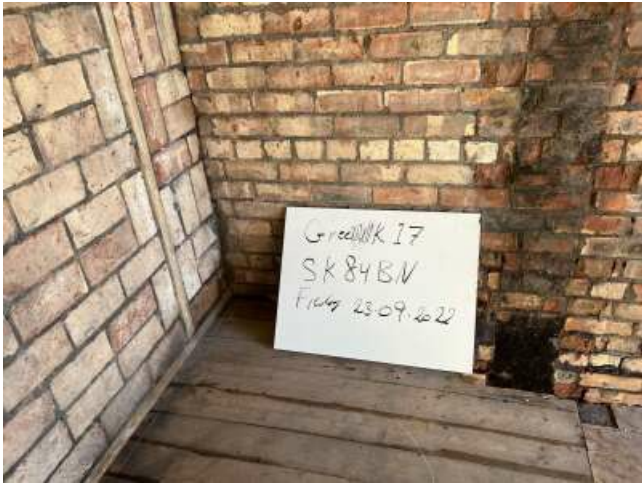
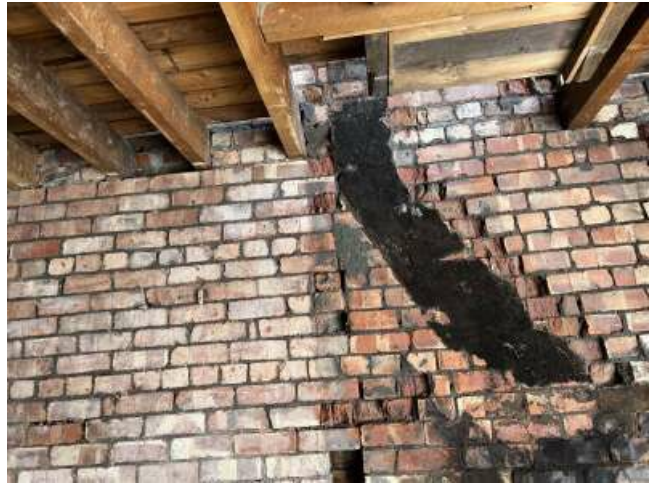
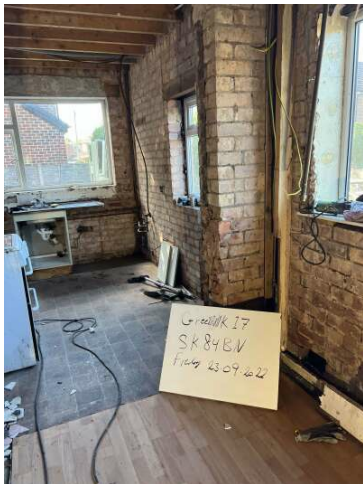
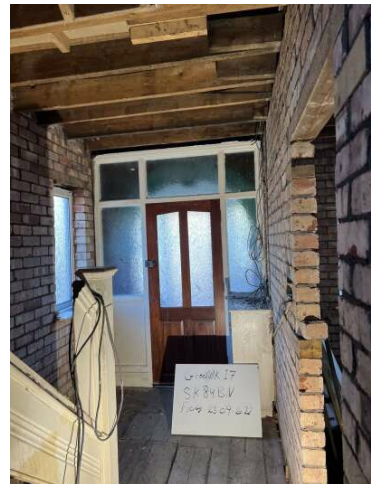
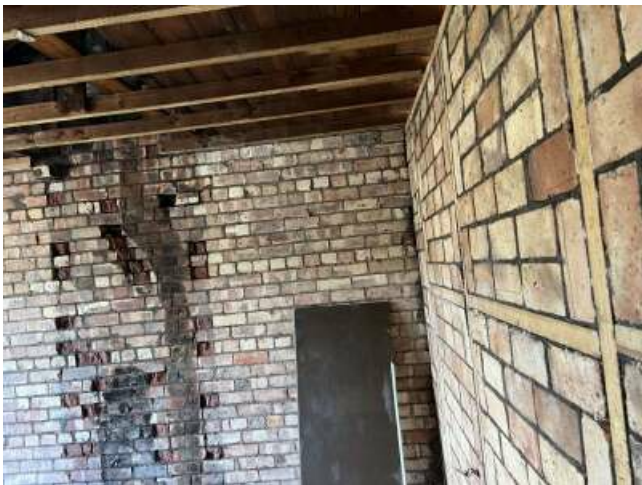
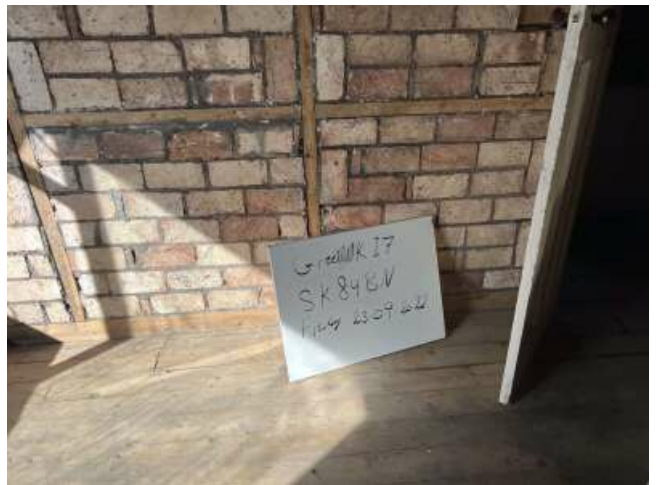
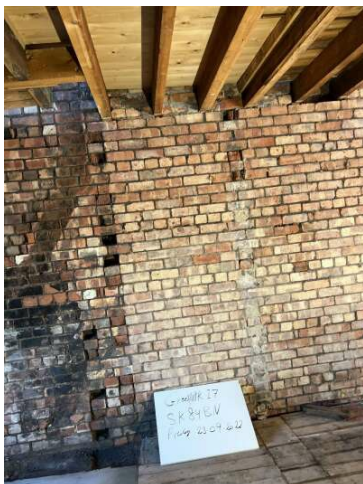
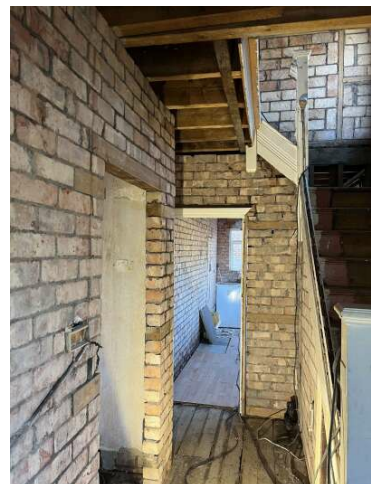
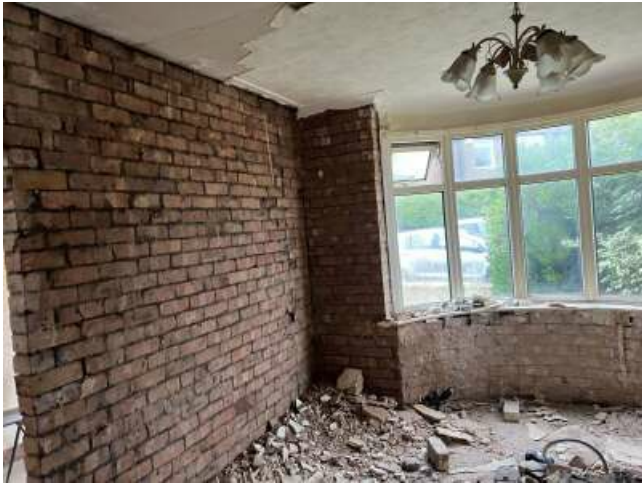
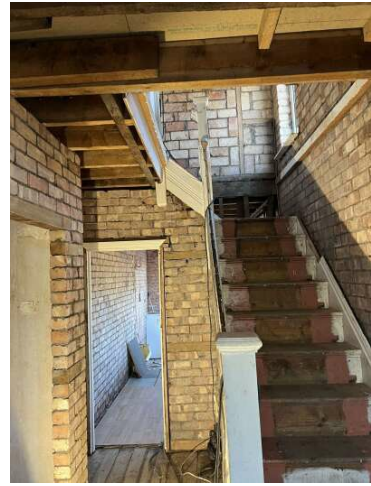
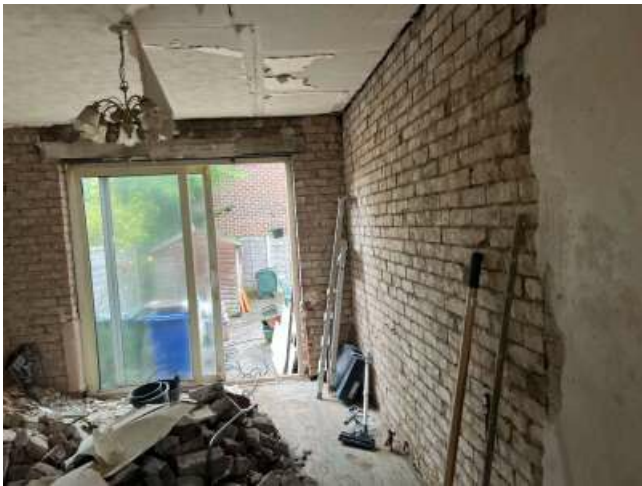
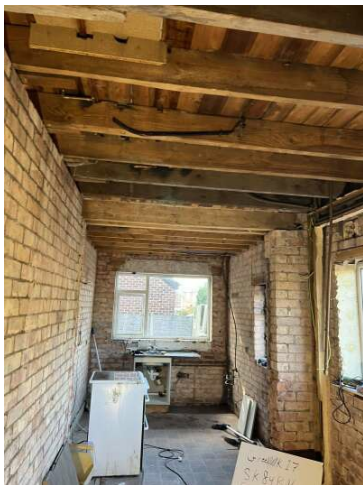
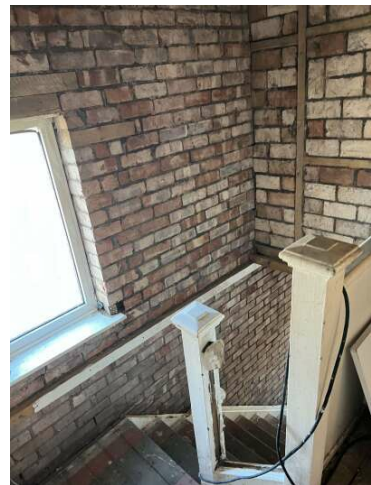
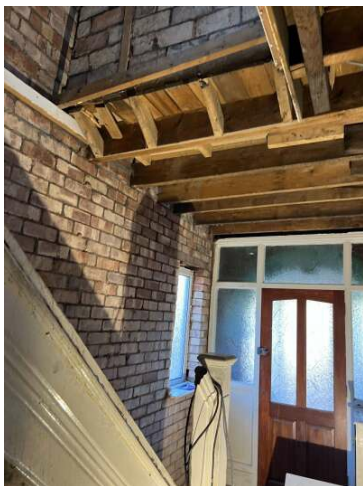
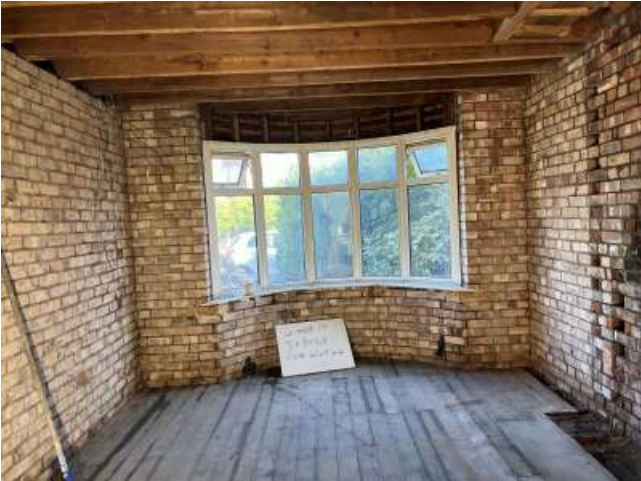
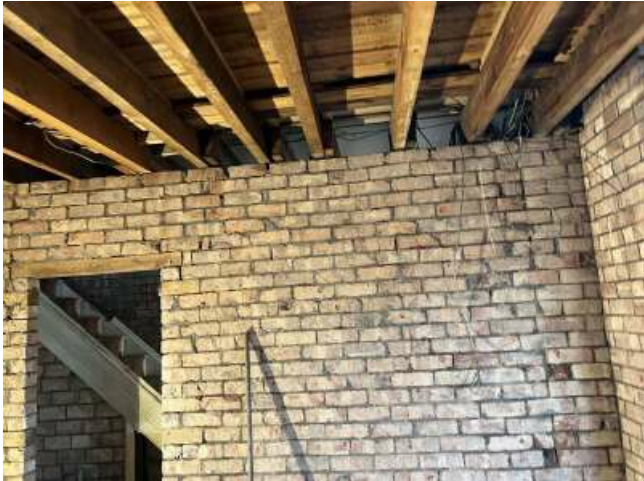
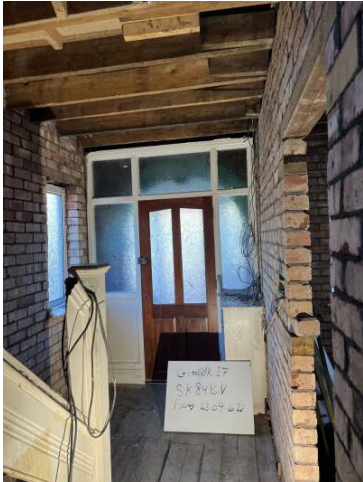
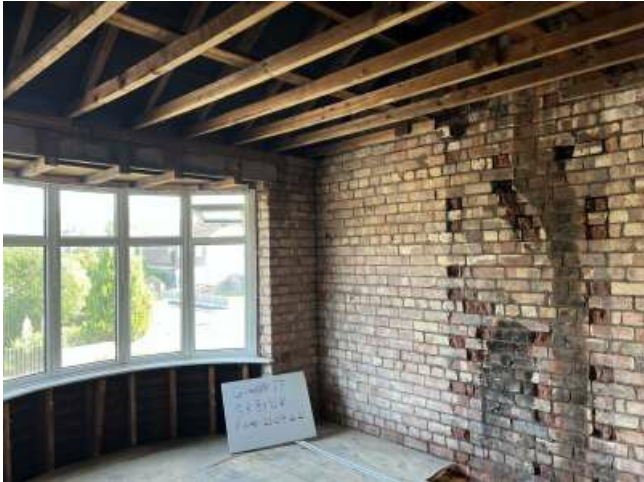
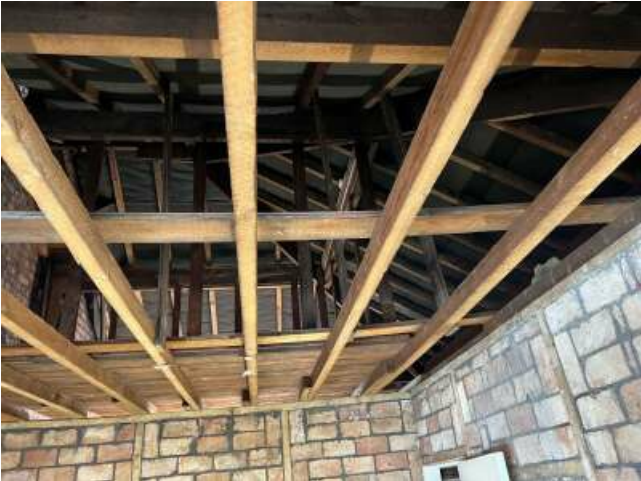
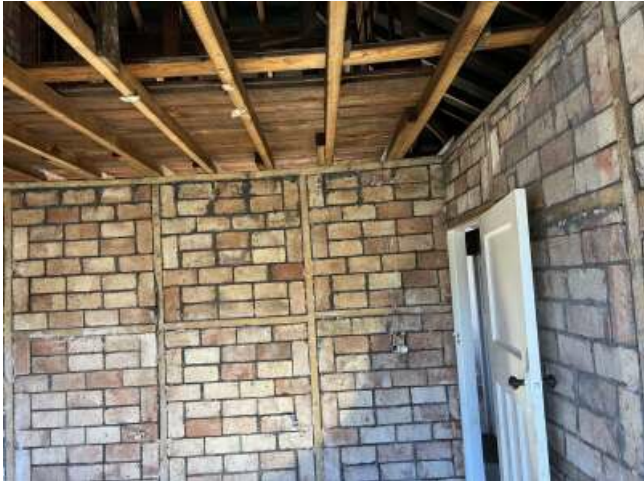
| Demolition | Demolition of plastering, ceiling plasterboard, and windows. | ✓ |

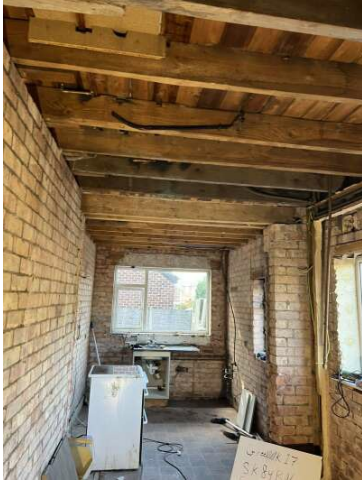
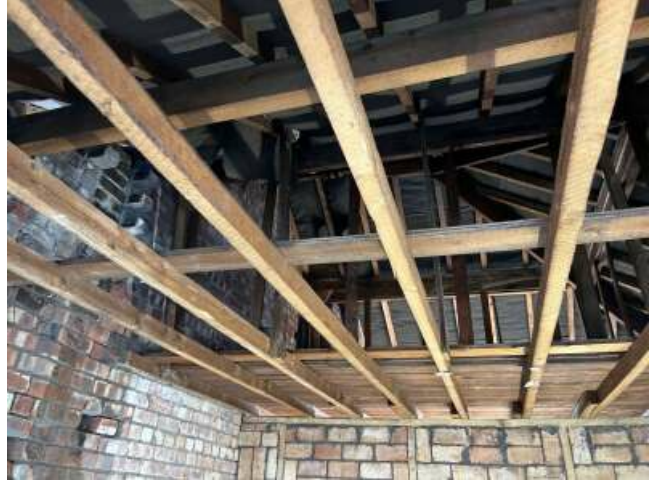
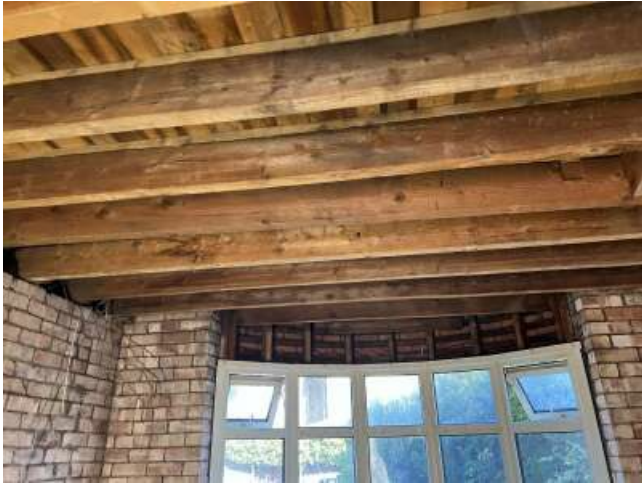
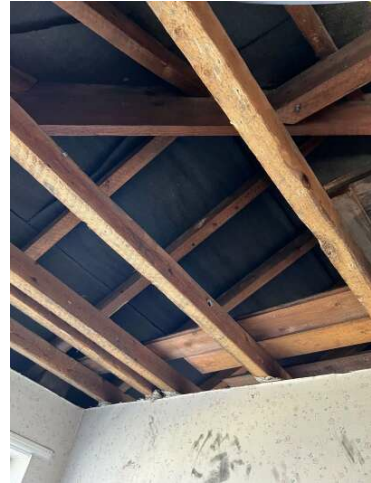
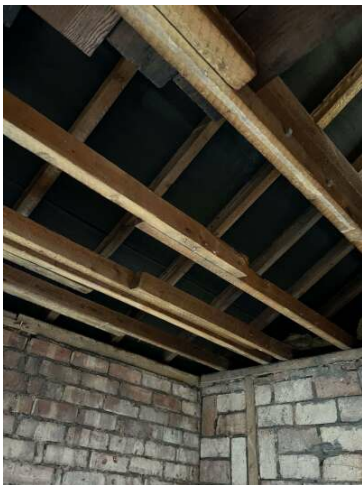
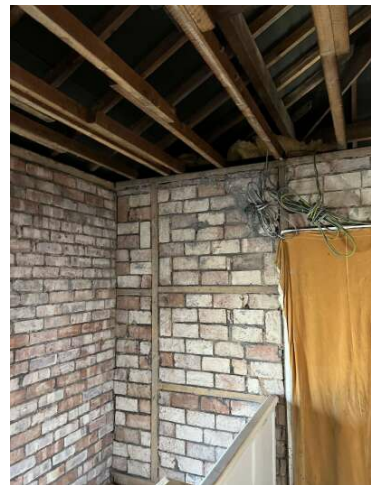
| Demolition | Demolition of ceiling panels and old insulation. | ✓ |
| Demolition | Demolition of all electrical cables and plastering on walls. Dismantling of radiators and old pipe installations. | ✓ |

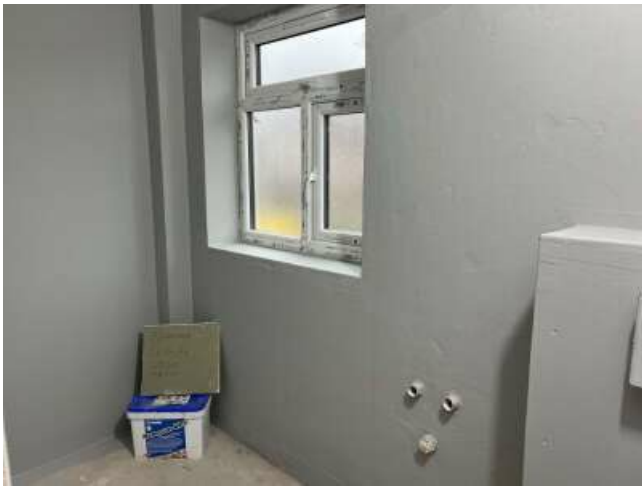
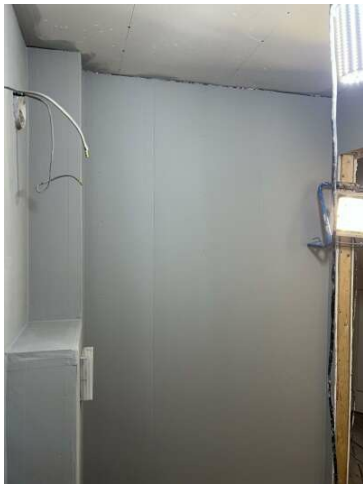
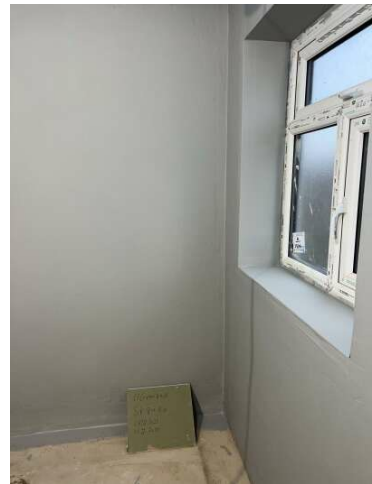
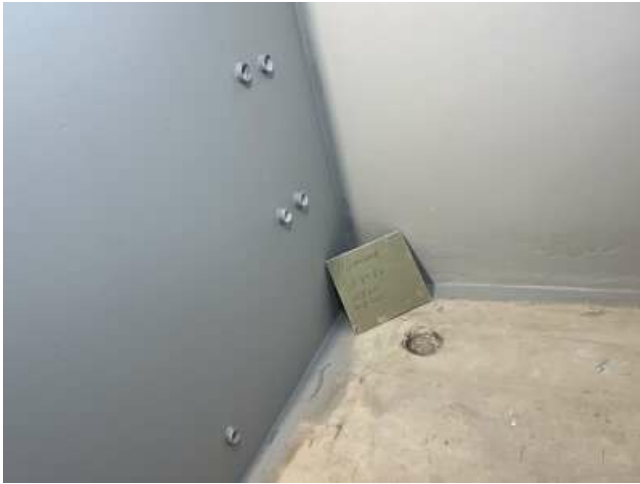
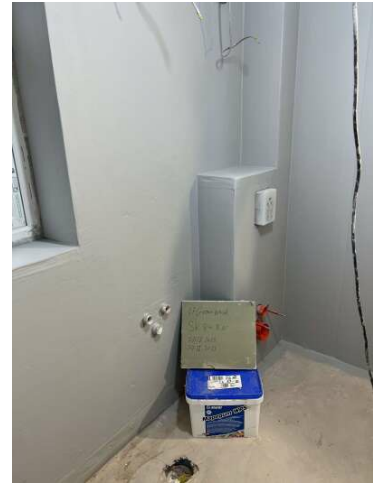
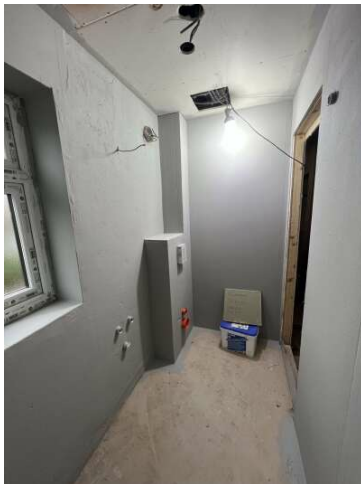
| Installation of Mapei Waterproofing membrane | <p>For the walls, MAPEI Mapegum WPS has been used, applied in three coats to ensure complete waterproofing. All walls are fully sealed, making it impossible for water damage to occur from the walls or floor. The area behind built-in toilets is also waterproofed with Mapegum WPS, as shown in the pictures.</p> <p>Warning: The bathroom floor must not be drilled or punctured, as it contains underfloor heating cables, and puncturing the floor would damage the welding membrane. The walls must also not be drilled or punctured due to water pipes and electrical cables inside the walls. If you need to hang or attach something to the walls, please refer to the provided pictures to identify safe areas for fixing anything. However, the floor must never be drilled or punctured. If the floor is drilled or punctured, it could damage the heating cables and compromise the waterproofing. Extreme caution is required.</p> | ✓ |

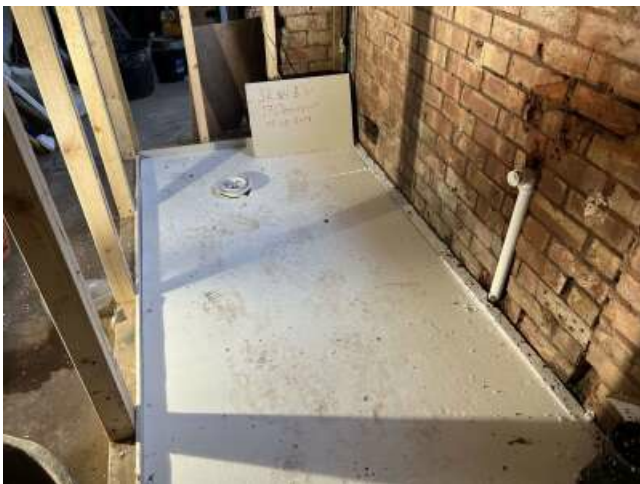
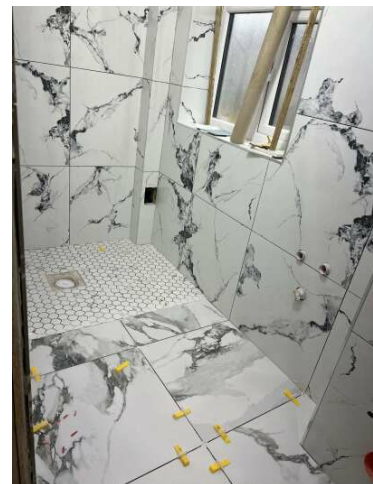
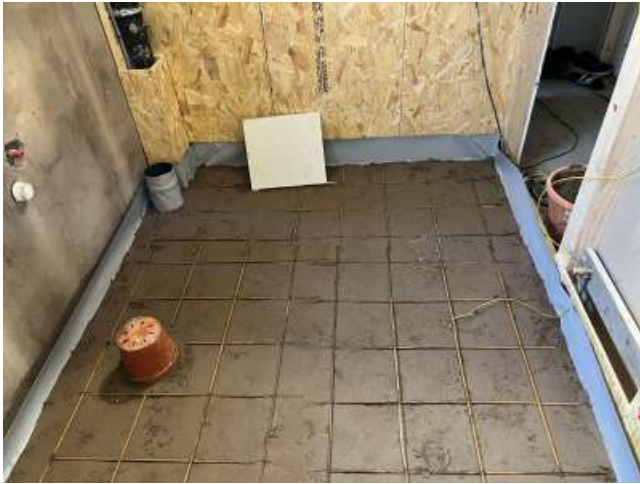
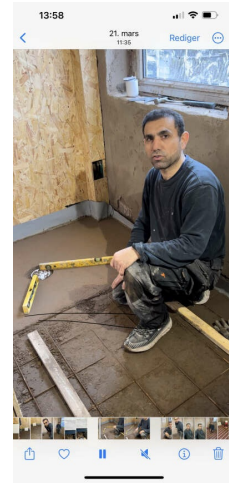
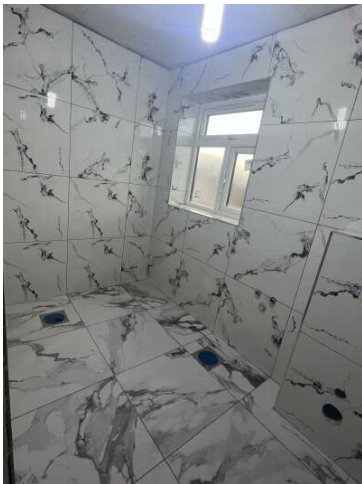
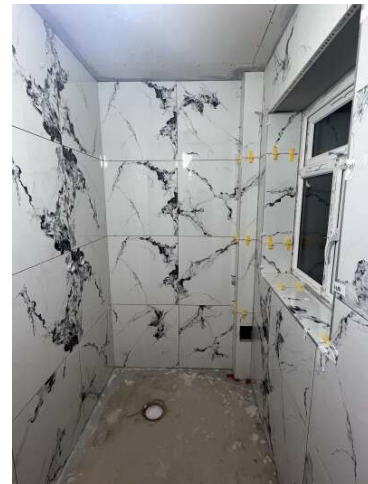
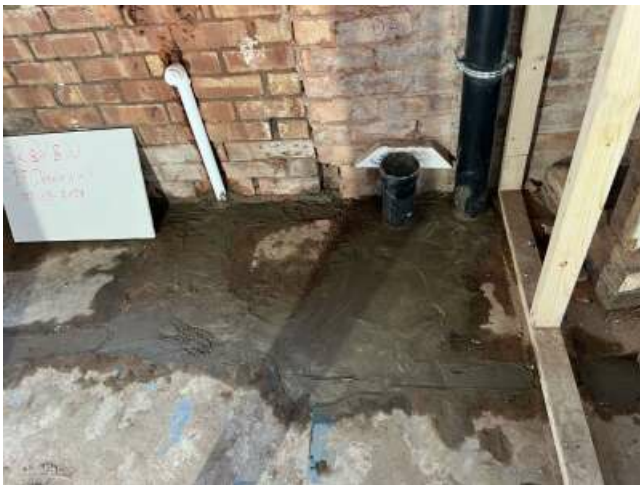
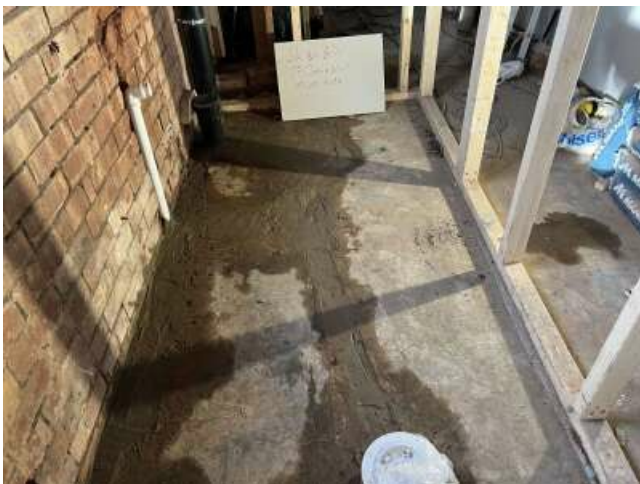
| Bathroom work | | |
|---|---|---|
| Floor installation | <p>The bathroom floor is constructed with lightweight concrete sloping toward the drain, with a grounding mesh for the electrical wiring. The floor is insulated in the first layer, followed by the installation of a welding membrane, and then the tiling is applied.</p> <p>Warning: The bathroom floor must not be drilled or punctured, as it contains underfloor heating cables, and puncturing the floor would damage the welding membrane. The walls must also not be drilled or punctured due to water pipes and electrical cables inside the walls. If you need to hang or attach something to the walls, please refer to the provided pictures to identify safe areas for fixing anything. However, the floor must never be drilled or punctured. If the floor is drilled or punctured, it could damage the heating cables and compromise the waterproofing. Extreme caution is required.</p> | ✓ |

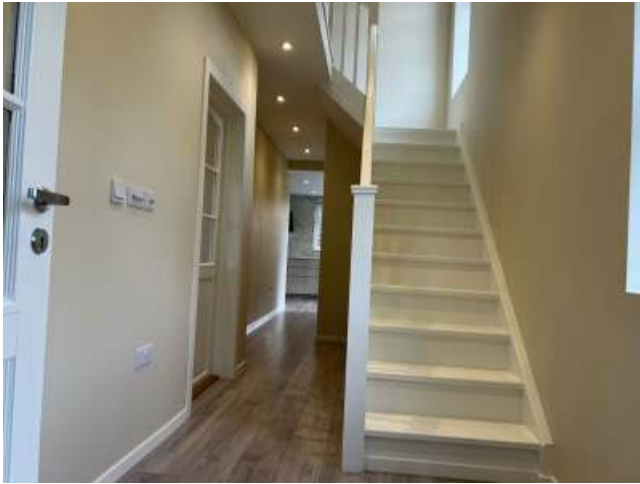
| Installation of stairs | Installation of a completely new staircase with railing. The stair treads are made entirely of 36mm wood, with full priming and painted with special stair paint that tolerates wear and tear. | ✓ |

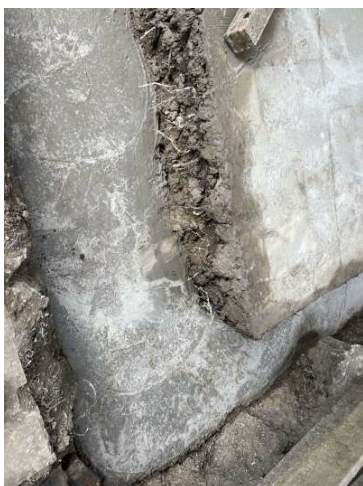
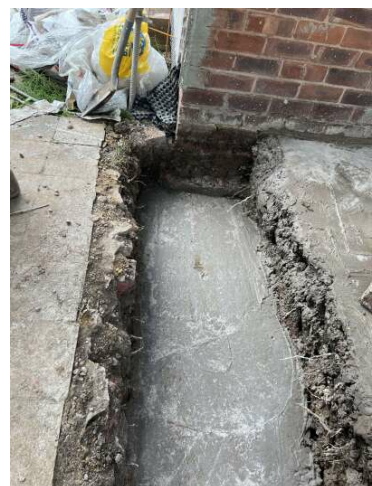
## Foundation work

| Foundation work | A vapor barrier plastic is laid, followed by reinforcement with steel rebar mesh. Concrete is poured with a thickness of 400mm. The interior floor is filled with stone material, followed by 100mm Isopor insulation. A vapor barrier membrane is installed for the floor, with a 100mm thick concrete layer on top. | ✓ |

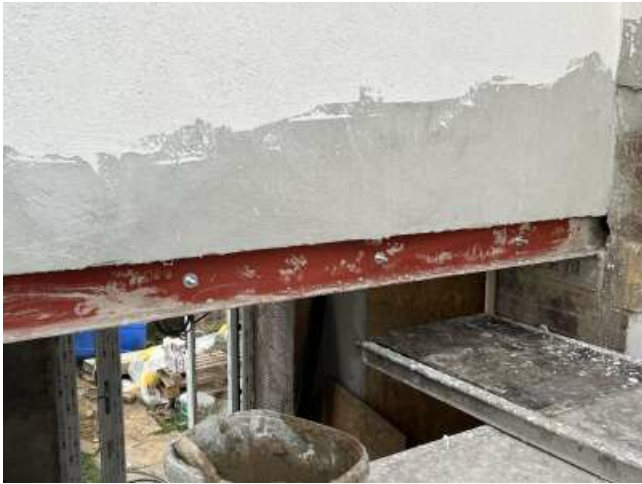
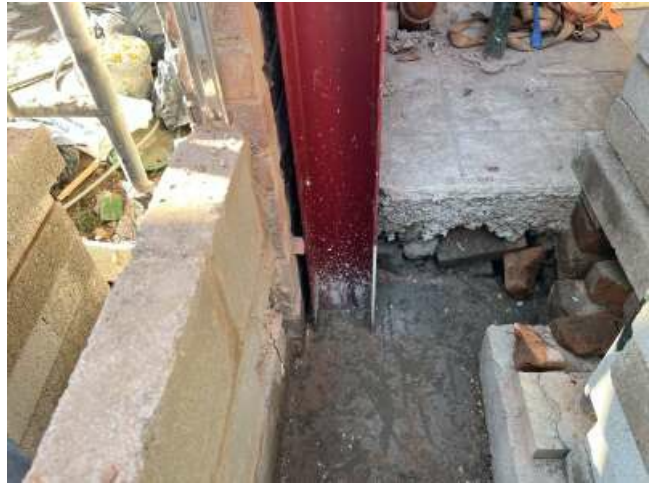
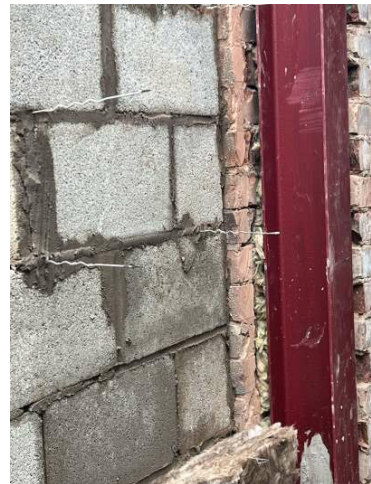
| Installation of steel lintels | The pictures show the steel beam, which is a double beam positioned under both brick exterior walls. The beams are connected using bolts with a 60 cm center-to-center spacing, as shown in the images. The beams have been painted with two coats of rust-resistant paint. | ✓ |

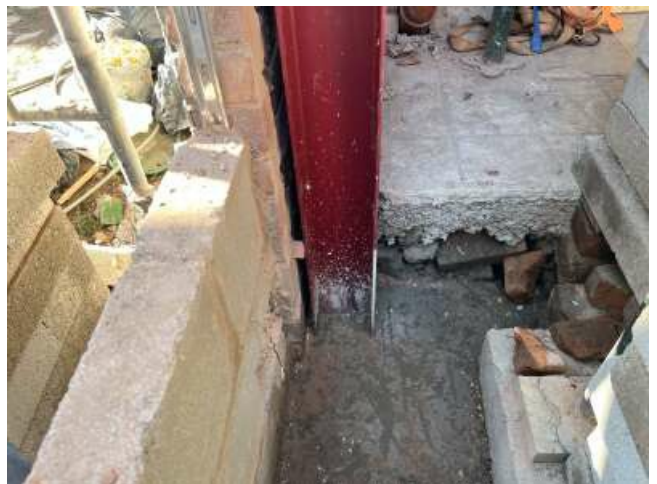
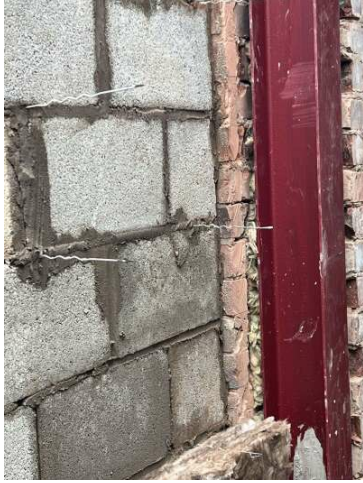
| Columns for new extension | The pictures show that the steel column is mounted directly onto the concrete foundation with bolts and connected to the steel beam using bolts. The column has been painted with two coats of rust-resistant paint. | ✓ |
