# Your survey report

172 Burton Road, Lincoln, LN1 3LT

02-09-2025

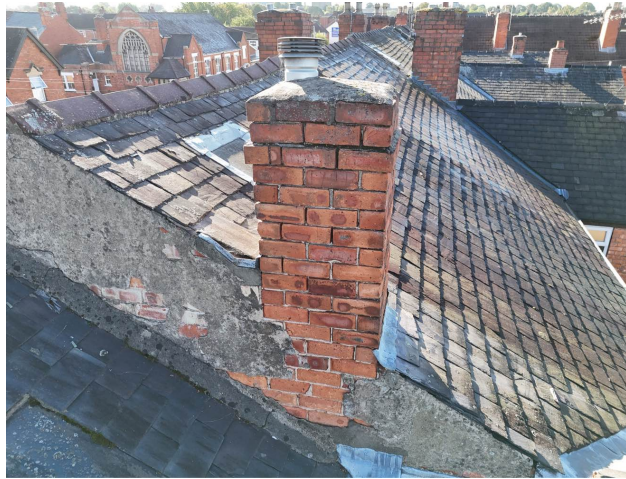
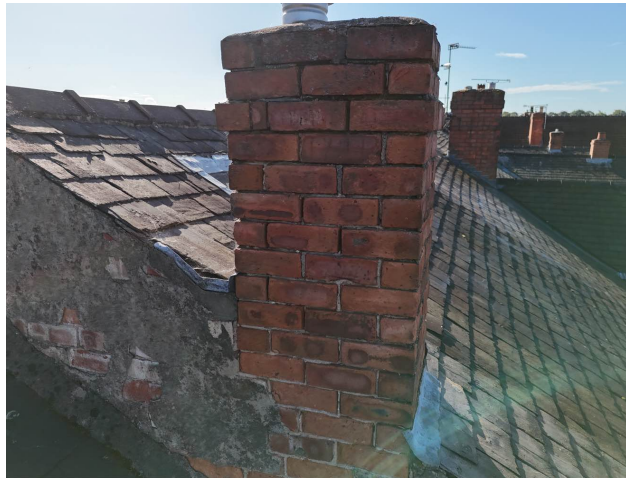
Chimneys in a property of this age are unlikely to contain a damp-proof course and there is a risk of rain penetration. To reduce this risk, they must be well maintained.

The owner of the neighbouring property will have rights and responsibilities with regard to the shared stack and you should check with your legal advisor before any work is undertaken.

To repoint the weathered chimney stack. To cap and ventilate the now redundant flues. To repair the cracked chimney flashing. These can be addressed in the medium term.

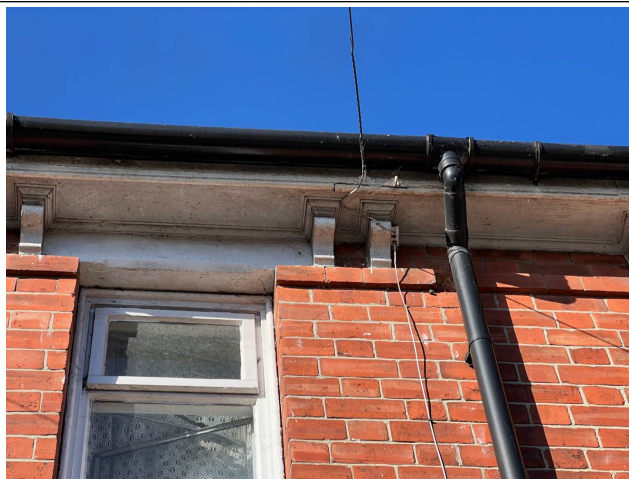
Given the age of the property, some paint may contain lead. Removal of lead-based paint can pose a health risk unless correct procedures are followed. Urgent action is not required, but before paint is removed advice should be obtained from the Health and Safety Executive - <https://www.gov.uk/search?q=lead+paint>.

The external woodwork will need regular redecoration, typically on a 3 - 5 yearly cycle depending on the quality of paint or stain coatings, exposure factors, and condition of the surfaces beneath.

To redecorate or replace the fascia boards. This can be done at the same time as the roof repairs/replacement.

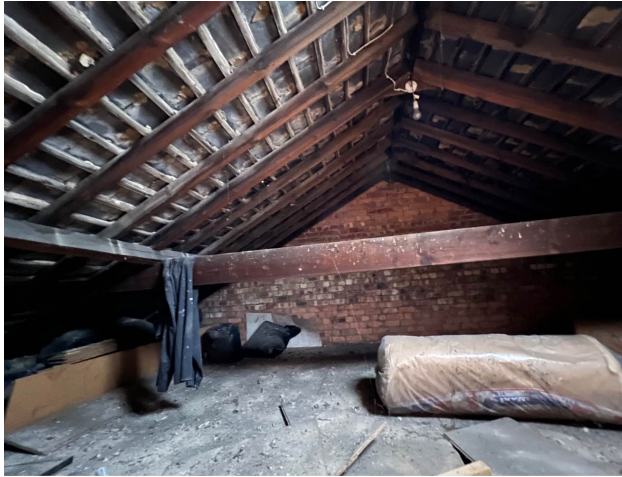
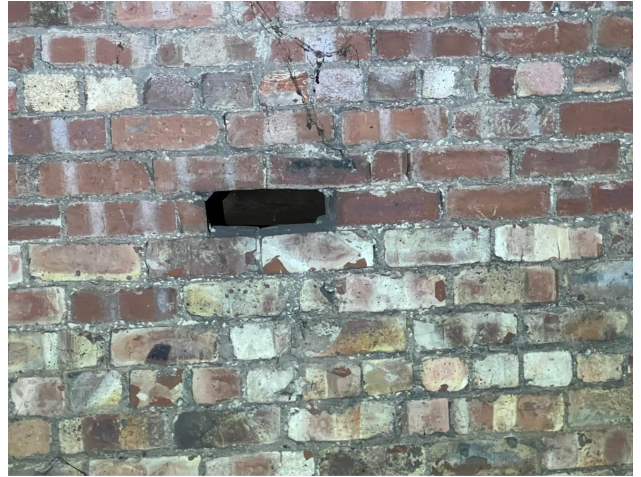
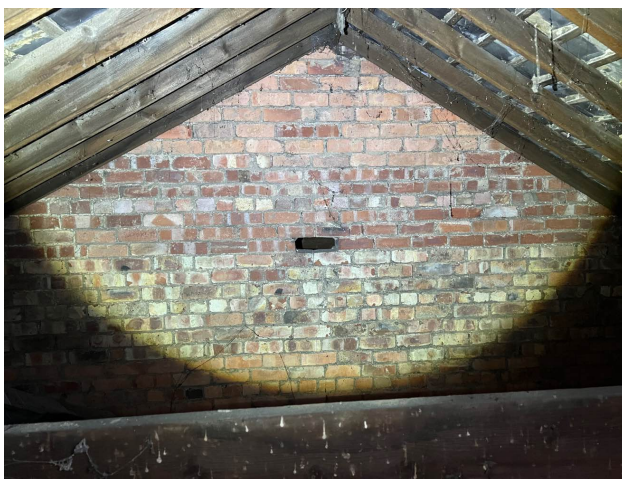
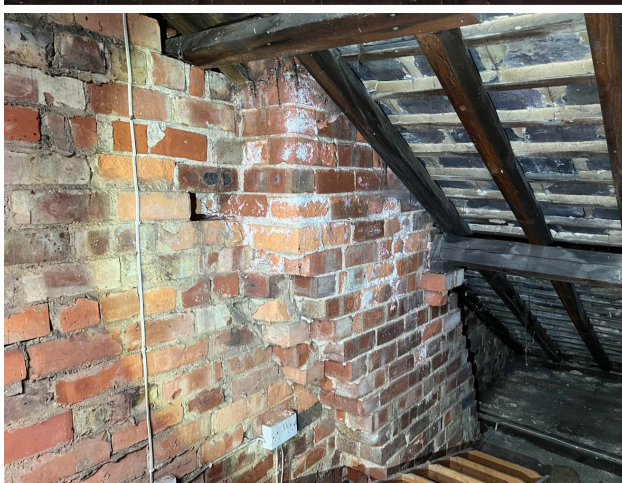
significant issues at present, but as mentioned, the now redundant flues should be ventilated.

A roof structure is not designed to accommodate large amounts of stored items. At the very most, storage should be restricted to light household items.

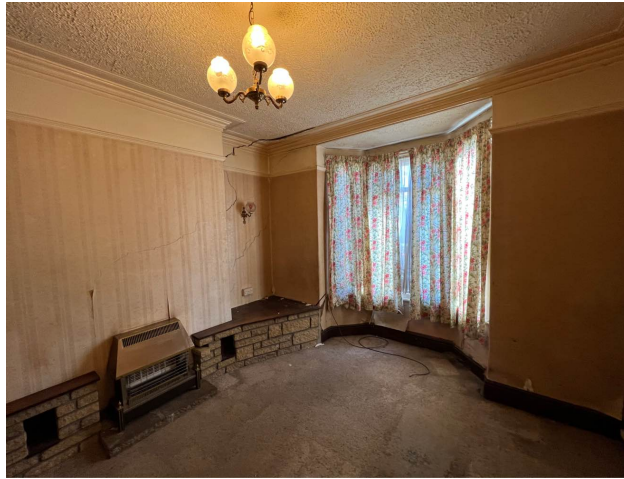
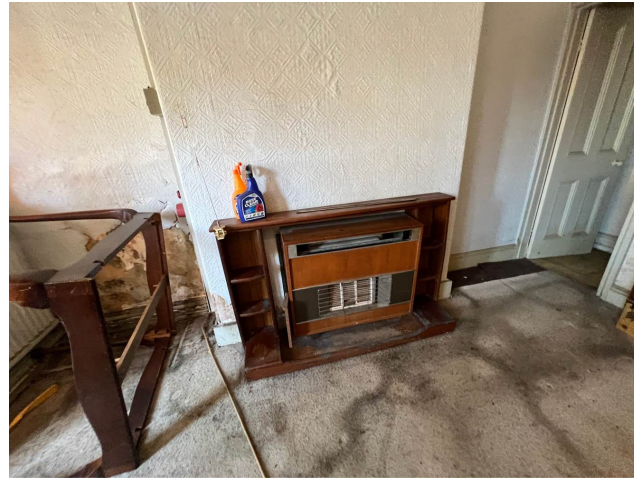
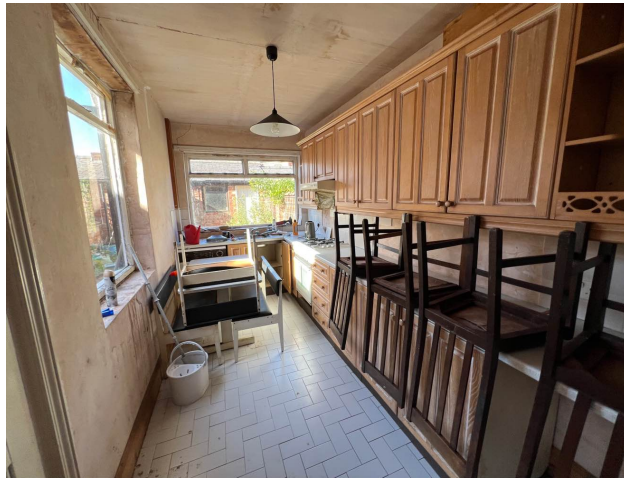
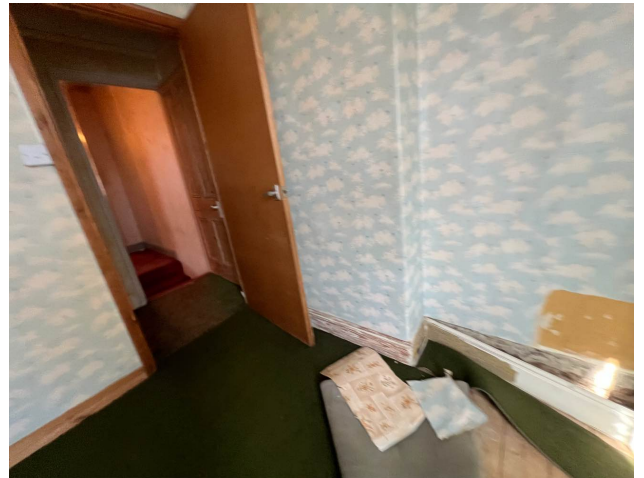
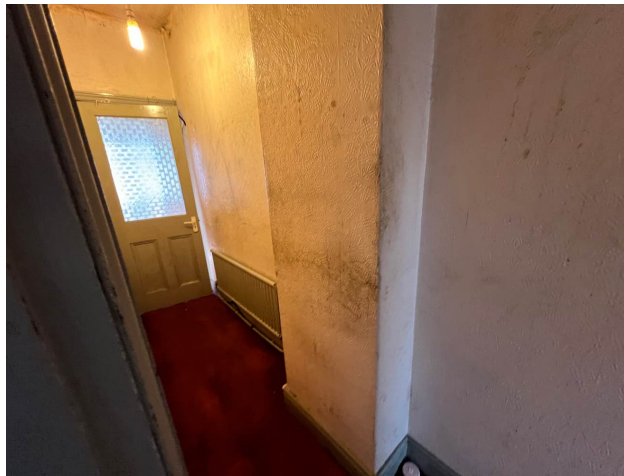
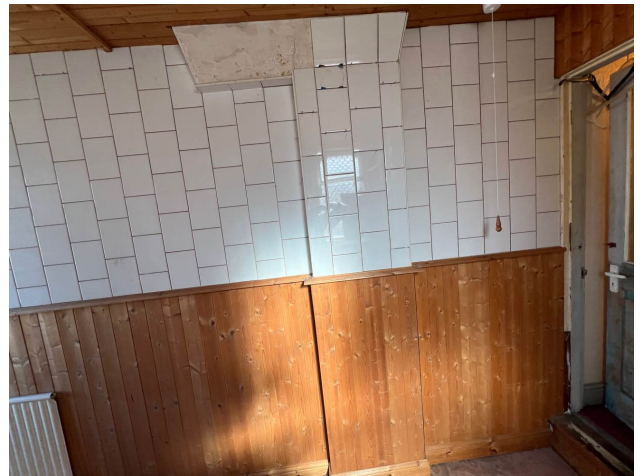
Flues should be checked and swept prior to use and this should be done by a reputable chimney sweep.

If you intend on bringing the redundant fires back into use, some repair and upgrading may be required and the flues may need repair or lining which could be costly. If this is your intention, you should seek specialist advice before proceeding.

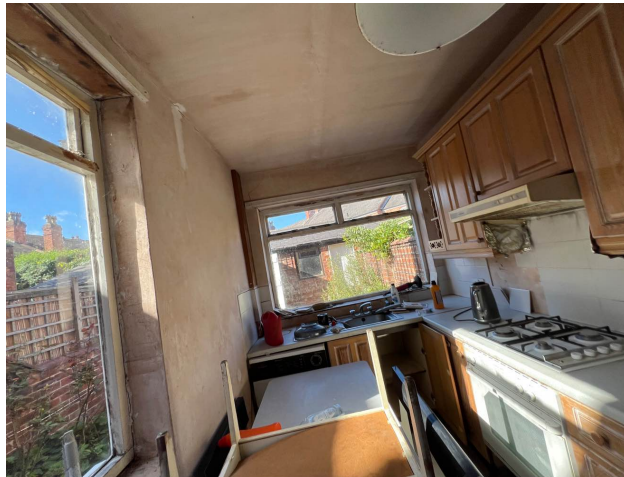
Adequate ventilation must be maintained within the kitchen. This will be achieved by periodically servicing any mechanical ventilation systems, installing trickle vents in windows, and maintaining a 10mm gap below doors.

A mastic seal should be applied along the back edges of the kitchen worktops to prevent water penetration behind the units. The carcassing to these units is made of chipboard which deteriorates when it becomes wet. It is therefore necessary to protect the chipboard by maintaining seals and laminated coverings in good condition.

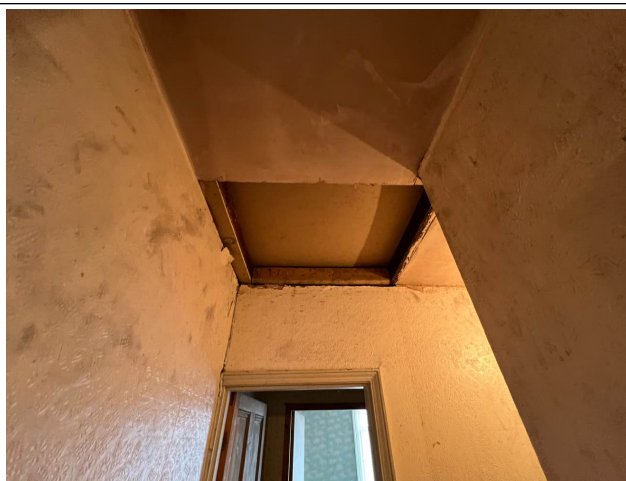
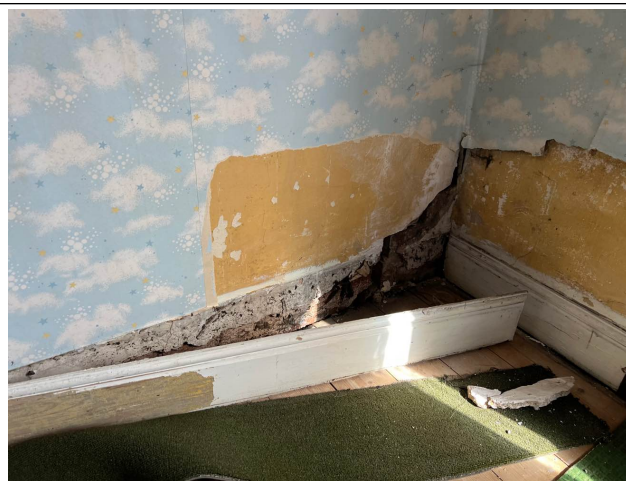
Given the age of the property, some paint may contain lead. Removal of lead-based paint can pose a health risk unless correct procedures are followed. Urgent action is not required, but before paint is removed advice should be obtained from the Health and Safety Executive - <https://www.gov.uk/search?q=lead+paint>.

Again, we found no visible evidence of active woodworm infestation, but this could be discovered when fitted covers, stored items and furniture are removed.

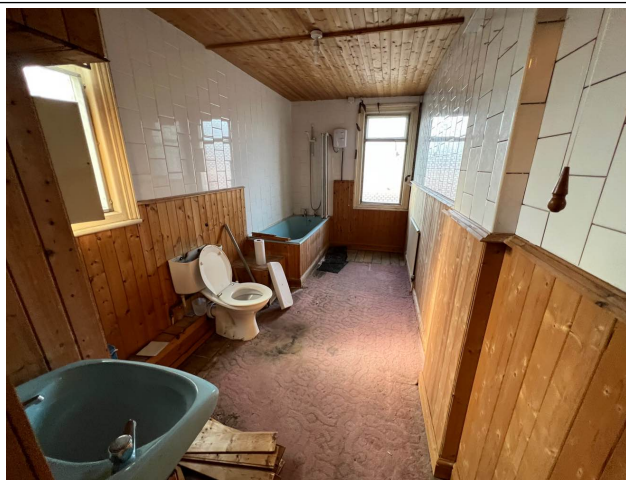
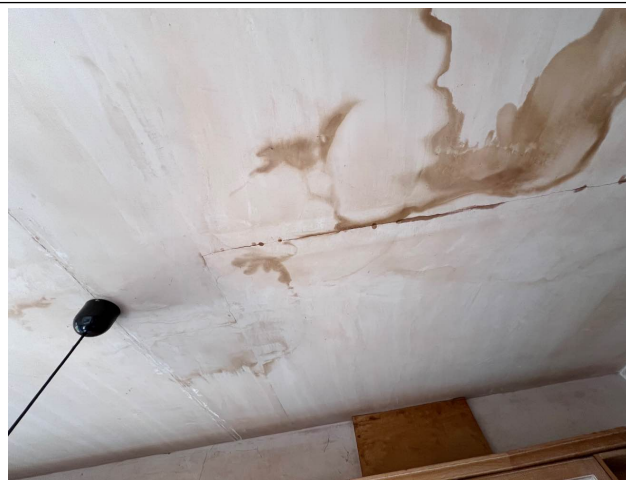
With respect to showers generally, they should be regularly cleaned, including the heads, to prevent the harbouring of bacteria such as Legionella.

The shower installation was not operated and this should be tested and checked before purchase. Only formal investigation and testing can confirm the adequate operation and efficiency of such installations.
