# Home Report

3 Novar Crescent  
Kirkcaldy KY1 1PT

# Single Survey

| Date of Inspection | 27/08/2025 |

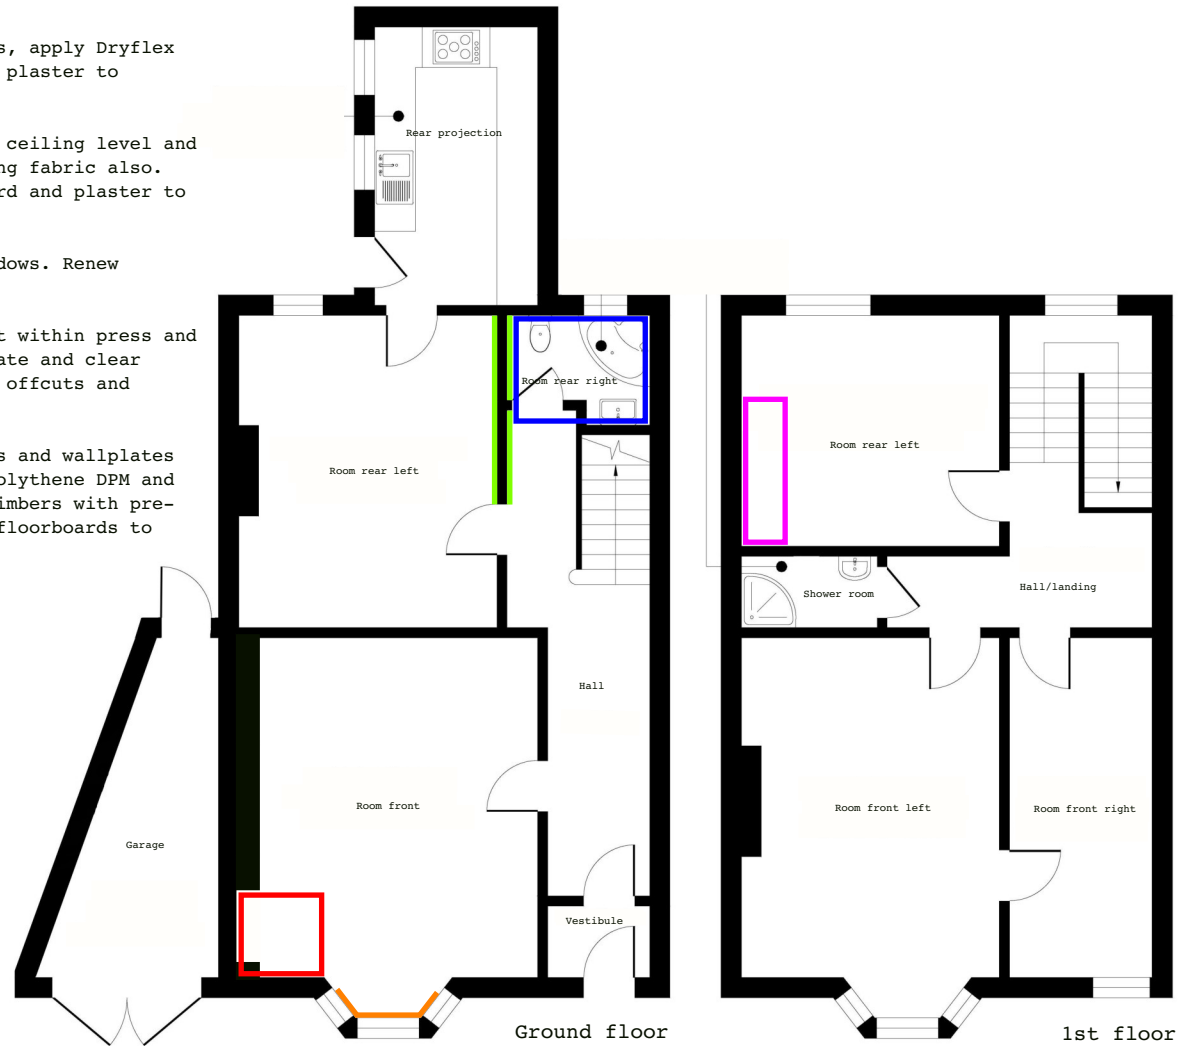
| <b>Notes</b> | <p>The bathroom floor displays significant deflection and is thought to be affected by rot. Higher than average moisture readings were recorded to some lower wall surfaces within the property and also to some localised upper wall surfaces at first floor level. There is evidence of infestation by wood boring insect to flooring and to roof space timbers. There is the potential for further related issues to exist in concealed areas.</p> <p>Subsequent to the date of inspection, The Preservation Company was commissioned to inspect the property on 8 September on behalf of the Seller. The specialist has produced a report dated 12 September detailing their findings and an associated quotation for treatments. All recommended remedial works should be implemented under cover of long-term guarantee.</p> |

Remove floorboards, floor joists and wallplates in entirety. Clear solum, lay polythene DPM and concrete mix. Renew all floor timbers with pre-treated timber and lay new T+G floorboards to match existing.
