YOUR ONESURVEY  
**HOME REPORT**

3/R  
180 Strathmartine Road  
Dundee  
DD3 8DQ

# SINGLE SURVEY

<b>Prepared by</b>	Blair Ferguson, MRICS Dundee - Allied Surveyors Scotland Ltd
--------------------	---

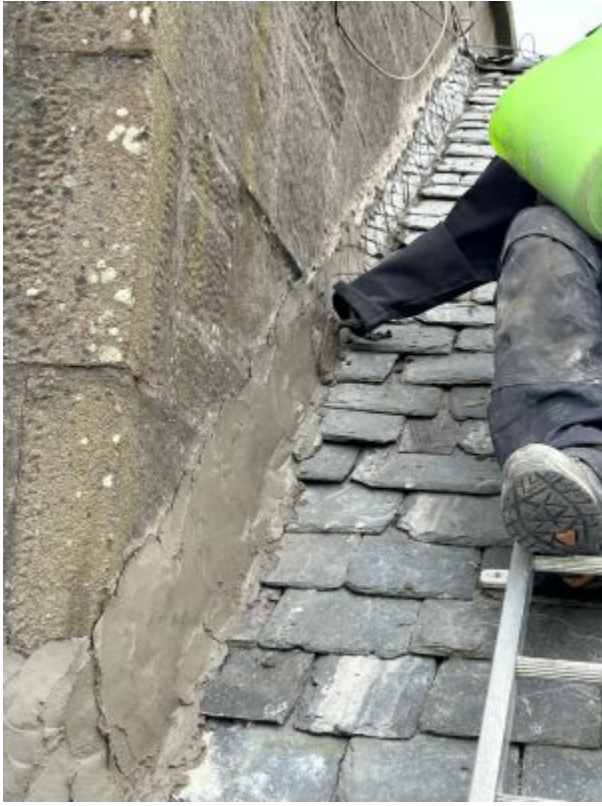
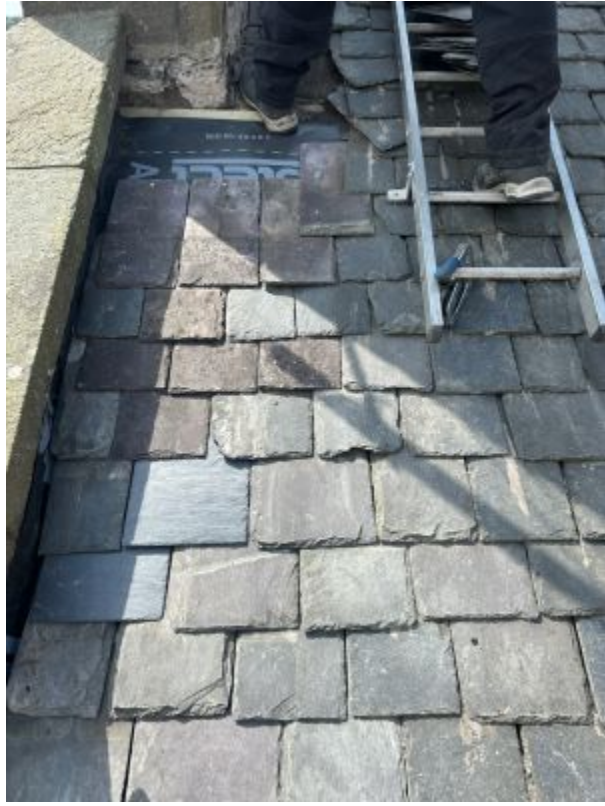
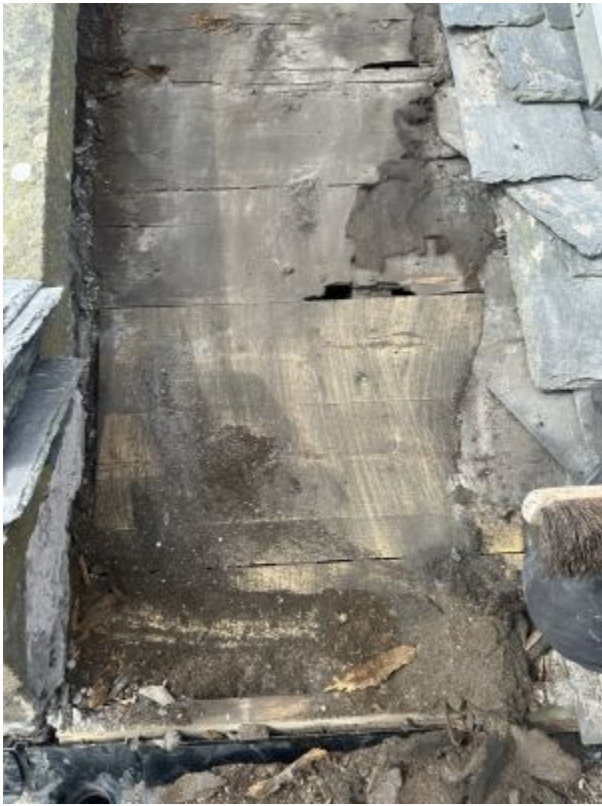
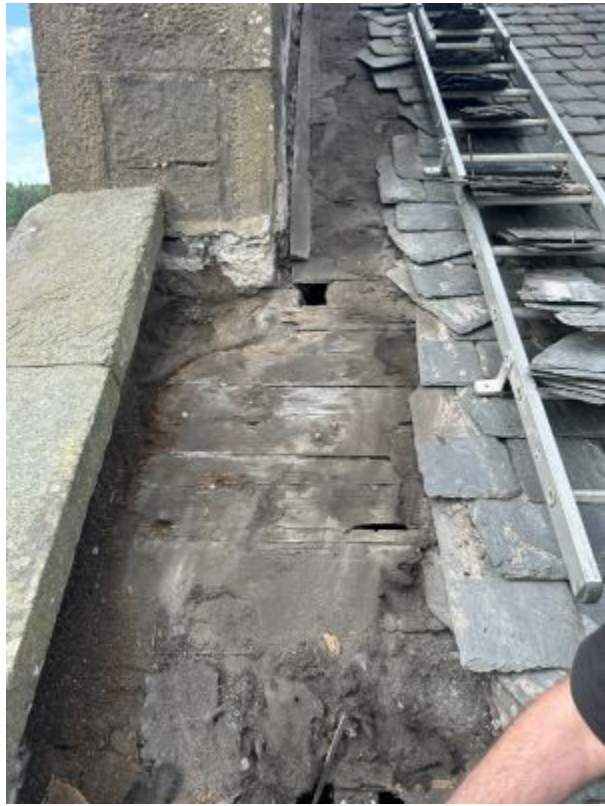
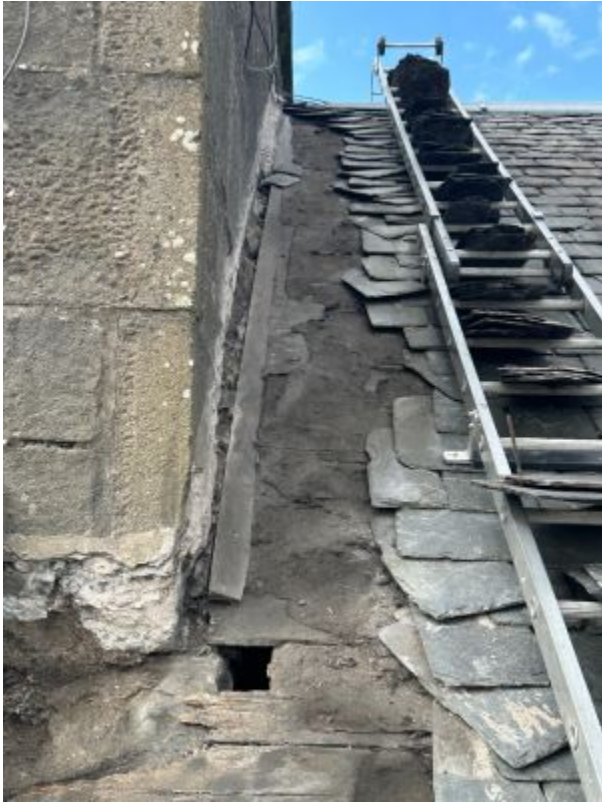
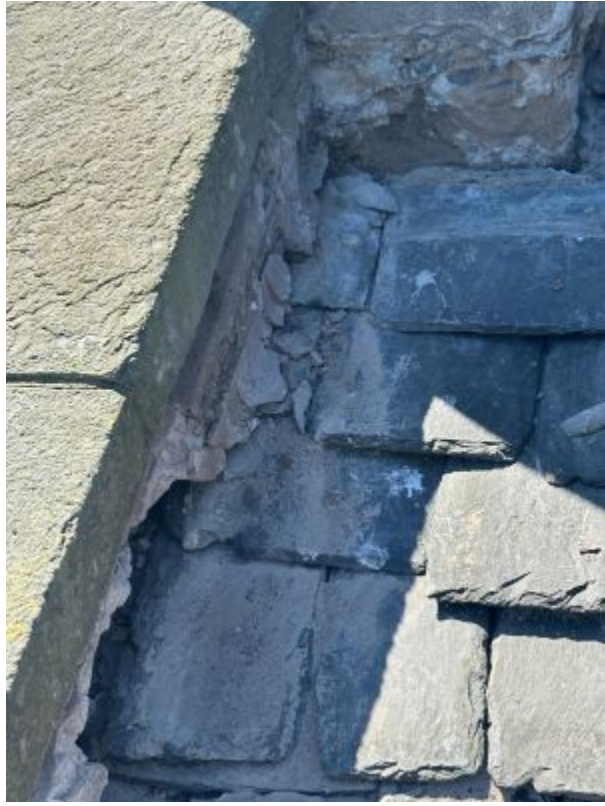
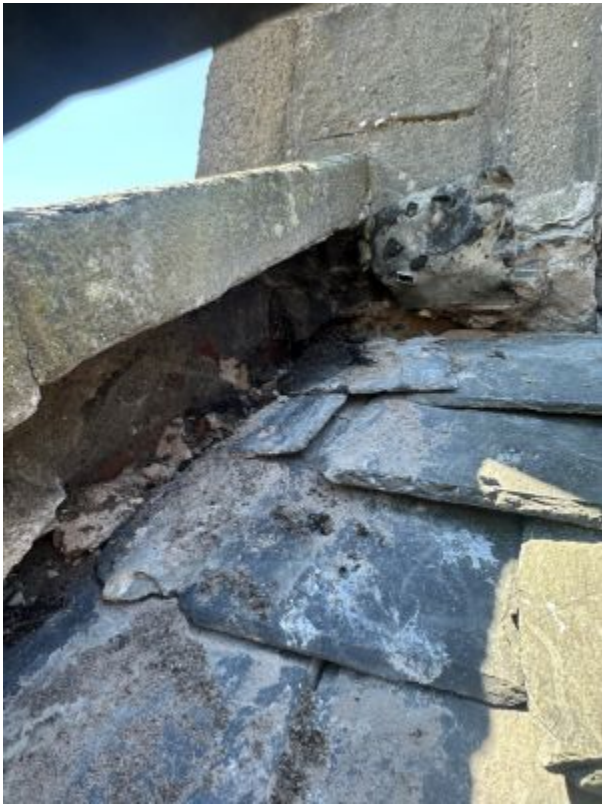
After inspection of the roof materials on this property it is our opinion that the damages have been caused by the recent multiple storms and high winds. This has resulted in slates being lifted and therefore breaking across the heads causing severe water ingress into the property. This has occurred above both flats on the building and we suspect the amount of movement in the slates has lead to cracking of the cement skew above top left flat.

DESCRIPTION	RATE	QTY	AMOUNT
Replacement of any broken slates Replacement of any slates that break during the removal and refitting process	£0.00	1	£0.00
Scaffolding to be erected at front of property	£0.00	1	£0.00
Removal of front right cement skew Skew to be removed to allow access to slates underneath	£0.00	1	£0.00
Stripping of broken slates on front right of roof	£0.00	1	£0.00
Stripping of a section of slates from front right Large area of old slates to be removed from front right of roof	£0.00	1	£0.00
Cleaning down of front right of roof	£0.00	1	£0.00
Fitting of new water proof membrane on front right side of roof	£0.00	1	£0.00
Fitting of slates to the stripped area on front of roof	£0.00	1	£0.00
Creation of new cement skew on front right of roof	£0.00	1	£0.00
Removal of all debris from site on completion	£0.00	1	£0.00
Removal of front left cement skew	£0.00	1	£0.00
Replacement of any slates that break on the left of roof due to skew removal	£0.00	1	£0.00

Creation of new cement skew on front left of roof	£0.00	1	£0.00
Cement work down gable end of building next to coping stones	£0.00	1	£0.00
Removal of broken downpipe on front of building	£0.00	1	£0.00
Fitting of new upvc downpipe on front of building	£0.00	1	£0.00
Stripping of a section of slates from front left area of old slates up length of skew to be removed from front left of roof	£0.00	1	£0.00
Fitting of new water proof membrane on front left side of roof	£0.00	1	£0.00
