Our Ref: 17775/KL

17th April 2025

72 Elmwood Crescent, Flitwick, Beds. MK45 1LJ - Structural Inspection

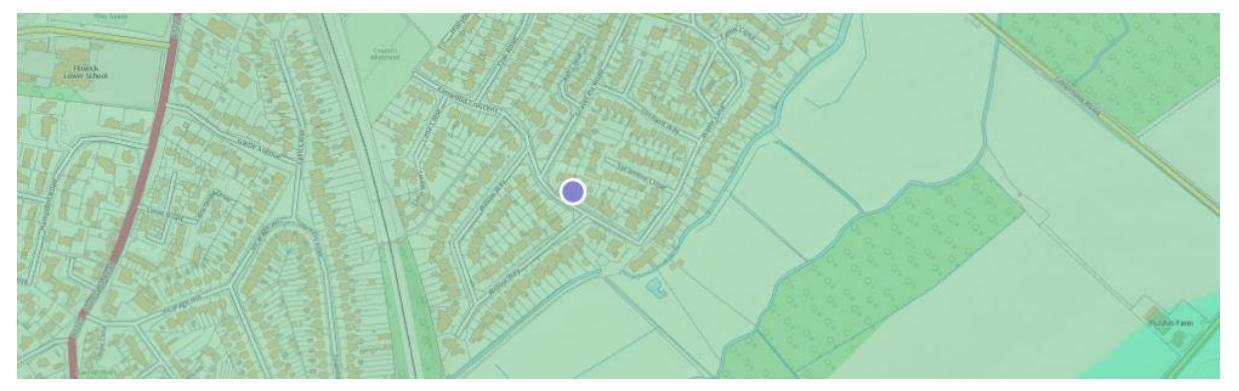
58. The British Geological Survey suggests the most likely 'bedrock' is expected to be:

Woburn Sands Formation - Sandstone. Sedimentary bedrock formed between 126.3 and 100.5 million years ago during the Cretaceous period.

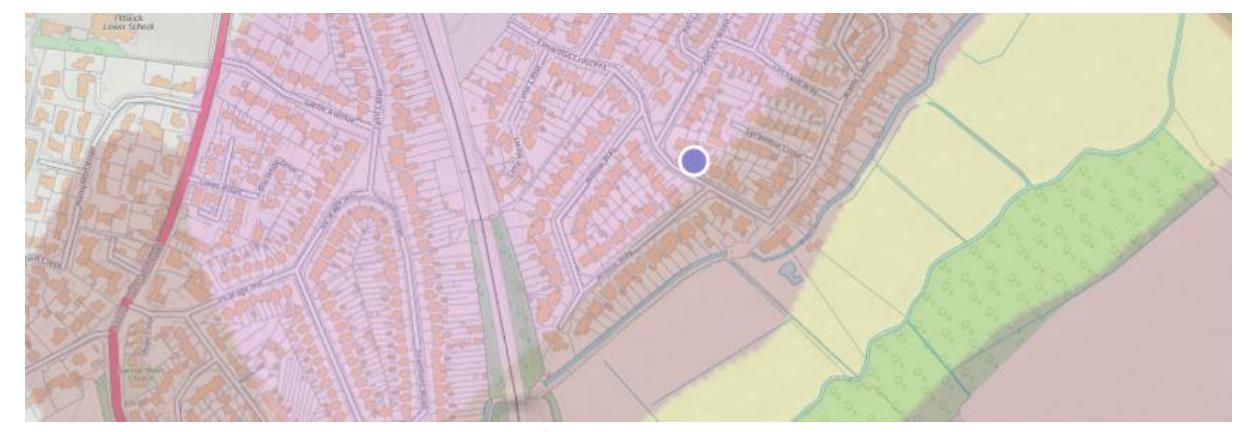
59. The superficial deposits are expected to be:

Glaciofluvial Deposits, Mid Pleistocene - Sand and gravel. Sedimentary superficial deposit formed between 860 and 116 thousand years ago during the Quaternary period.

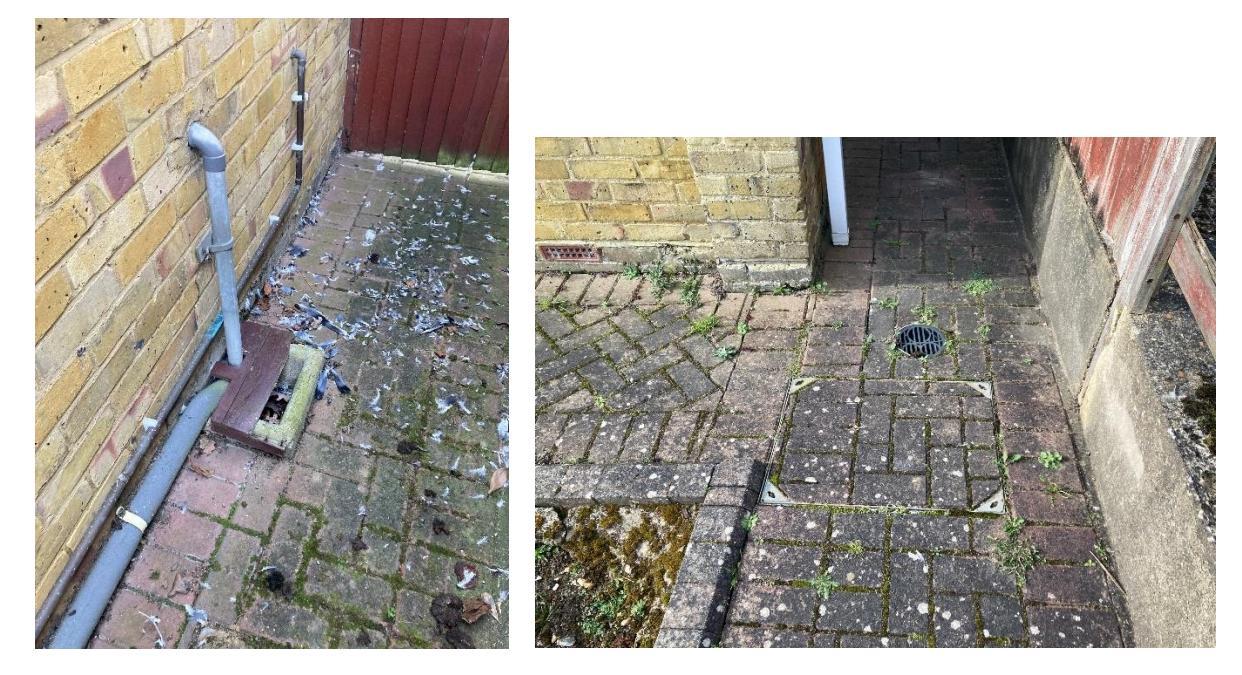
64. The drainage from the kitchen discharge to a gully to the right-hand side of the property. There is a manhole in the footpath close to the front right hand corner of the property.

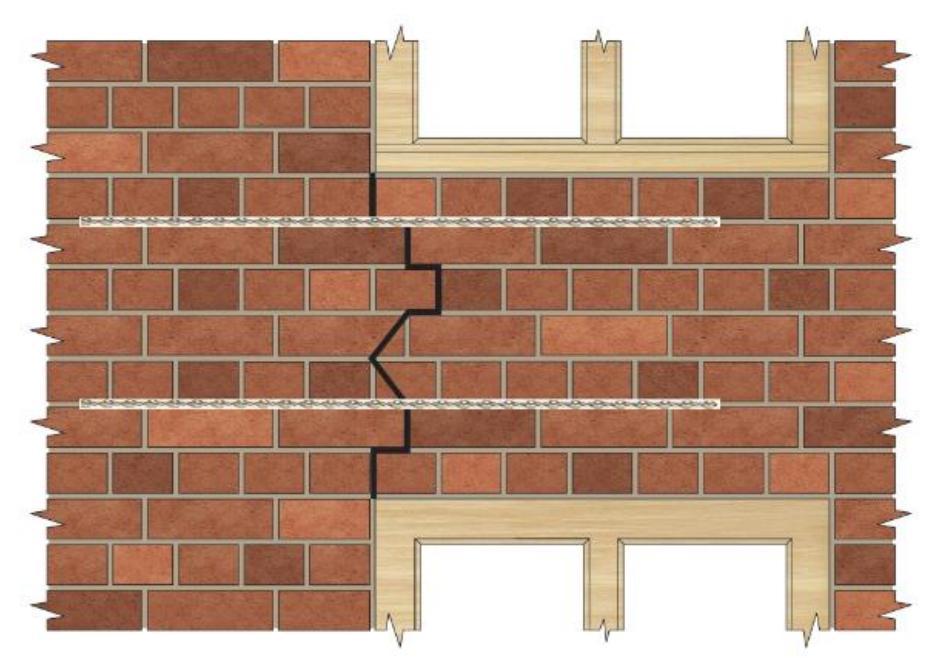
- 88. If you use the analogy of repairing a torn piece of paper, you wouldn't attempt to repair this by just applying glue to the edges of the tear but instead reinforce the repair with maybe tape stuck across the torn section to strengthen the repair. Similarly, with cracks in masonry, the best approach is to do a structural repair where the crack is 'stitched' across the crack using resin fixed ties to strengthen the repair.

- 89. Lengths of HeliBar are bonded with resin into slots cut in the bed joints. The crack itself should also be filled with grout or resin.
- 90. Once this has been completed, the crack can be repointed externally, ideally repointing an area around the crack to blend the repairs.
- 91. Internally the plaster should be removed for 100-150mm either side of the crack and the substrate repaired using resin ties as described above. Stainless-steel expanded metal lathing can be fixed across the line of the cracking with plugs and stainless-steel screws and washers prior to re-plastering.
- 92. If this approach is followed, then this should return the wall to its original strength and make it better able to resist normal building movements without cracking.
- 93. The contractor that we find does a very good job with these crack repairs is:

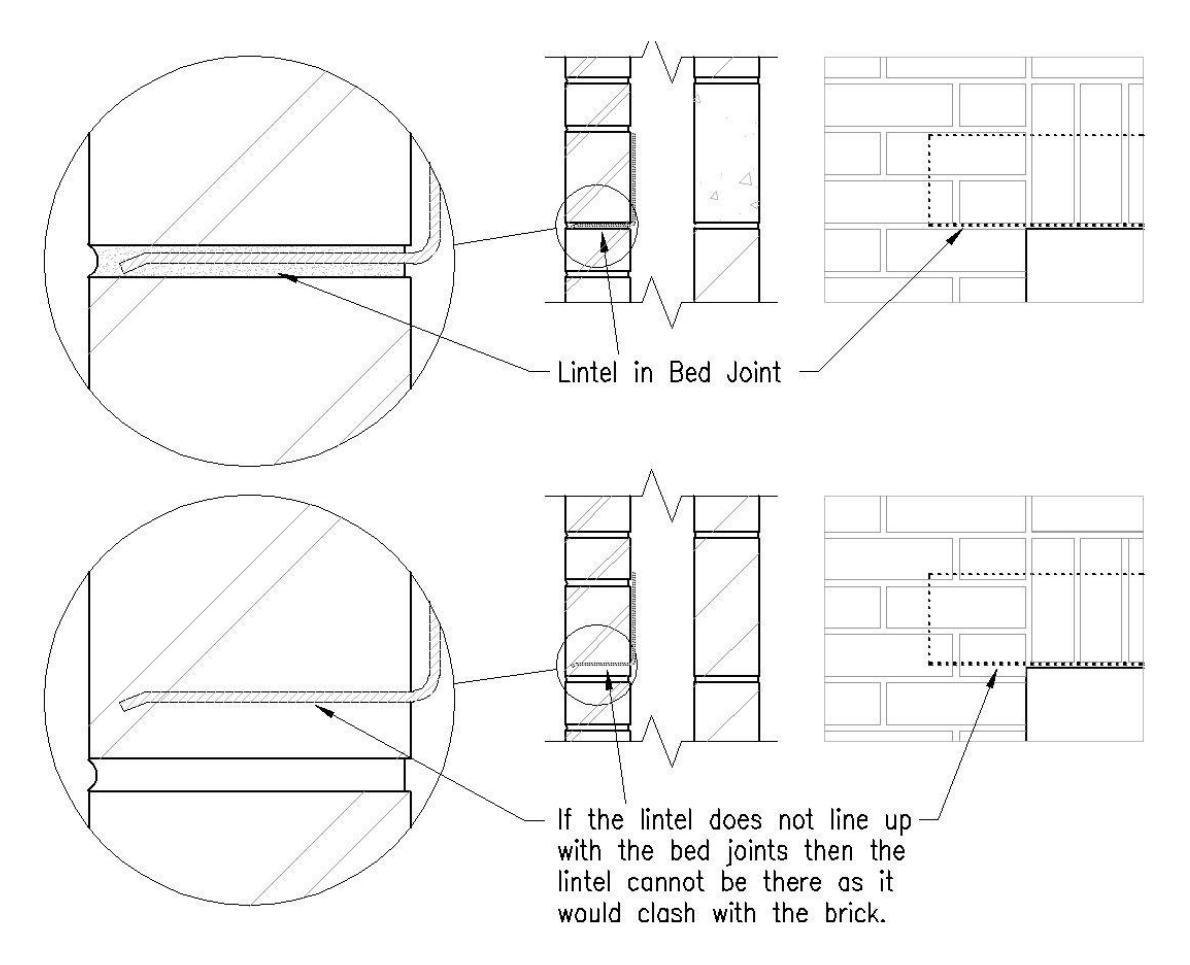
96. If the top of the window opening does not line up with a mortar bed joint, there is a high chance that there are no lintels supporting the outer leaf of the wall.

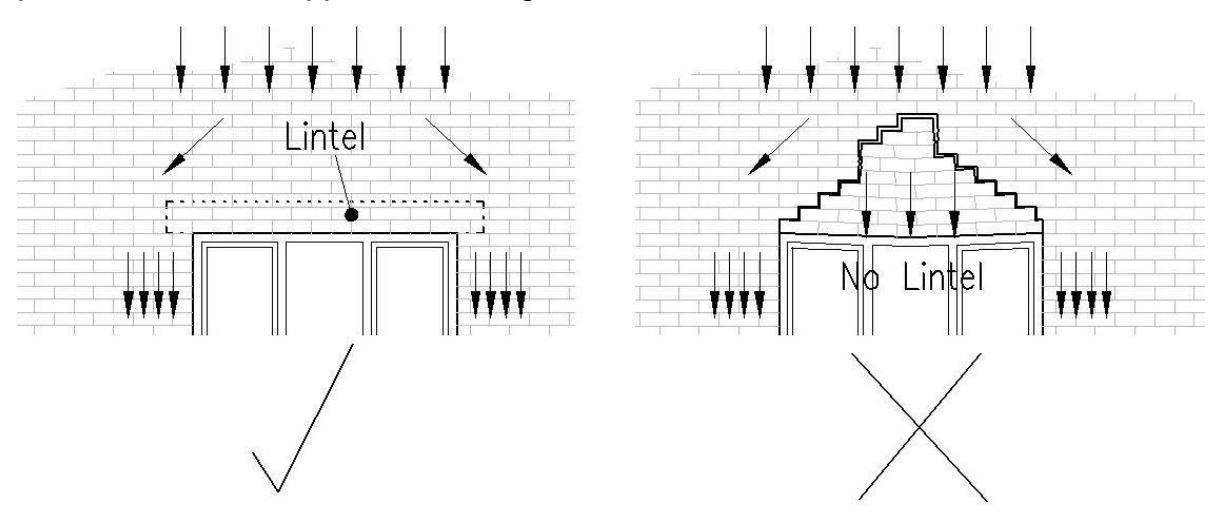
- 101. If the mortar is strong or the opening width small, the bricks over the window can hang in place without any issues. If the mortar is weaker then, the brickwork over the window can crack and drop, resulting in cracking.
