## Church Farm House Hilperton.

### **Current renovations**

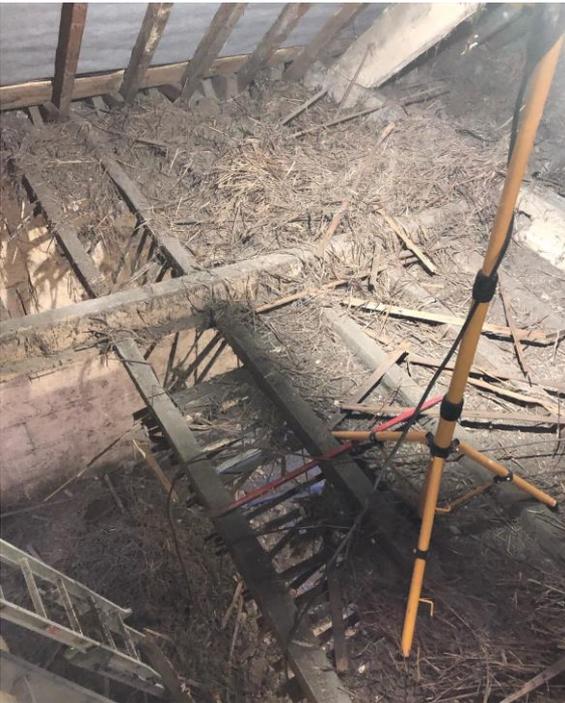
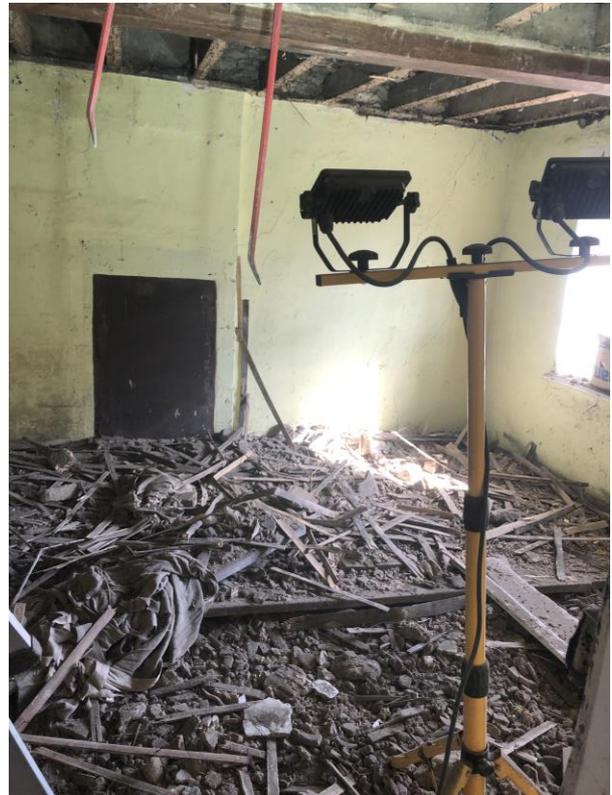
The house was purchased in Oct 2021 in state of considerable disrepair. Considerable neglect to the property resulted in a severely damaged leaking roof, structural problems on the barn, barn gable end, chimneys/coping stones, roof timbers and ceiling joists, rotting lintels above north side windows, unusable drainage and sewage system, poor stone work and pointing across the whole property and unusable plumbing, heating and electrical systems throughout. The gardens and barns were also in a poor state of repair/up keep.
