# YOUR ONESURVEY HOME REPORT

8/1  
112 Lancefield Quay  
Glasgow  
G3 8HR

# **Lancefield Quay**

## **Single Building Assessment (SBA)**

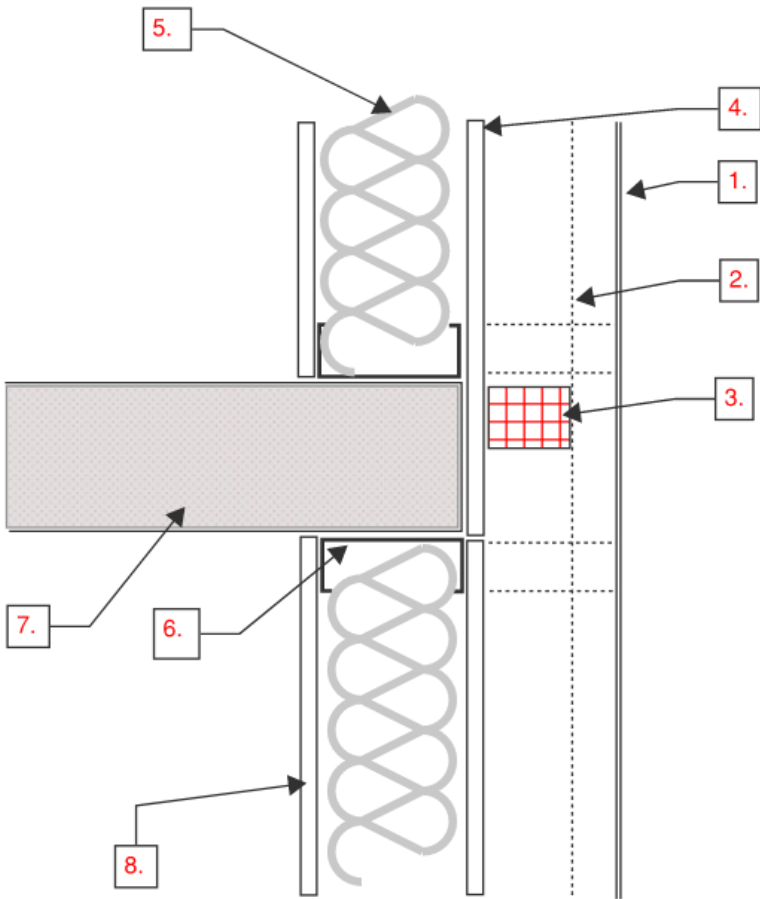
Typical External Wall

- 1- Cladding
- 2- Cladding support system (rail)
- 3- Horizontal cavity barrier (open state intumescent)
- 4- CP board
- 5- Insulation within stud zone
- 6- SFS
- 7- Floor construction (concrete slab)
- 8- Inner linings (typically plasterboard)

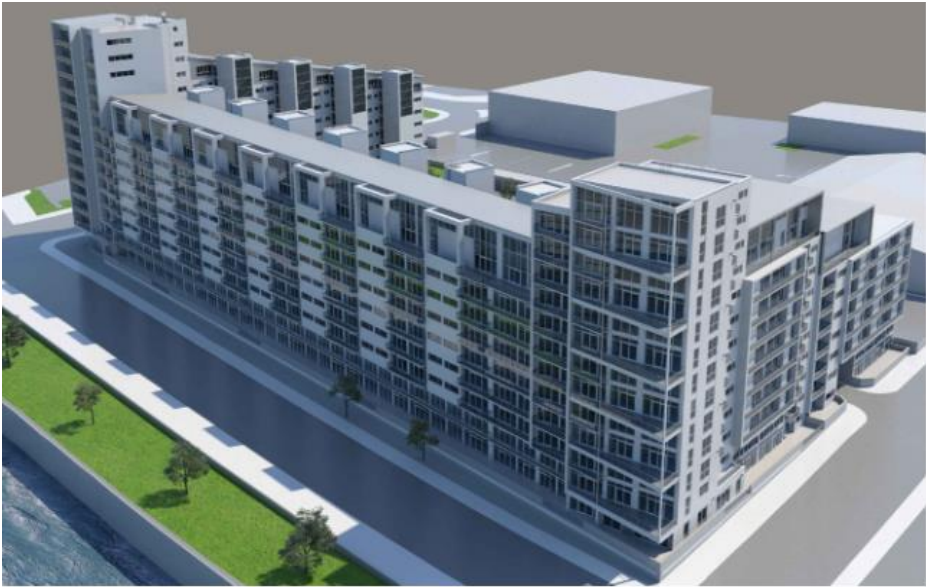
Figure 1—2 Overview of site – Image from BBP Opening Up Investigations September 2025

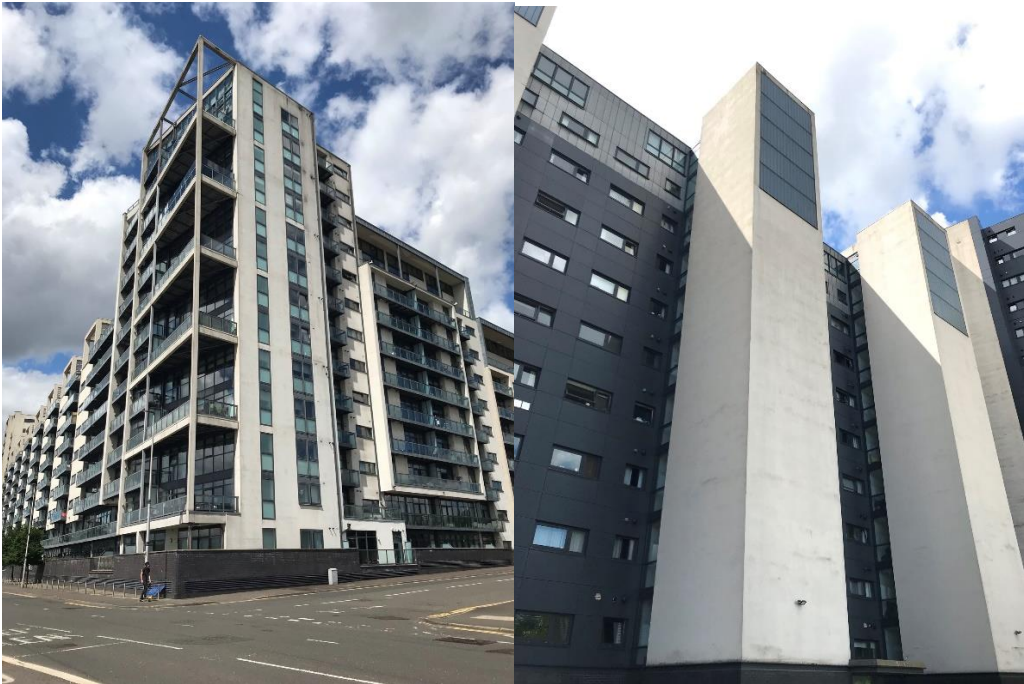
Figure 1—3 Development Views – Lancefield Quay and Courtyard Cores

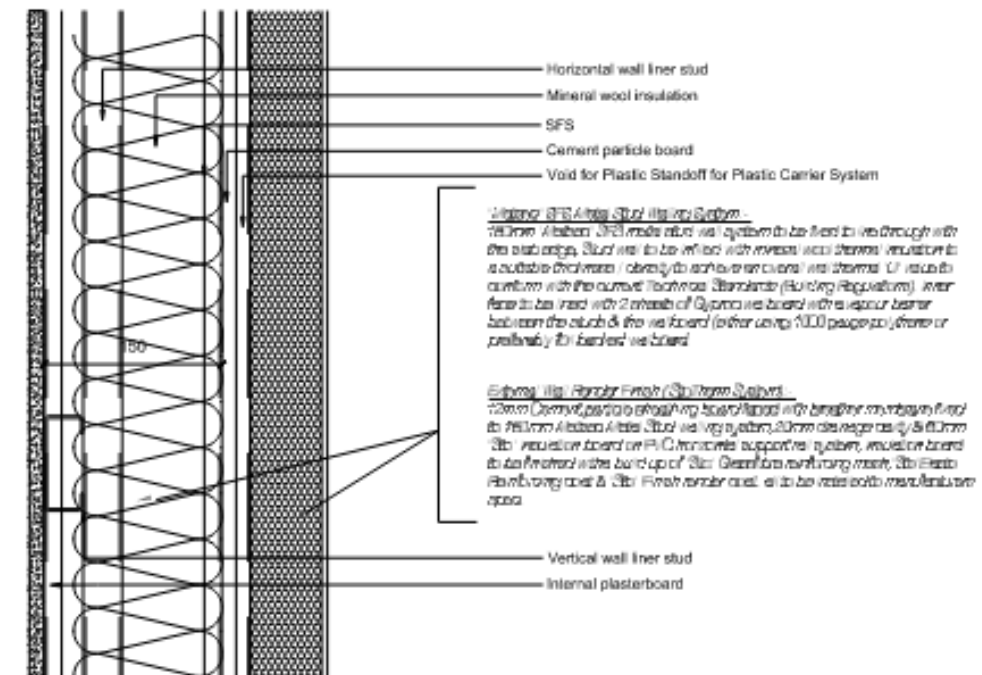
**Figure 5—6 Detail Drawing 12 – BBP Investigations September 2025**

The build up noted in Table 5-2 is per BBP Detail Drawing 12 shown below, as referenced within BBP Intrusive Investigations Report September 2025.

**Note:** Through the investigations carried out, a variant of this wall type was also confirmed, where the substrate is concrete (stair cores) as opposed to SFS and cement particle board.

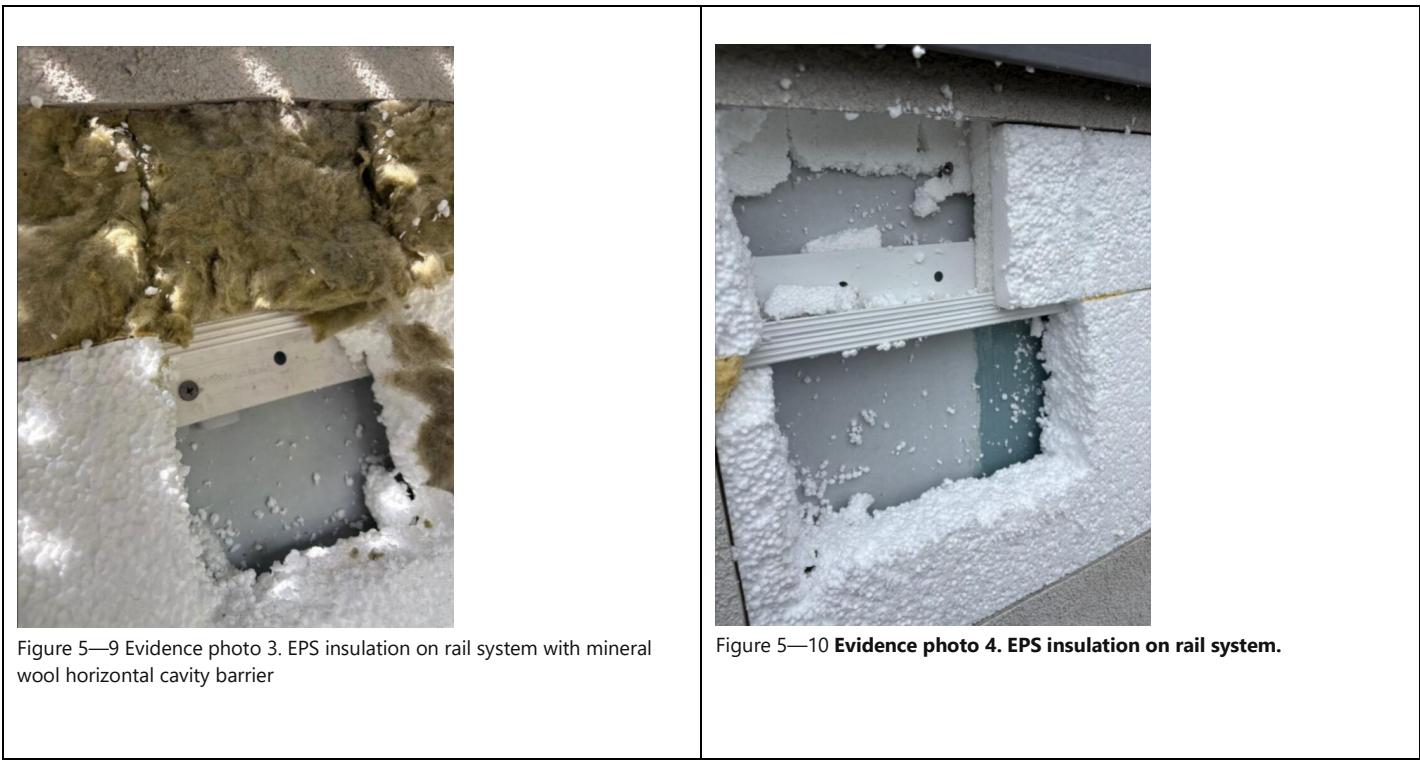
Note mineral wool type horizontal cavity barriers have been observed in some locations.

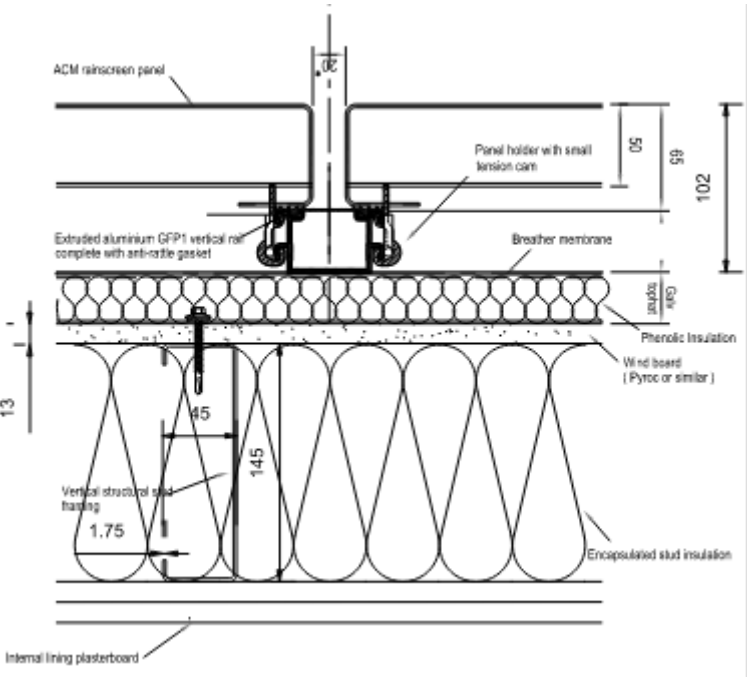
Figure 5—11 Detail Drawing 3 - BBP Investigations September 2025

The build up noted in Table 5-3 above is per BBP Detail Drawing 3 shown in Figure 5-12, as referenced within BBP Intrusive Investigations Report September 2025.

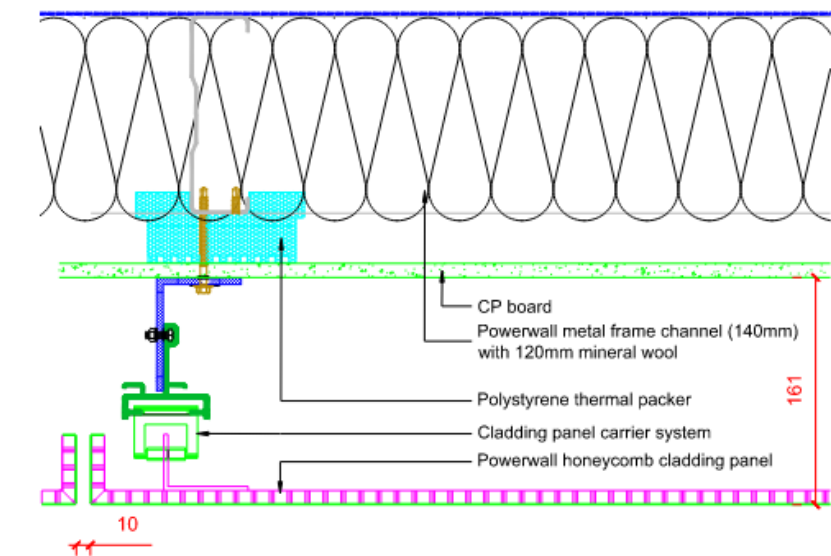
Figure 5—14 Detail Drawing 34 – BBP Investigations September 2025

The build up noted above is per BBP Detail Drawing 34 shown Figure 5-, as referenced within BBP Intrusive Investigations Report September 2025.

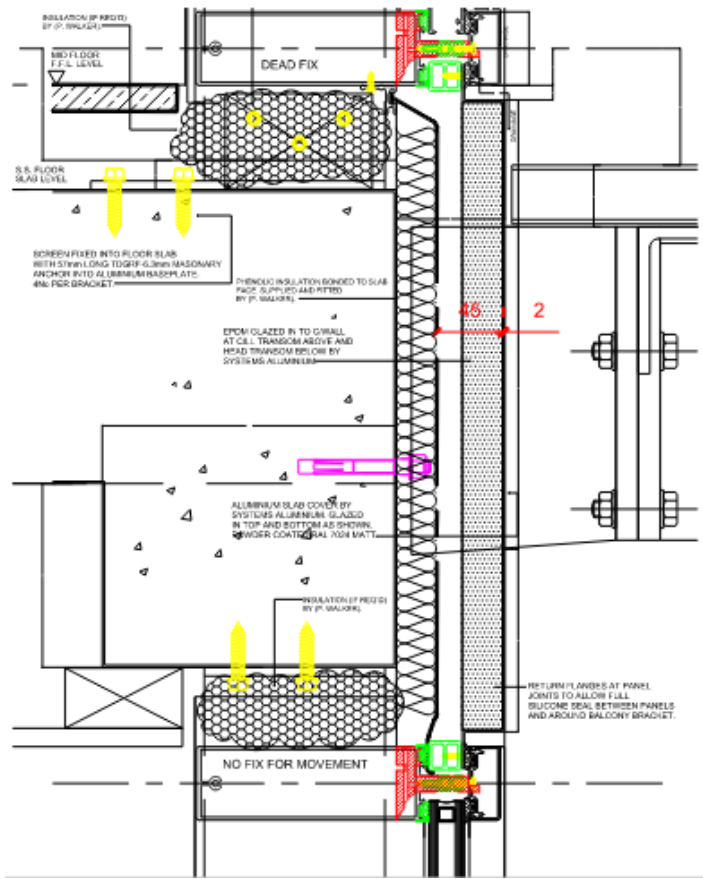
Figure 5—19 Detail Drawing 32 – BBP Investigations September 2025

| External Wall Element | Notes |
|---|---|
| insulation | Phenolic insulation noted at slab level, to the rear of spandrel panel |

The build up noted in Table 5-5 is per BBP Detail Drawing 32 shown in Figure 5-19, as referenced within BBP Intrusive Investigations Report September 2025.

**Note:** Combustible Phenolic insulation to be removed and replaced with A1/A2. Spandrel panel to be replaced with A1/A2 as required in order to complete the insulation replacement.

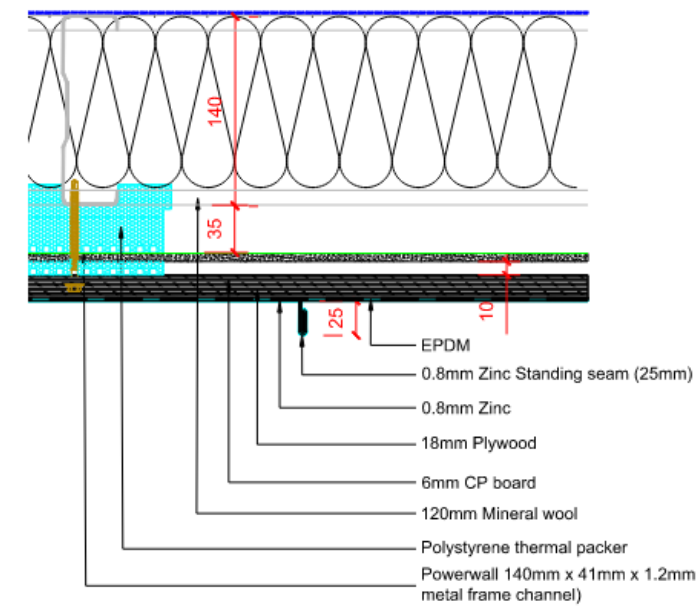
Figure 5—22 Detail Drawing 36 – BBP Investigations September 2025

Note: The foregoing (Table 5-6) wall type is relevant to Phases 1-3 of the development. The build up noted above is per BBP Detail Drawing 36 shown in Figure 5-22), as referenced within BBP Intrusive Investigations Report September 2025.

No vertical or horizontal cavity barriers were confirmed as being present within the zinc cladding systems in the areas investigated by BBP.

| Risk Factor | Comments | Risk Impact |
|---|---|---|
| Cavities | The above construction would be seen to have a negative impact given the presence of polystyrene packers and plywood. The polystyrene packers create a cavity. No vertical compartmentation / cavity barriers were noted during the investigations. No cavity closers around windows were noted in the investigations. | Negative |

Note: Vertical compartmentation to be installed. Existing zinc standing seam to be opened up / unzipped with FR120 vertical cavity barrier installed between flats. New replacement cladding system (installed locally) to satisfy current A1/A2 regulatory requirements

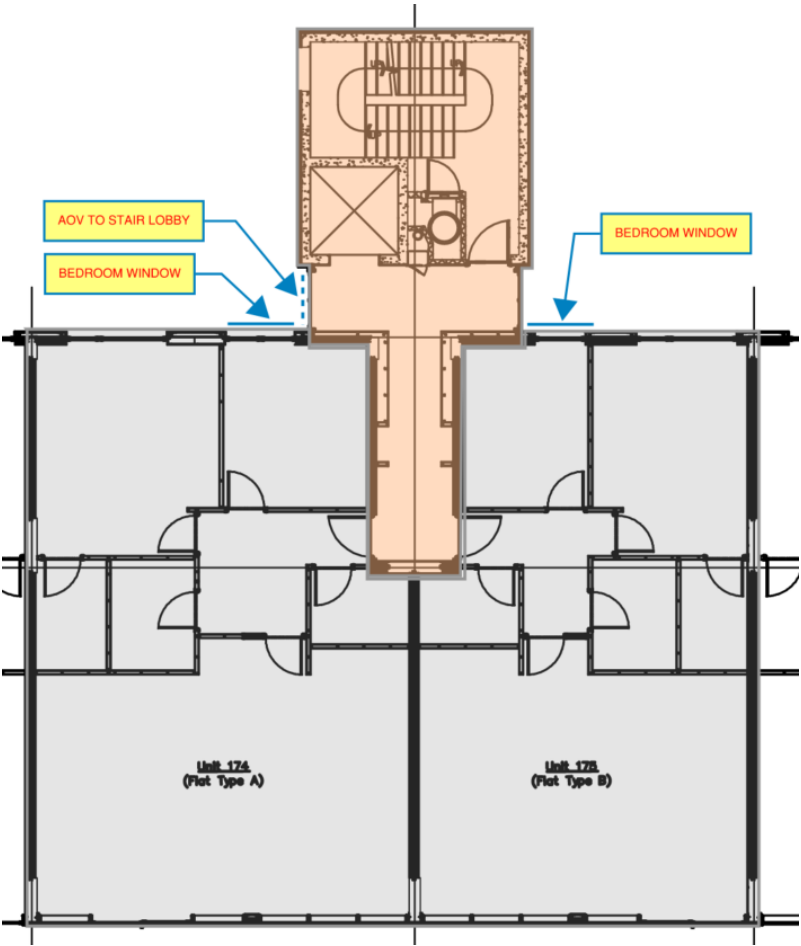
Figure 7—4 Stair Geometry

Given the proximity of the flat bedroom windows to the stair core AoV installed each level, there is a possibility that a fire may break out of a flat window and compromise the escape route – via the glazed fixed pane / AoV per the current arrangement.

Investigations completed on site have also confirmed that there is no vertical cavity barrier is installed at the junction of the vertical ribbon windows and WT04 – it is recommended that this is addressed as part of remediation works

In order to mitigate potential smoke logging of the escape corridor in this situation, it is recommended that a second AoV is installed to the stair lobby (each floor) where there is currently a fixed pane. This would provide a secondary vent in order to clear any smoke should the first vent become compromised due to proximity to the flat windows.

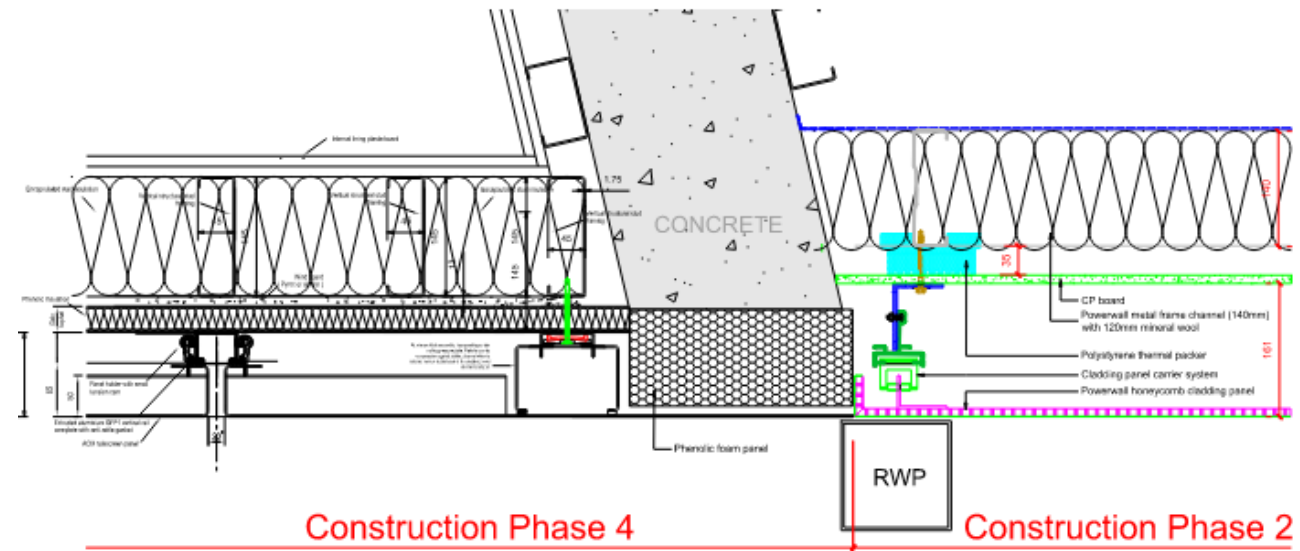
Figure 8—1 BBP Detail Drawing 33 BBP Investigations September 2025

This timeline has resulted in a 'gap' in construction between Phases 2 & 4 as shown in the Figures below:

The transition between Phases 02 and 04 is currently covered by 2no. Wall types, **WT03** ACM cladding and **WT04** Aluminum Rainscreen.

It is recommended that during the remediation works where both of these wall types are to be removed and replaced, that this gap (cavity) between the construction phases is suitably sealed / closed off
