Home Report

10 Aitken Street
Kirkcaldy KY1 3DR

Date of Valuation: 01/06/2026

Single Survey

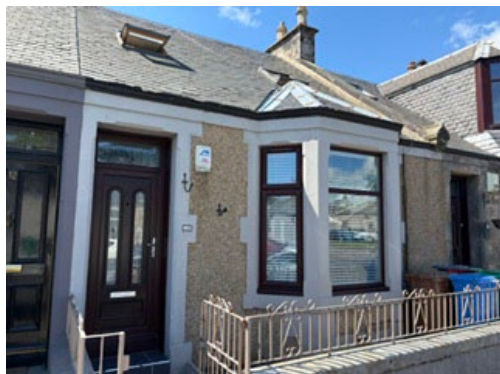
Front elevation

The property is a traditional stone/brick built mid-terraced house with slate roof coverings and rear kitchen projection.
