# Home Report

3 Novar Crescent  
Kirkcaldy KY1 1PT

Date of Valuation: 03/02/2026

## Property Owner's Completion Pack

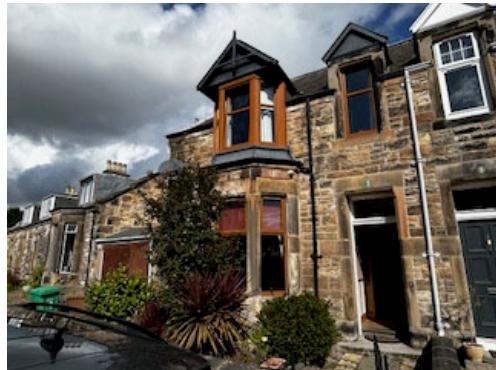
Front elevation

The property is a traditional stone/brick built semi-detached house with slate and flat roof coverings and rear single storey projection.
