YOUR ONESURVEY  
**HOME REPORT**

0/1  
11 Montague Street  
Woodlands Glasgow  
G4 9HU

# SINGLE SURVEY

<b>Surveyor Reference</b>	GG/3364
<b>Customer</b>	Mr. Martyn Nicholson
<b>Selling address</b>	0/1 11 Montague Street Woodlands Glasgow G4 9HU
<b>Date of Inspection</b>	08/06/2026
<b>Prepared by</b>	A E MacDonald, BSc (Hons) MRICS Glasgow North - Allied Surveyors Scotland Ltd

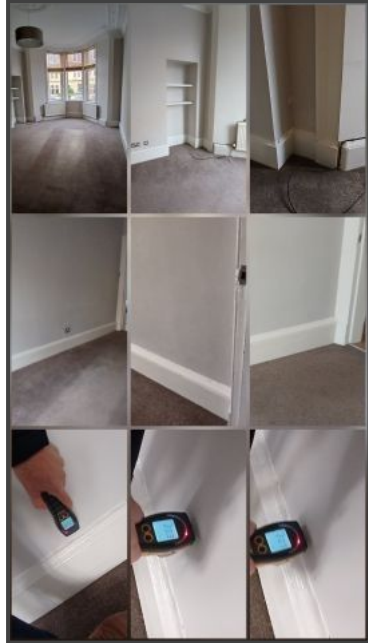
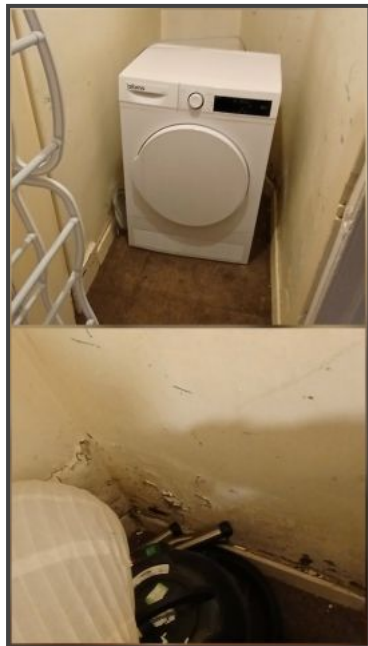
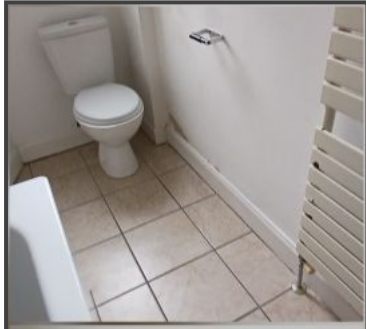
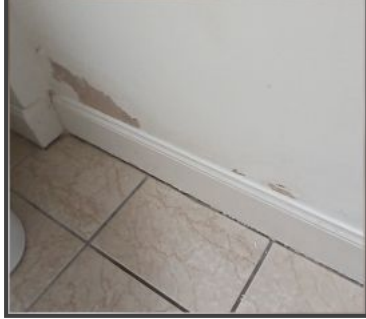
safeguard the property. Delays could escalate costs and compromise habitability.

We strongly advise that you arrange for all the above noted defects to be attended to ASAP.
