26-6486 – 6 Hazeldean Crescent, Oban – Structural Inspection

Further to your recent request, we confirm that we visited 6 Hazeldean Crescent, Oban on Wednesday 25th March 2026. The purpose of the visit was to inspect the condition of the existing dwelling and identify any visible structural defects or repairs that may be required. At the time of the inspection, the weather conditions were bright and wet.

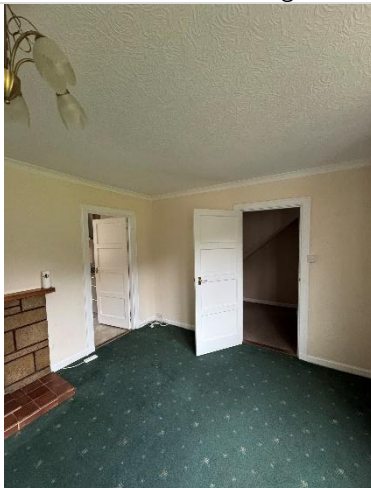
Photo 16 – Ground floor hallway

Upon entry into the property, the first area of inspection was the ground floor hallway which was in sound condition with no cracking or defects noted within the space (See photos 16-17). The living room space was inspected next which was also in sound condition with no structural cracking identified at the time of inspection. A small, localised area of discolouration was noted on the ceiling within the living room which appeared to follow a linear pattern approximately 1m from the gable wall (See photo 18). An additional area of discolouration was also noted on the internal wall to the left of the electric fireplace (See photo 19). The cause of the discolouration could not be confirmed at the time of inspection due to finishes being present therefore intrusive investigations would be required to assess the condition of the structure. The ground floor bathroom also appeared to be in sound condition with no notable defects identified in the finishes (See photo 20). The kitchen space was also in good condition with no visible cracking or deformations noted at the time of inspection (See photo 21). The floor space within the kitchen pantry had no finishes present which confirmed that the ground floor is constructed of concrete slab (See photo 22). All ground floor door and window openings appeared to be level and opened with ease.
