YOUR ONESURVEY  
**HOME REPORT**

Flat 0/2  
234 Bearsden Road  
Glasgow  
G13 1LA

# SINGLE SURVEY

<b>Surveyor Reference</b>	GG/1951
---------------------------	---------

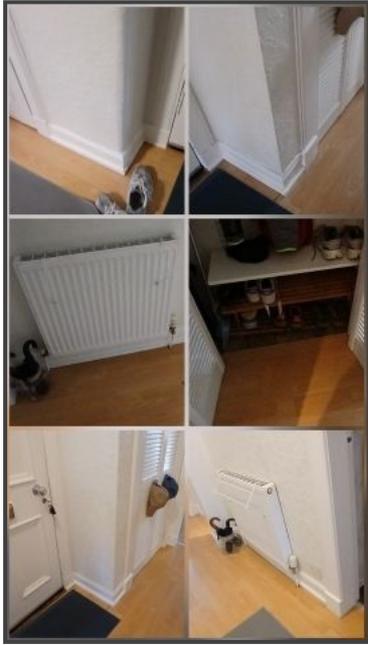
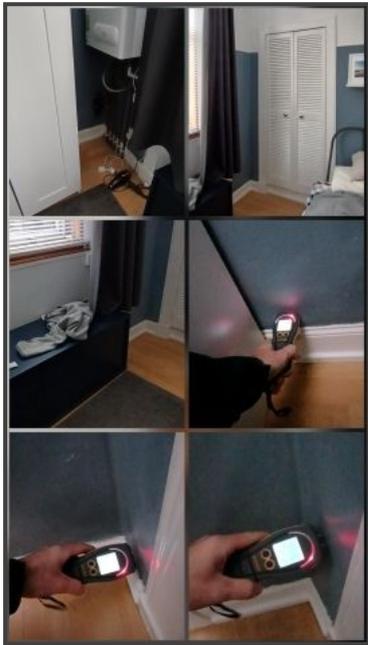
Effects:

- Moisture bridging: Debris acts as a wick, enabling lateral damp penetration and condensation, leading to staining and salt efflorescence.
- Timber risks: Concealed framing becomes prone to fungal decay if saturation persists.
- Finish damage: Internal linings may delaminate, with potential for mould proliferation in humid conditions.
