Home Report

Single Survey

Property address	6 Carrieblair Crescent Edderton Tain IV19 1JZ
Customer	Executry of the Late Cyril Giles
Customer address	6 Carrieblair Crescent Edderton Tain IV19 1JZ
Prepared by	Shepherd Chartered Surveyors
Date of inspection	09/05/2025

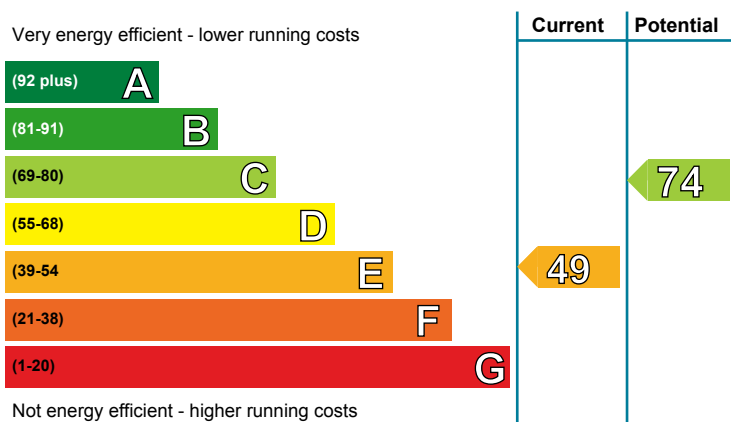
Energy Efficiency Rating

This graph shows the current efficiency of your home, taking into account both energy efficiency and fuel costs. The higher this rating, the lower your fuel bills are likely to be.

The potential rating shows the effect of undertaking all of the improvement measures listed within your recommendations report.

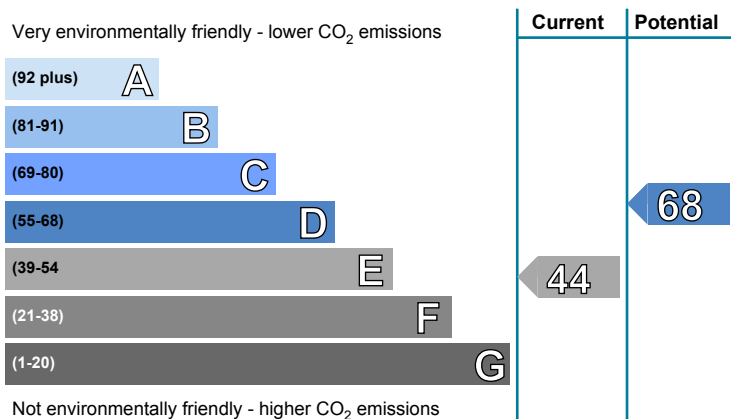
Environmental Impact (CO₂) Rating

This graph shows the effect of your home on the environment in terms of carbon dioxide (CO₂) emissions. The higher the rating, the less impact it has on the environment.
