# Home Report

# Single Survey

| Property address | Ramiah<br>Arthurville Gardens<br>Tain<br>IV19 1PL |
| Prepared by | Shepherd Chartered Surveyors |

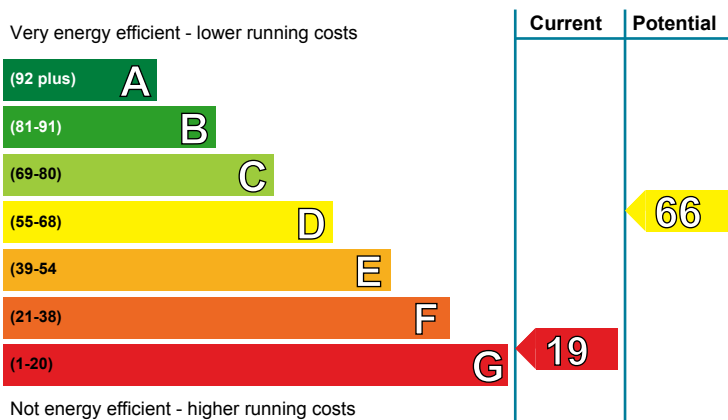
## Energy Efficiency Rating

This graph shows the current efficiency of your home, taking into account both energy efficiency and fuel costs. The higher this rating, the lower your fuel bills are likely to be.

Your current rating is **band G (19)**. The average rating for EPCs in Scotland is **band D (61)**.

The potential rating shows the effect of undertaking all of the improvement measures listed within your recommendations report.
