Home Report

Single Survey

Property address	Armadale Main Street Portmahomack Tain IV20 1YB
Customer	Tony Smith
Customer address	Armadale Main Street Portmahomack Tain IV20 1YB
Prepared by	Shepherd Chartered Surveyors
Date of inspection	06/10/2025

Energy Performance Certificate (EPC)

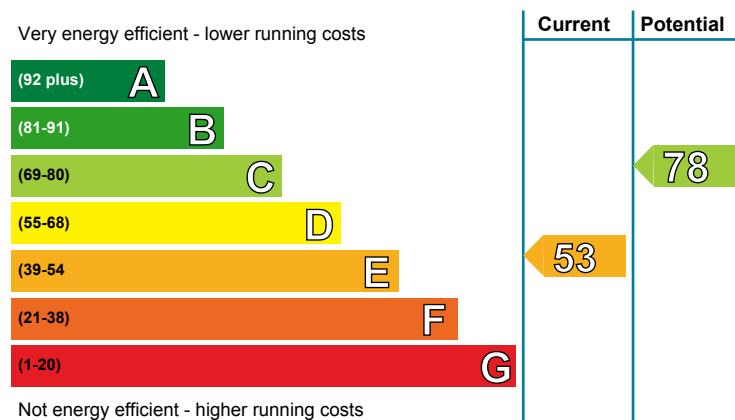
Energy Efficiency Rating

This graph shows the current efficiency of your home, taking into account both energy efficiency and fuel costs. The higher this rating, the lower your fuel bills are likely to be.

Your current rating is **band E (53)**. The average rating for EPCs in Scotland is **band D (61)**.

The potential rating shows the effect of undertaking all of the improvement measures listed within your recommendations report.

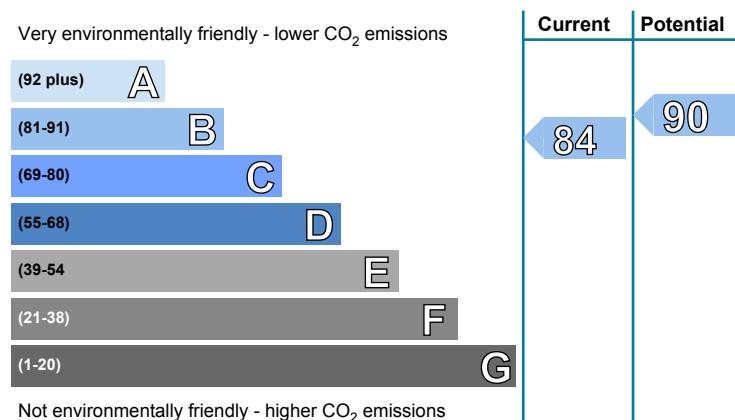
Environmental Impact (CO₂) Rating

This graph shows the effect of your home on the environment in terms of carbon dioxide (CO₂) emissions. The higher the rating, the less impact it has on the environment.
