## Home Report

8 SPEY ROAD, BEARSDEN, GLASGOW, G61 1LA

## survey report on:

Property address	8 SPEY ROAD BEARSDEN GLASGOW G61 1LA
Customer	Mr & Mrs Hazell
Customer address	
Prepared by	White Horse Surveyors Limited
Date of inspection	10th November 2020

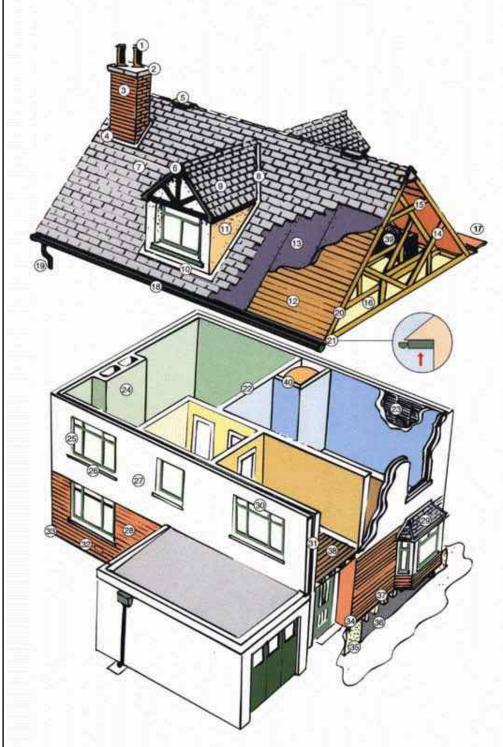
#### Sectional Diagram showing elements of a typical house

Reference may be made in this report to some or all of the above component parts of the property. This diagram may assist you in locating and understanding these items.

- 1 Chimney pots
- 2) Coping stone
- 3) Chimney head
- 4) Flashing
- (5) Ridge ventilation
- 6) Ridge board
- 7) Slates / tiles
- (8) Valley guttering
  - 9) Dormer projection
- 10 Dormer flashing
- 11 Dormer cheeks
- 12) Sarking
- (13) Roof felt
- (14) Trusses
- 15) Collar
- (16) Insulation
- 7) Parapet gutter
- 18) Eaves guttering
- (19) Rainwater downpipe
- 0) Verge boards /skews
- 21) Soffit boards
- 22) Partition wall
- 23) Lath / plaster
- 24) Chimney breast
- (25) Window pointing
- Window sills
- (27) Rendering
- (28) Brickwork / pointing
- (29) Bay window projection
- (30) Lintels
- (31) Cavity walls / wall ties
- 32) Subfloor ventilator
- 33) Damp proof course
- 34) Base course
- 35) Foundations
- 36) Solum
- Floor joists
- 38) Floorboards
- 9) Water tank
- 40) Hot water tank
