# HARVEY DONALDSON & GIBSON

### **Survey report on:**

Property Address	Drums Of Park House . Cornhill Banff AB45 2BT
Customer	Mr J Christie
Date of Inspection	07/05/2024
Prepared by	Keith Alexander AssocRICS Harvey Donaldson & Gibson Chartered Surveyors

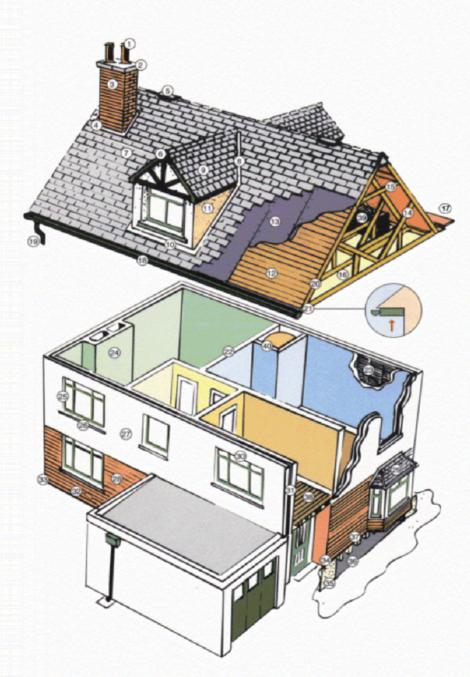
#### Sectional Diagram showing elements of a typical house

Reference may be made in this report to some or all of the above component parts of the property. This diagram may assist you in locating and understanding these items.

- 1) Chimney pots
- 2) Coping stone
- 3) Chimney head
- 4 Flashing
- 5) Ridge ventilation
- 6 Ridge board
- (7) Slates / tiles
- (8) Valley guttering
- Dormer projection
- 10 Dormer flashing
- 11) Dormer cheeks
- 12) Sarking
- (13) Roof felt
- 14) Trusses
- (15) Collar
- (16) Insulation
- (17) Parapet gutter
- (18) Eaves guttering
- (19) Rainwater downpipe
- 20) Verge boards /skews
- (21) Soffit boards
- (22) Partition wall
- 23 Lath / plaster
- 24) Chimney breast
- 25) Window pointing
- (26) Window sills
- (27) Rendering
- (28) Brickwork / pointing
- 29 Bay window projection
- 30 Lintels
- 31) Cavity walls / wall ties
- 32) Subfloor ventilator
- 33 Damp proof course
- 34) Base course
- 35) Foundations
- 36) Solum
- (37) Floor joists
- (38) Floorboards
- 39) Water tank
- (40) Hot water tank
