# Single Survey

survey report on:

<b>Property address</b>	Nether Ord, Rhynie, Huntly, AB54 4HF
-------------------------	-----------------------------------------------

<b>Prepared by</b>	Allied Surveyors Scotland Ltd
--------------------	-------------------------------

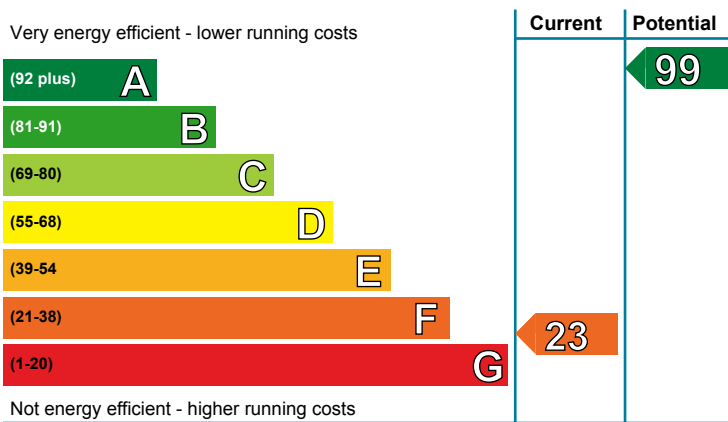
## Energy Efficiency Rating

This graph shows the current efficiency of your home, taking into account both energy efficiency and fuel costs. The higher this rating, the lower your fuel bills are likely to be.

Your current rating is **band F (23)**. The average rating for EPCs in Scotland is **band D (61)**.

The potential rating shows the effect of undertaking all of the improvement measures listed within your recommendations report.
