Home Report

9 Reveston Lane

survey report on:

Property address	9 Reveston Lane, Whitburn, BATHGATE, West Lothian, EH47 8HH
Customer	Mr T Hall & Mr W Anderson
Customer address	C/O Sneddon Morrison, 36-46 North Bridge Street, Bathgate, West Lothian, EH48 4PP
Prepared by	Allied Surveyors Scotland Ltd
Date of inspection	27th May 2024

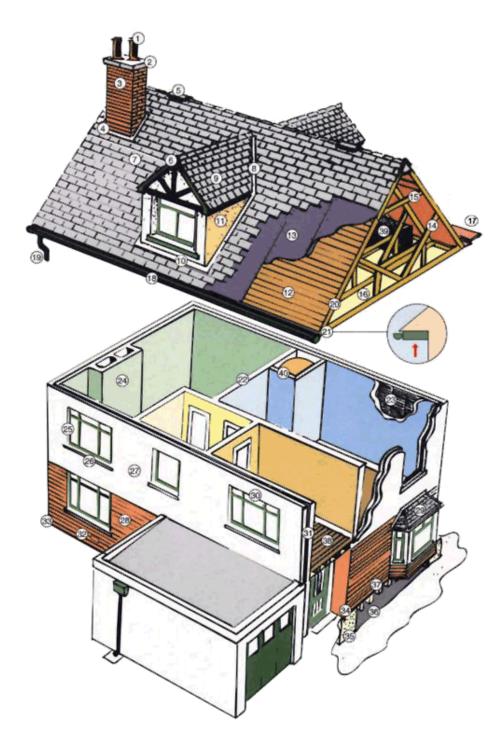
Sectional Diagram showing elements of a typical house

Reference may be made in this report to some or all of the above component parts of the property. This diagram may assist you in locating and understanding these items.

- 1) Chimney pots
- 2) Coping stone
- 3) Chimney head
- 4 Flashing
- 5 Ridge ventilation
- 6) Ridge board
- 7) Slates / tiles
- 8 Valley guttering
- 9 Dormer projection
- 10 Dormer flashing
- 11) Dormer cheeks
- 12) Sarking
- (13) Roof felt
- (14) Trusses
- (15) Collar
- 16 Insulation
- (17) Parapet gutter
- 18) Eaves guttering
- 19) Rainwater downpipe
- 20) Verge boards /skews
- 21) Soffit boards
- 22) Partition wall
- 23) Lath / plaster
- 24) Chimney breast
- (25) Window pointing
 - 6) Window sills
- 27) Rendering
- (28) Brickwork / pointing
- 29) Bay window projection
- 30 Lintels
- (31) Cavity walls / wall ties
- 32) Subfloor ventilator
- 33 Damp proof course
- 34) Base course
- 35) Foundations
- (36) Solum
- 37) Floor joists
- 38) Floorboards
- 39) Water tank
- 40 Hot water tank
