# Home Report

27 Mathers Avenue

## survey report on:

Property address	27 Mathers Avenue, Whitburn, BATHGATE, West Lothian, EH47 0NA
Customer	Power of Attorney of Mrs J McGill
	,
Customer address	C/O Sneddon Morrison, 34-46 North Bridge Street, Bathgate, West Lothian, EH48 1TL
Prepared by	Allied Surveyors Scotland Ltd

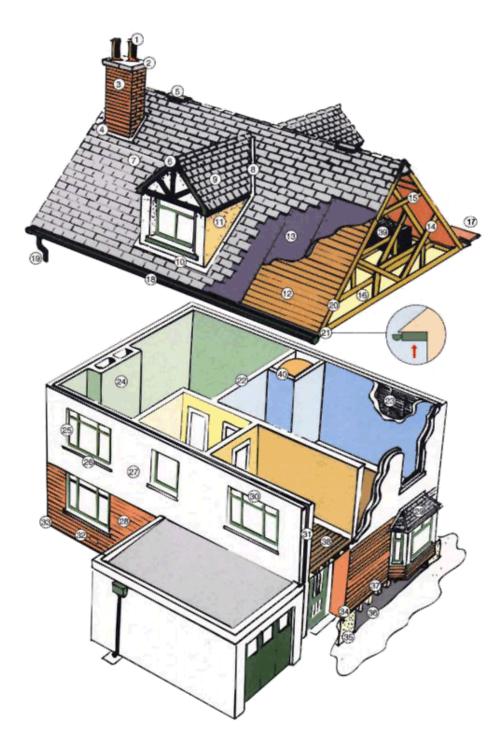
### Sectional Diagram showing elements of a typical house

Reference may be made in this report to some or all of the above component parts of the property. This diagram may assist you in locating and understanding these items.

- 1) Chimney pots
- 2 Coping stone
- 3) Chimney head
- 4 Flashing
- 5 Ridge ventilation
- 6 Ridge board
- 7) Slates / tiles
- 8 Valley guttering
- 9 Dormer projection
- 10 Dormer flashing
- 11) Dormer cheeks
- (12) Sarking
- (13) Roof felt
- (14) Trusses
- 15) Collar
- (16) Insulation
- 17) Parapet gutter
- (18) Eaves guttering
- (19) Rainwater downpipe
- 20) Verge boards/skews
- 21) Soffit boards
- 22) Partition wall
- 23) Lath / plaster
- 24) Chimney breast
- 25) Window pointing
- 6) Window sills
- 27) Rendering
- (28) Brickwork / pointing
- 29) Bay window projection
- 30 Lintels
- (31) Cavity walls / wall ties
- 32) Subfloor ventilator
- 33) Damp proof course
- 34) Base course
- 35) Foundations
- 36) Solum
- 37) Floor joists
- 38) Floorboards
- 39) Water tank
- 40 Hot water tank
