# Home Report

2 Yule Place Blackburn Bathgate West Lothian EH47 7HD

Prepared by	Allied Surveyors Scotland Ltd

Date of inspection	1st April 2025
--------------------	----------------

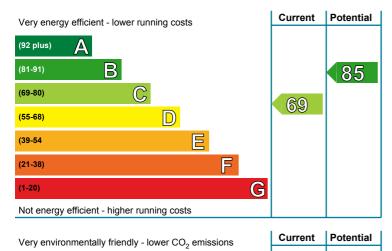
#### **Energy Efficiency Rating**

This graph shows the current efficiency of your home, taking into account both energy efficiency and fuel costs. The higher this rating, the lower your fuel bills are likely to be.
