Home Report

17 Watt Avenue

Single Survey

| Property address | 17 Watt Avenue, Bathville, BATHGATE, West Lothian, EH48 2LB |

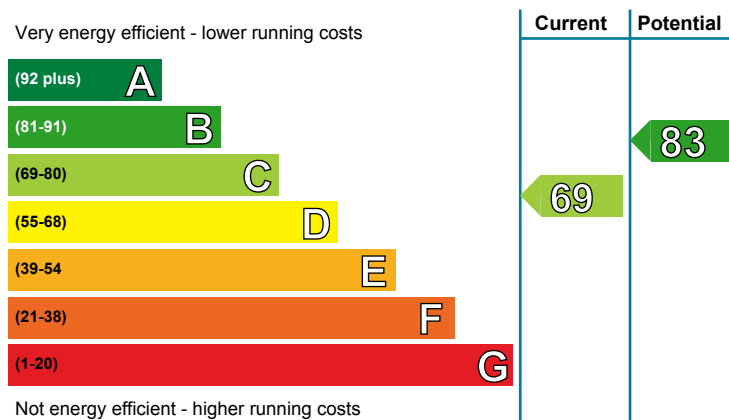
Energy Efficiency Rating

This graph shows the current efficiency of your home, taking into account both energy efficiency and fuel costs. The higher this rating, the lower your fuel bills are likely to be.

The potential rating shows the effect of undertaking all of the improvement measures listed within your recommendations report.

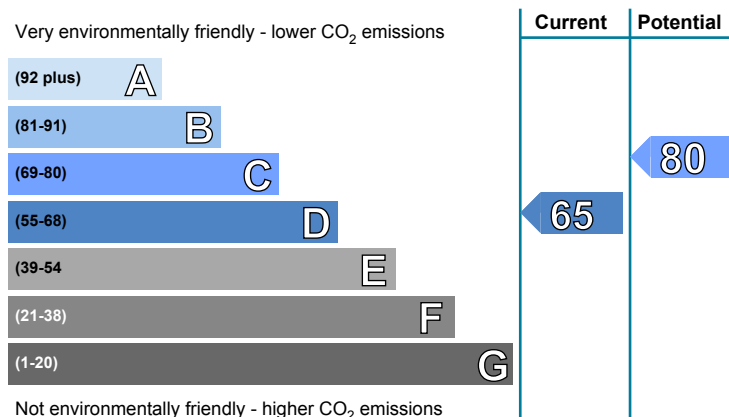
Environmental Impact (CO₂) Rating

This graph shows the effect of your home on the environment in terms of carbon dioxide (CO₂) emissions. The higher the rating, the less impact it has on the environment.
