# Home Report

# Single Survey

<b>Property address</b>	Rhugarbh Church Barcaldine Oban PA37 1SE
<b>Customer</b>	Alan & Fiona Anderson
<b>Customer address</b>	Rhugarbh Church Barcaldine Oban PA37 1SE
<b>Prepared by</b>	Shepherd Chartered Surveyors
<b>Date of inspection</b>	10/09/2025

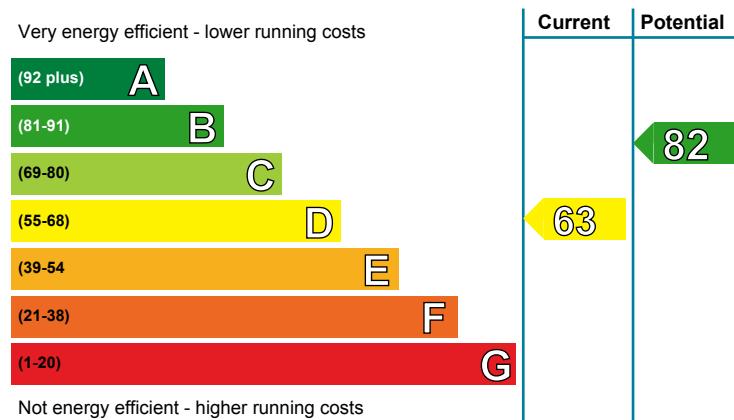
## Energy Efficiency Rating

This graph shows the current efficiency of your home, taking into account both energy efficiency and fuel costs. The higher this rating, the lower your fuel bills are likely to be.

Your current rating is **band D (63)**. The average rating for EPCs in Scotland is **band D (61)**.

The potential rating shows the effect of undertaking all of the improvement measures listed within your recommendations report.

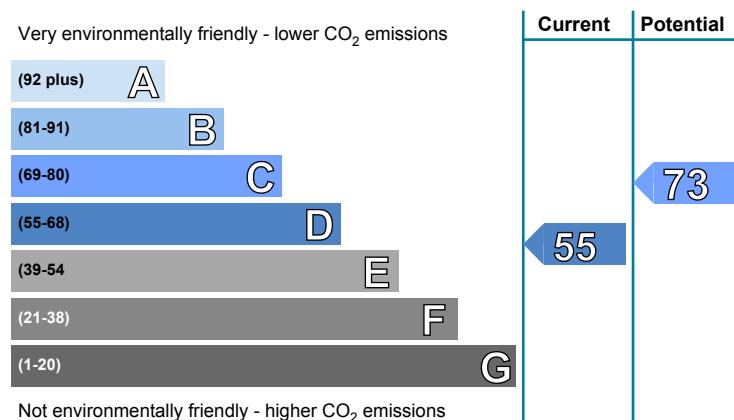
## Environmental Impact (CO<sub>2</sub>) Rating

This graph shows the effect of your home on the environment in terms of carbon dioxide (CO<sub>2</sub>) emissions. The higher the rating, the less impact it has on the environment.
