Home Report

Scottish Single Survey

Property address	1a Broadstone Park Inverness IV2 3JZ
-------------------------	--

Prepared by	Shepherd Chartered Surveyors
--------------------	------------------------------

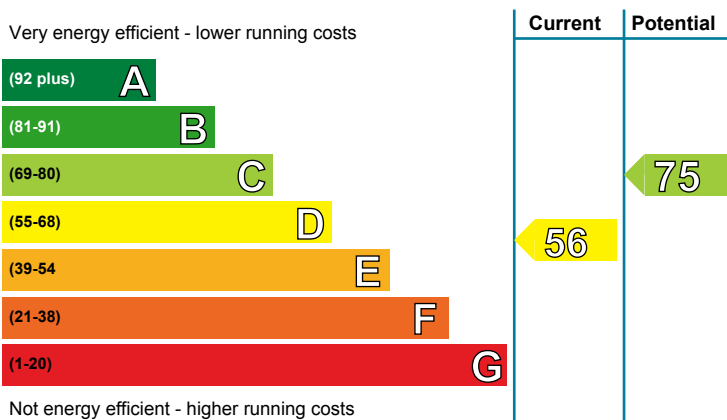
Energy Efficiency Rating

This graph shows the current efficiency of your home, taking into account both energy efficiency and fuel costs. The higher this rating, the lower your fuel bills are likely to be.

Your current rating is **band D (56)**. The average rating for EPCs in Scotland is **band D (61)**.

The potential rating shows the effect of undertaking all of the improvement measures listed within your recommendations report.

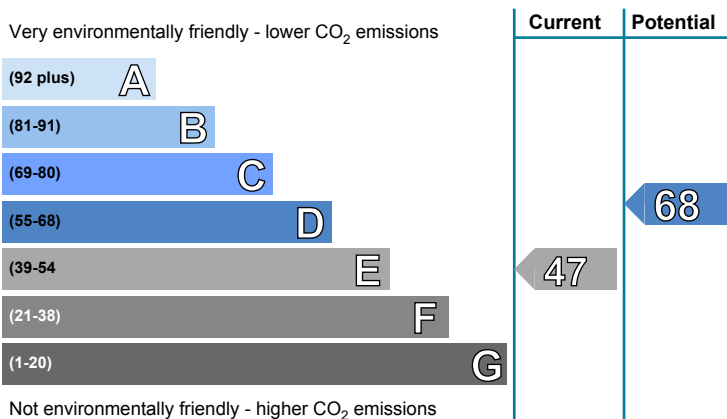
Environmental Impact (CO₂) Rating

This graph shows the effect of your home on the environment in terms of carbon dioxide (CO₂) emissions. The higher the rating, the less impact it has on the environment.
