# YOUR ONESURVEY HOME REPORT

30 Drummond Crescent  
Inverness  
IV2 4QR

# SINGLE SURVEY

# Single Survey

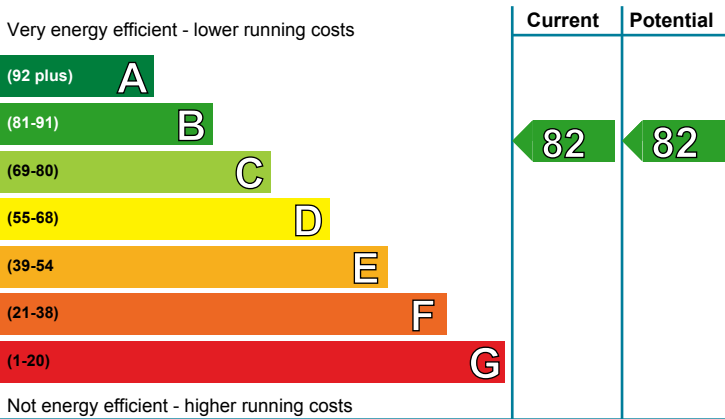
## Energy Efficiency Rating

This graph shows the current efficiency of your home, taking into account both energy efficiency and fuel costs. The higher this rating, the lower your fuel bills are likely to be.

Your current rating is **band B (82)**. The average rating for EPCs in Scotland is **band D (61)**.

The potential rating shows the effect of undertaking all of the improvement measures listed within your recommendations report.

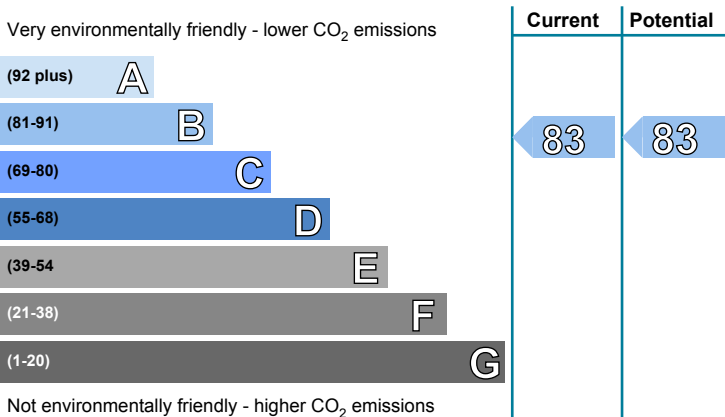
## Environmental Impact (CO<sub>2</sub>) Rating

This graph shows the effect of your home on the environment in terms of carbon dioxide (CO<sub>2</sub>) emissions. The higher the rating, the less impact it has on the environment.
