HOME
report

SINGLE SURVEY
ENERGY REPORT
PROPERTY QUESTIONNAIRE
VALUATION REPORT

Survey report on:

Property Address	22 Culduthel Avenue Inverness IV2 6BD
Customer	Mr A Jackman & Mrs C Jackman
Date of Inspection	15/07/2024
Prepared by	Douglas J H Mowat Harvey Donaldson & Gibson Chartered Surveyors

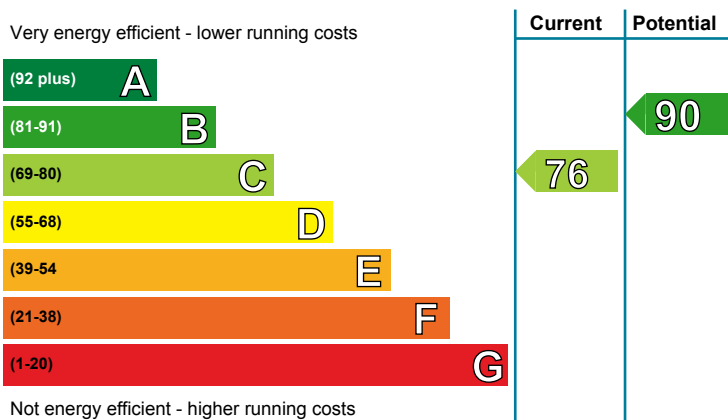
Energy Efficiency Rating

This graph shows the current efficiency of your home, taking into account both energy efficiency and fuel costs. The higher this rating, the lower your fuel bills are likely to be.

Your current rating is **band C (76)**. The average rating for EPCs in Scotland is **band D (61)**.

The potential rating shows the effect of undertaking all of the improvement measures listed within your recommendations report.
