Home Report

Scottish Single Survey

Property address	10 St. Fergus Drive Inverness IV3 5AN
Customer	Trustee sale for 10 St. Fergus Drive
Customer address	10 St. Fergus Drive Inverness IV3 5AN
Prepared by	Shepherd Chartered Surveyors
Date of inspection	26/09/2024

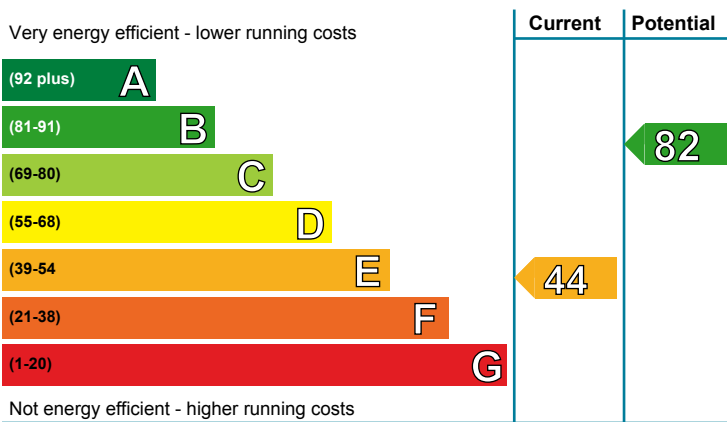
Energy Efficiency Rating

This graph shows the current efficiency of your home, taking into account both energy efficiency and fuel costs. The higher this rating, the lower your fuel bills are likely to be.

Your current rating is **band E (44)**. The average rating for EPCs in Scotland is **band D (61)**.

The potential rating shows the effect of undertaking all of the improvement measures listed within your recommendations report.

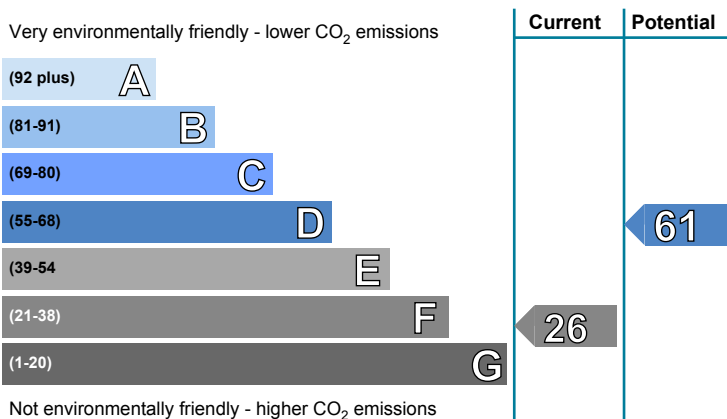
Environmental Impact (CO₂) Rating

This graph shows the effect of your home on the environment in terms of carbon dioxide (CO₂) emissions. The higher the rating, the less impact it has on the environment.
