HOME REPORT

17 ANNE CRESCENT NAIRN IV12 5DL

SINGLE SURVEY

17 ANNE CRESCENT, NAIRN, IV12 5DL		
Estate of late Elizabeth Violet Spence		
c/o Ledingham Chalmers, Ord House, Cradlehall Business Park, Inverness, IV2 5GH		
DM Hall LLP		
24th February 2025

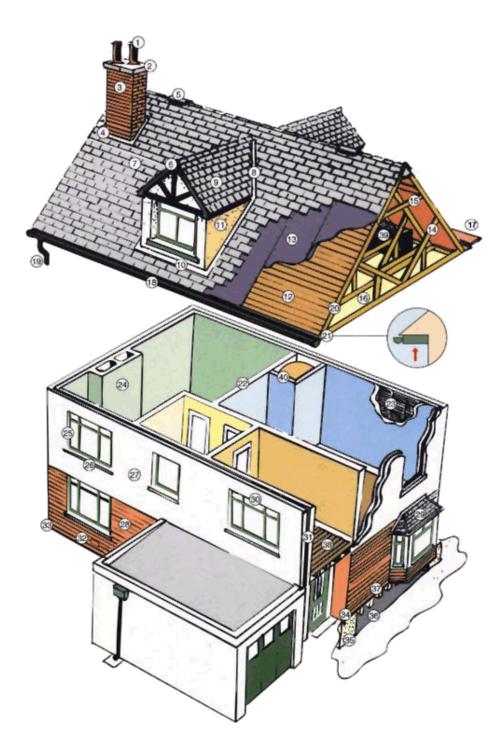
Sectional Diagram showing elements of a typical house

Reference may be made in this report to some or all of the above component parts of the property. This diagram may assist you in locating and understanding these items.

- 1) Chimney pots
- 2) Coping stone
- 3) Chimney head
- 4 Flashing
- 5 Ridge ventilation
- 6 Ridge board
- 7) Slates / tiles
- 8 Valley guttering
- 9 Dormer projection
- 10 Dormer flashing
- 11) Dormer cheeks
- 12) Sarking
- (13) Roof felt
- (14) Trusses
- (15) Collar
- 16 Insulation
- 17) Parapet gutter
- (18) Eaves guttering
- Rainwater downpipe
- 20) Verge boards/skews
- 21) Soffit boards
- 22) Partition wall
- 23) Lath / plaster
- 24) Chimney breast
- (25) Window pointing
 - 6) Window sills
- 27) Rendering
- (28) Brickwork / pointing
- 29) Bay window projection
- 30 Lintels
- (31) Cavity walls / wall ties
- 32) Subfloor ventilator
- 33) Damp proof course
- 34) Base course
- 35) Foundations
- (36) Solum
- 37) Floor joists
- 38) Floorboards
- 39) Water tank
- 40 Hot water tank
