HOME REPORT

Single Survey

Property address	PHAROS, 5B Ferryhills Road, North Queensferry, Inverkeithing, KY11 1HE
-------------------------	--

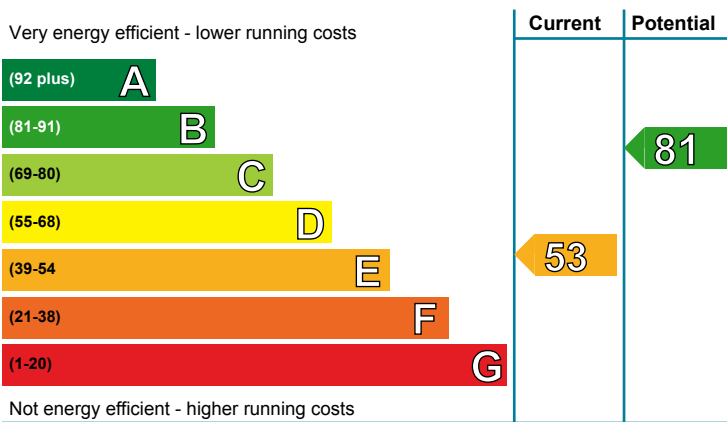
Energy Efficiency Rating

This graph shows the current efficiency of your home, taking into account both energy efficiency and fuel costs. The higher this rating, the lower your fuel bills are likely to be.

Your current rating is **band E (53)**. The average rating for EPCs in Scotland is **band D (61)**.

The potential rating shows the effect of undertaking all of the improvement measures listed within your recommendations report.

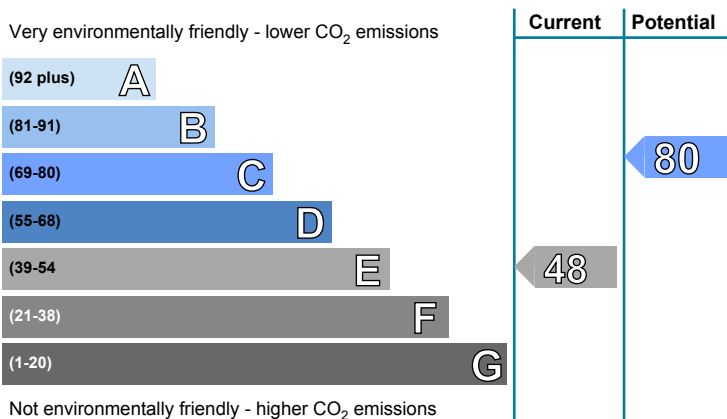
Environmental Impact (CO₂) Rating

This graph shows the effect of your home on the environment in terms of carbon dioxide (CO₂) emissions. The higher the rating, the less impact it has on the environment.

The potential rating shows the effect of undertaking all of the improvement measures listed within your recommendations report.

The average Scottish household produces about 6 tonnes of carbon dioxide every year. Based on this assessment, heating and lighting this home currently produces approximately 10 tonnes of carbon dioxide every year. Adopting recommendations in this report can reduce emissions and protect the environment. If you were to install all of these recommendations this could reduce emissions by 5.7 tonnes per year. You could reduce emissions even more by switching to renewable energy sources.
