# HOME REPORT

82 Dunfermline Road,  
Crossgates,  
Cowdenbeath,  
Fife,  
KY4 8AS

# Single Survey

## Survey Report on:

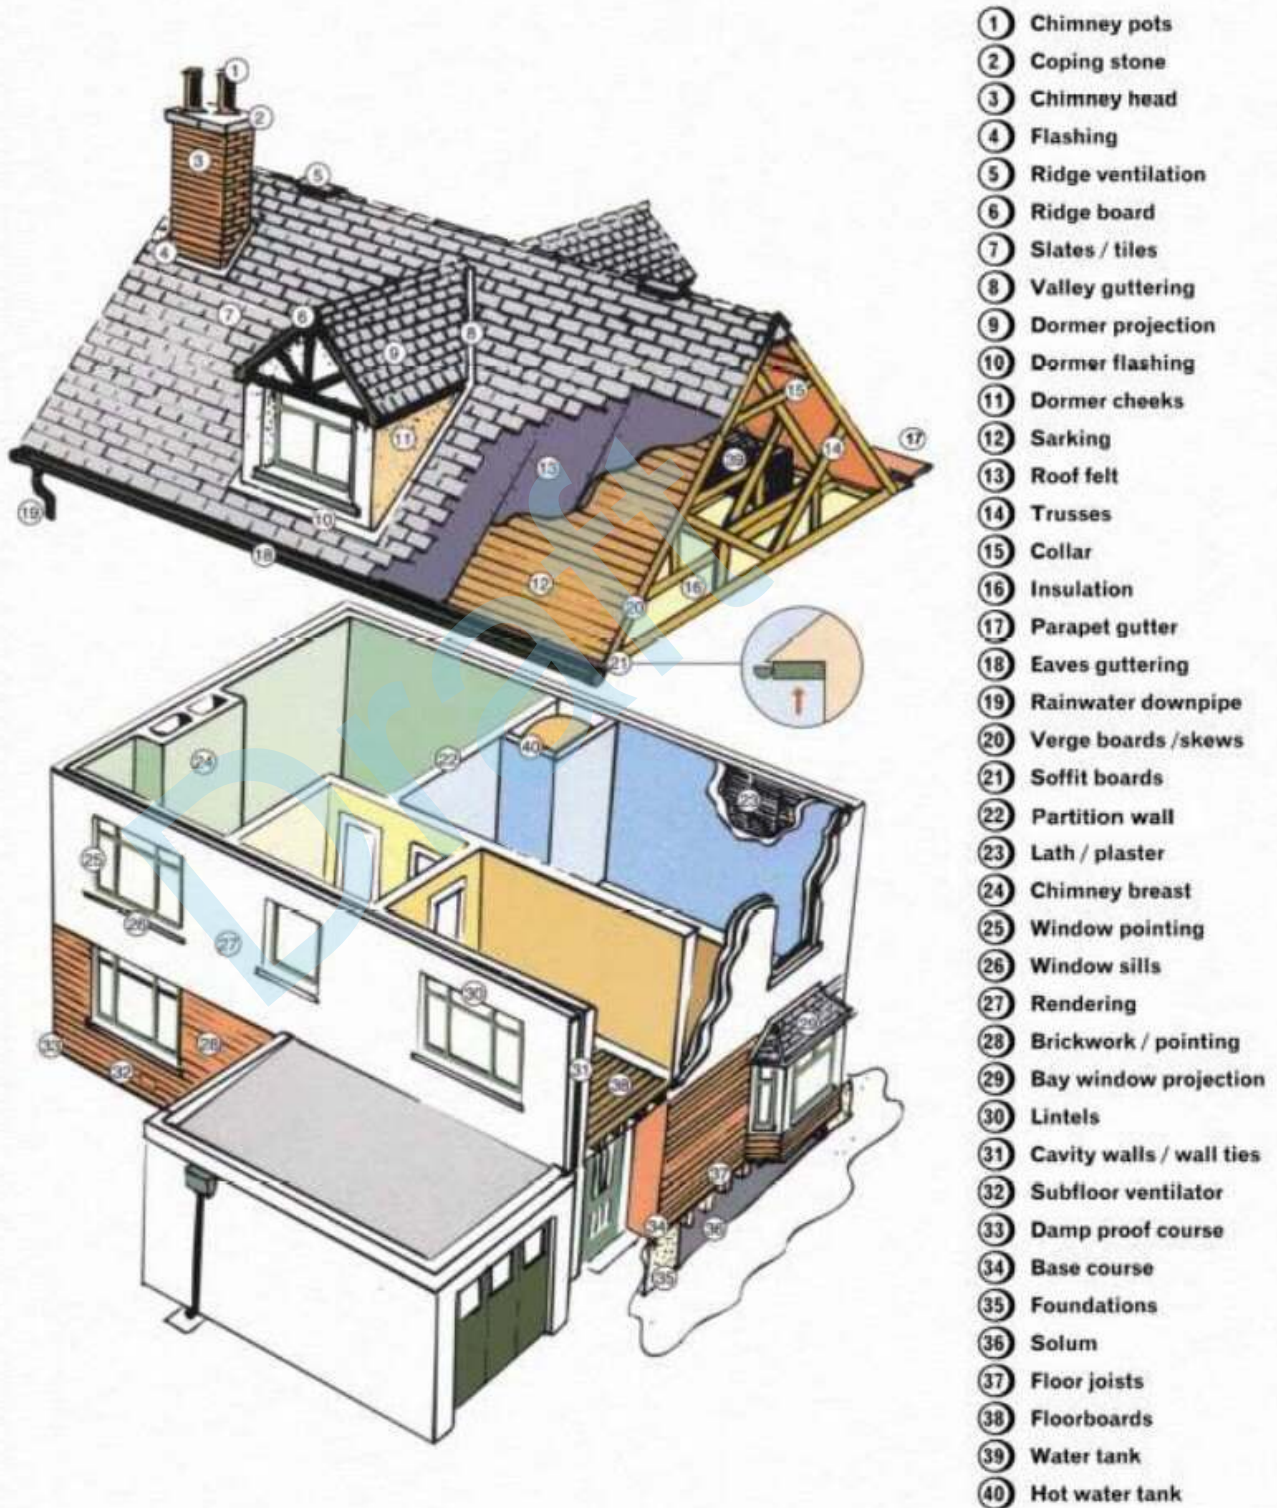
## Sectional Diagram showing elements of a typical house

Reference may be made in this report to some or all of the above component parts of the property. This diagram may assist you in locating and understanding these items.
