HOME
report

SINGLE SURVEY
ENERGY REPORT
PROPERTY QUESTIONNAIRE
VALUATION REPORT

Single Survey

Property Address	98 Montford Avenue Glasgow G44 4NZ
Customer	Ms Y Wong
Date of Inspection	26/04/2024
Prepared by	R Fitzpatrick Harvey Donaldson & Gibson Chartered Surveyors

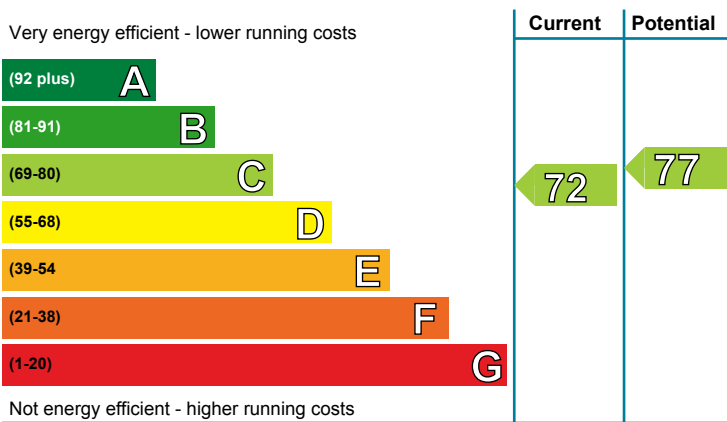
Energy Efficiency Rating

This graph shows the current efficiency of your home, taking into account both energy efficiency and fuel costs. The higher this rating, the lower your fuel bills are likely to be.

Your current rating is **band C (72)**. The average rating for EPCs in Scotland is **band D (61)**.

The potential rating shows the effect of undertaking all of the improvement measures listed within your recommendations report.

Estimated energy costs for your home for 3 years*	£3,291	See your recommendations report for more information
Over 3 years you could save*	£705

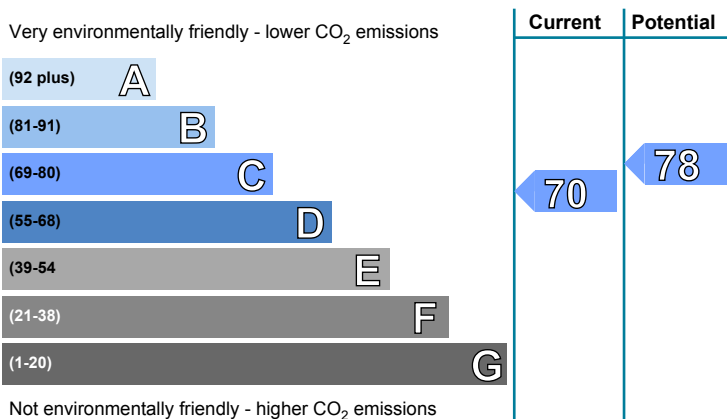
Environmental Impact (CO₂) Rating

This graph shows the effect of your home on the environment in terms of carbon dioxide (CO₂) emissions. The higher the rating, the less impact it has on the environment.
