HOME
report

SINGLE SURVEY
ENERGY REPORT
PROPERTY QUESTIONNAIRE
VALUATION REPORT

Property Address	345 Kingsacre Road Rutherglen Glasgow G73 2EL
Customer	Ms K Y J Chan
Date of Inspection	19/09/2024
Prepared by	Brett G McMillan Harvey Donaldson & Gibson Chartered Surveyors

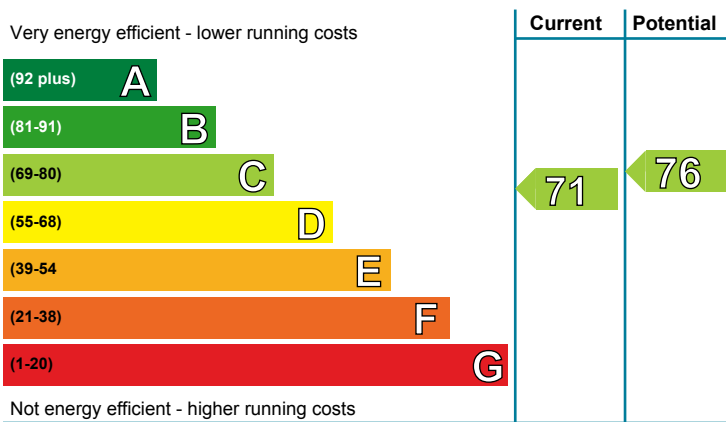
Energy Efficiency Rating

This graph shows the current efficiency of your home, taking into account both energy efficiency and fuel costs. The higher this rating, the lower your fuel bills are likely to be.

Your current rating is **band C (71)**. The average rating for EPCs in Scotland is **band D (61)**.

The potential rating shows the effect of undertaking all of the improvement measures listed within your recommendations report.

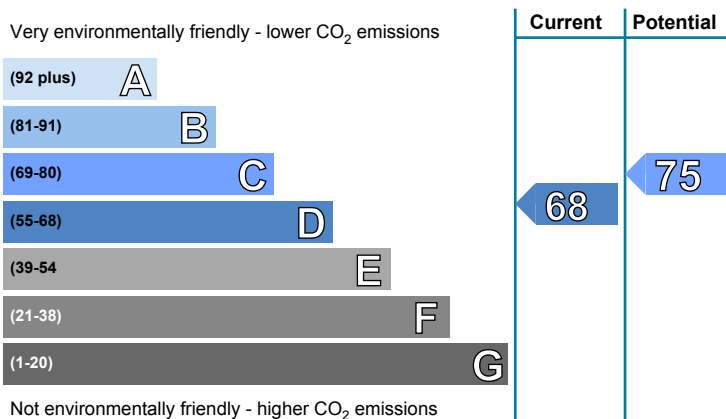
Environmental Impact (CO₂) Rating

This graph shows the effect of your home on the environment in terms of carbon dioxide (CO₂) emissions. The higher the rating, the less impact it has on the environment.
