# Home Report

# Scottish Single Survey

<b>Property address</b>	24/3 Riccartbar Avenue Paisley PA2 6BG
-------------------------	--

<b>Prepared by</b>	Shepherd Chartered Surveyors
--------------------	------------------------------

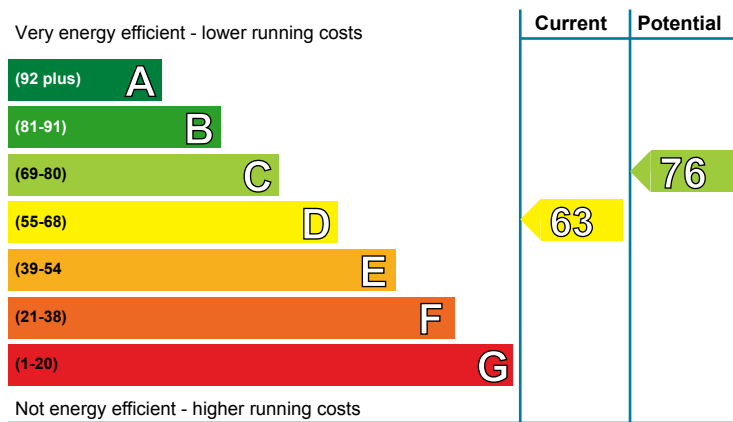
## Energy Efficiency Rating

This graph shows the current efficiency of your home, taking into account both energy efficiency and fuel costs. The higher this rating, the lower your fuel bills are likely to be.

Your current rating is **band D (63)**. The average rating for EPCs in Scotland is **band D (61)**.

The potential rating shows the effect of undertaking all of the improvement measures listed within your recommendations report.

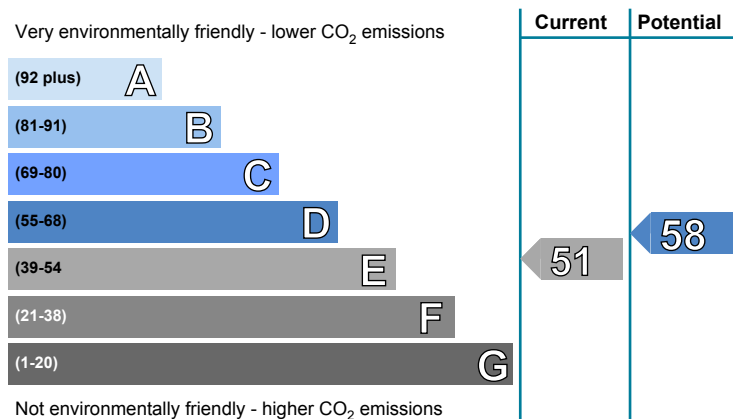
## Environmental Impact (CO<sub>2</sub>) Rating

This graph shows the effect of your home on the environment in terms of carbon dioxide (CO<sub>2</sub>) emissions. The higher the rating, the less impact it has on the environment.
