YOUR ONESURVEY HOME REPORT

17 Shaw Place Coylton, Ayr KA6 6QF

SINGLE Survey

Single Survey

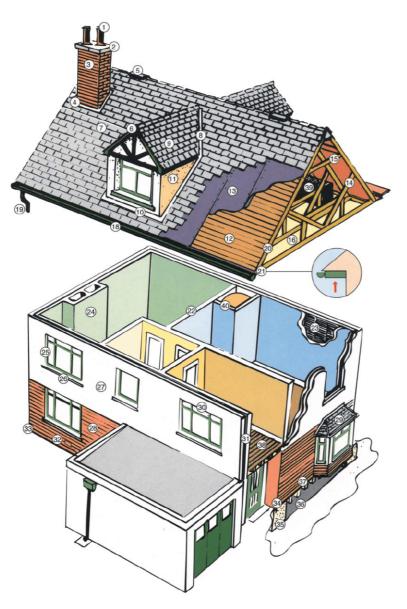
Sectional Diagram showing elements of a typical house

Reference may be made in this report to some or all of the above component parts of the property. This diagram may assist you in locating and understanding these items.
