# Home Report

54 Bellevue Crescent  
Ayr  
KA7 2DR

# single survey

## survey report on:

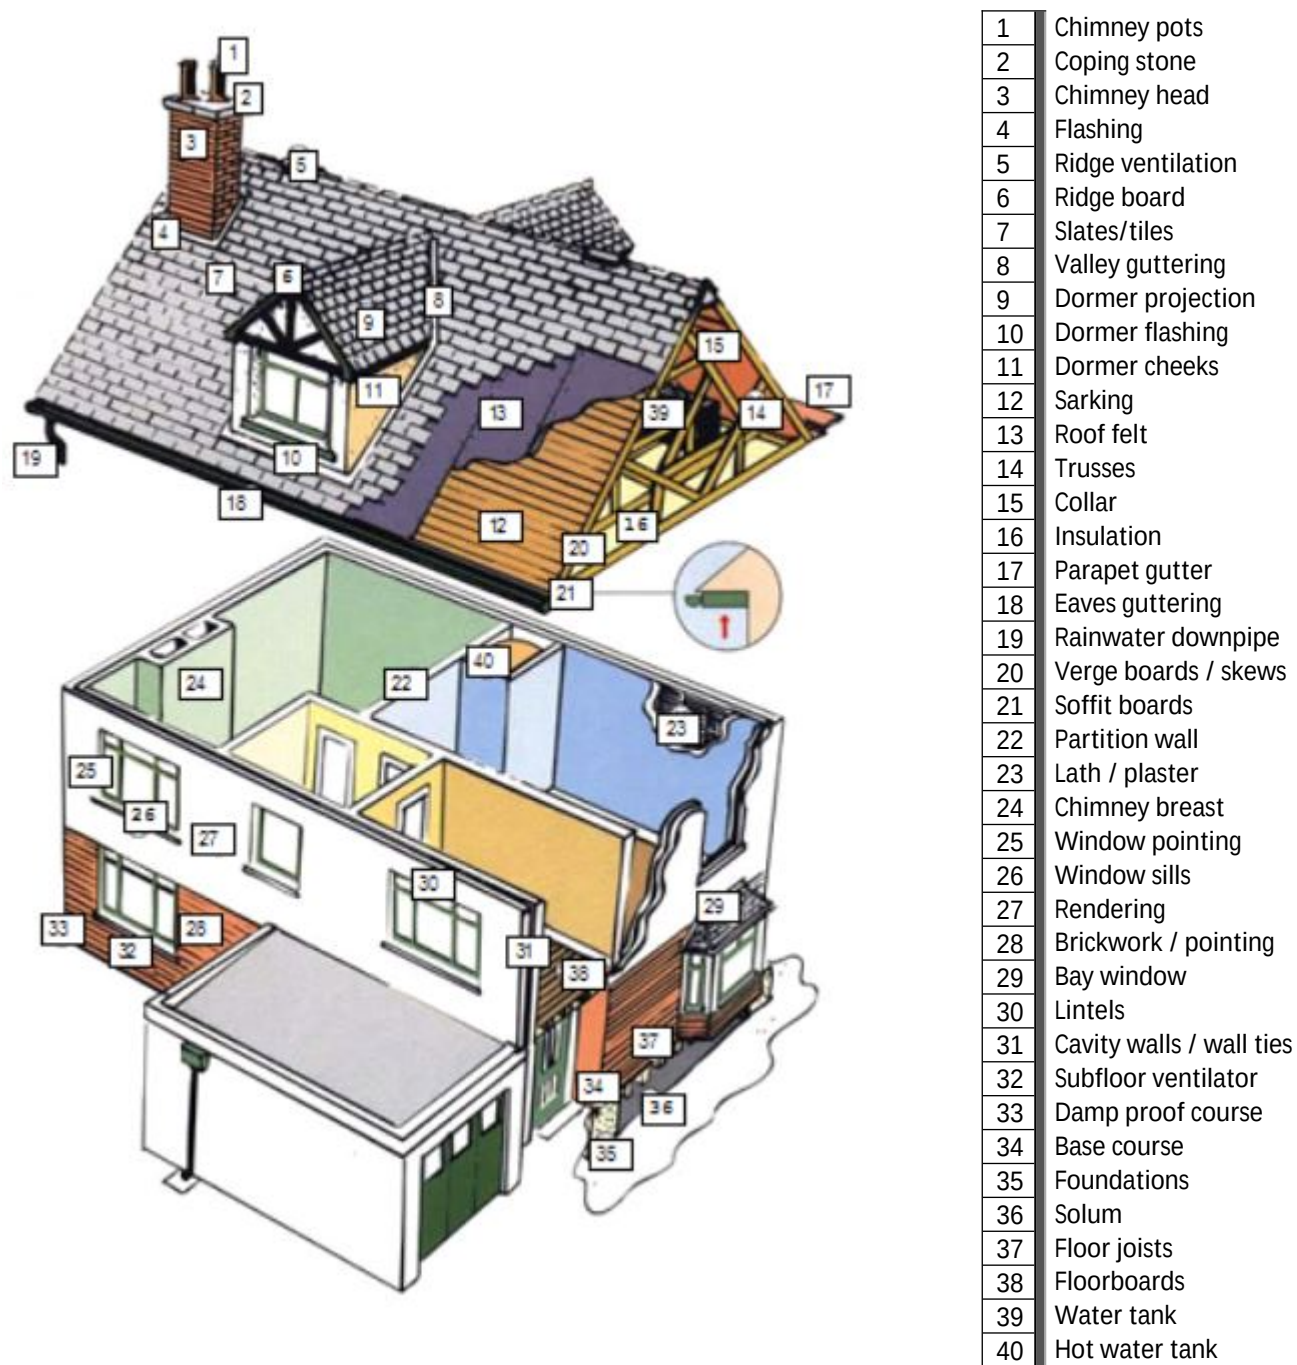
### Sectional Diagram showing elements of a typical house

Reference may be made in this report to some or all of the above component parts of the property. This diagram may assist you in locating and understanding these items.
