# Home Report

The Granary  
Knockdon Maybole KA19 8EH

Date of Valuation: 25/02/2025

# Single Survey

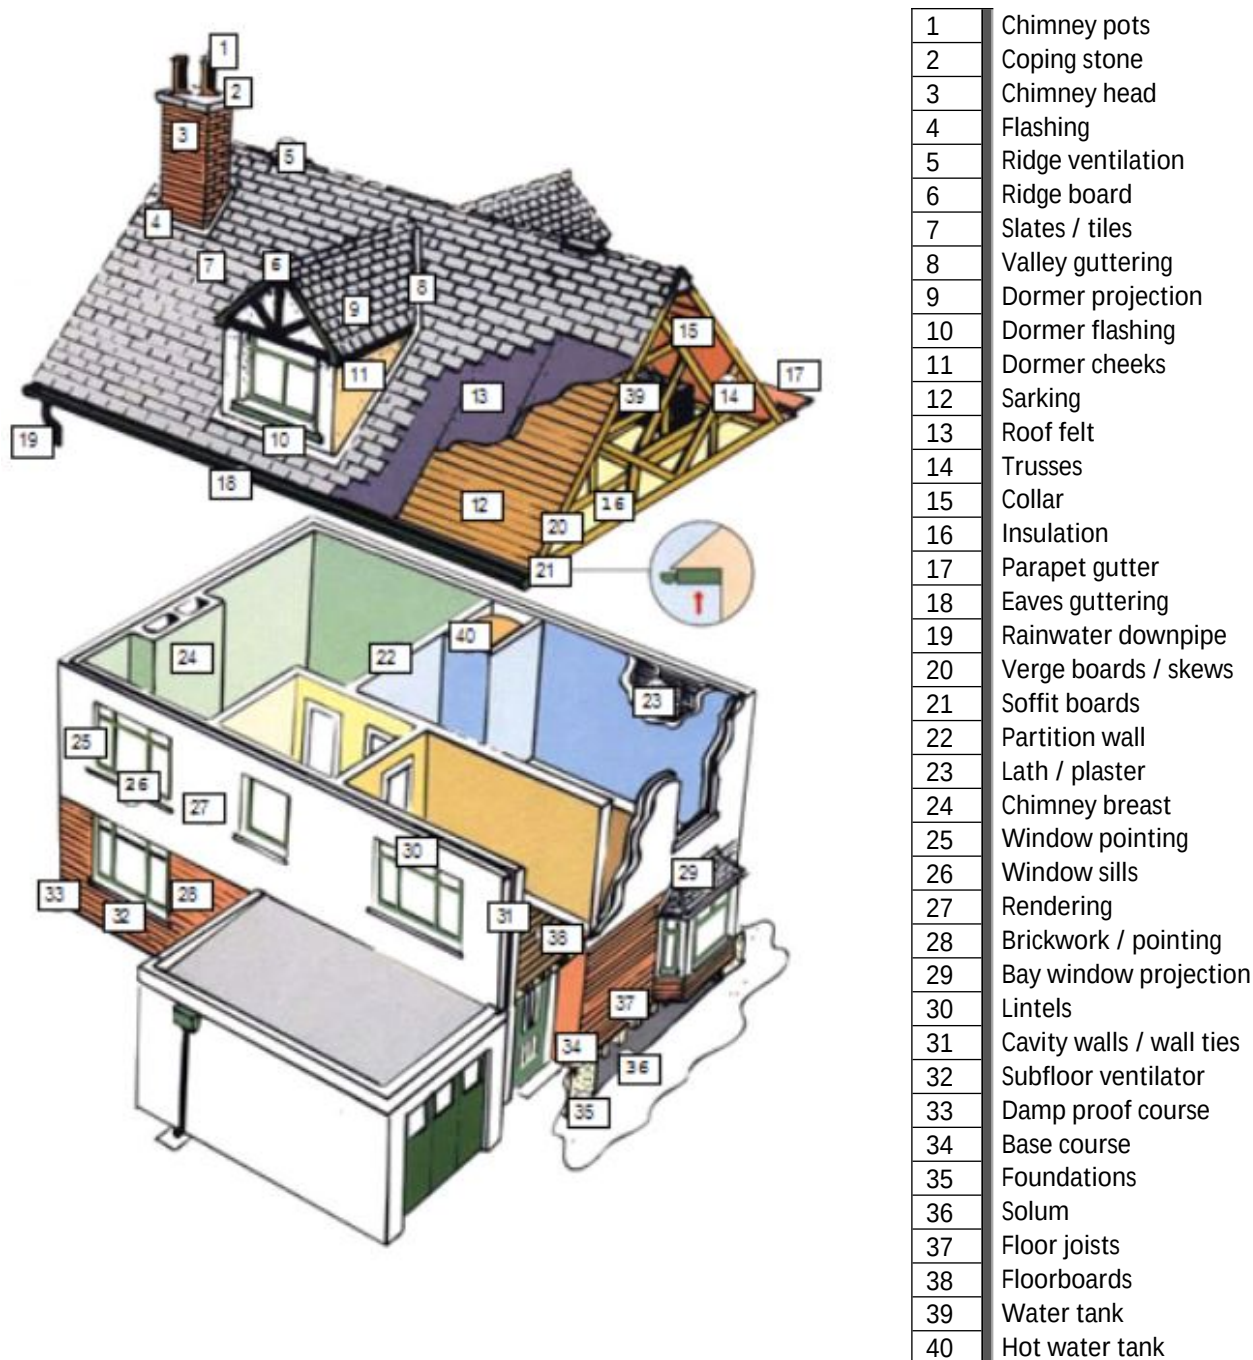
## Sectional diagram showing elements of a typical house

Reference may be made in this report to some or all of the above component parts of the property. This diagram may assist you in locating and understanding these items.

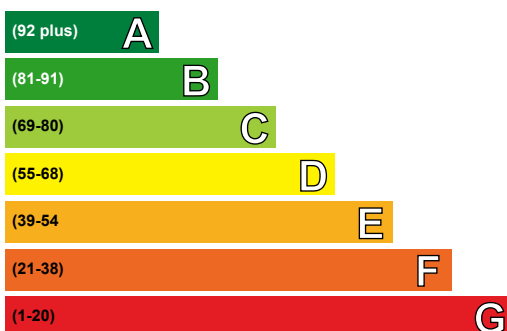
\* based upon the cost of energy for heating, hot water, lighting and ventilation, calculated using standard assumptions

Very energy efficient - lower running costs

Not energy efficient - higher running costs
