# YOUR ONESURVEY HOME REPORT

37 Maxwell Street  
Girvan  
KA26 9EJ

# SINGLE SURVEY

# Single Survey

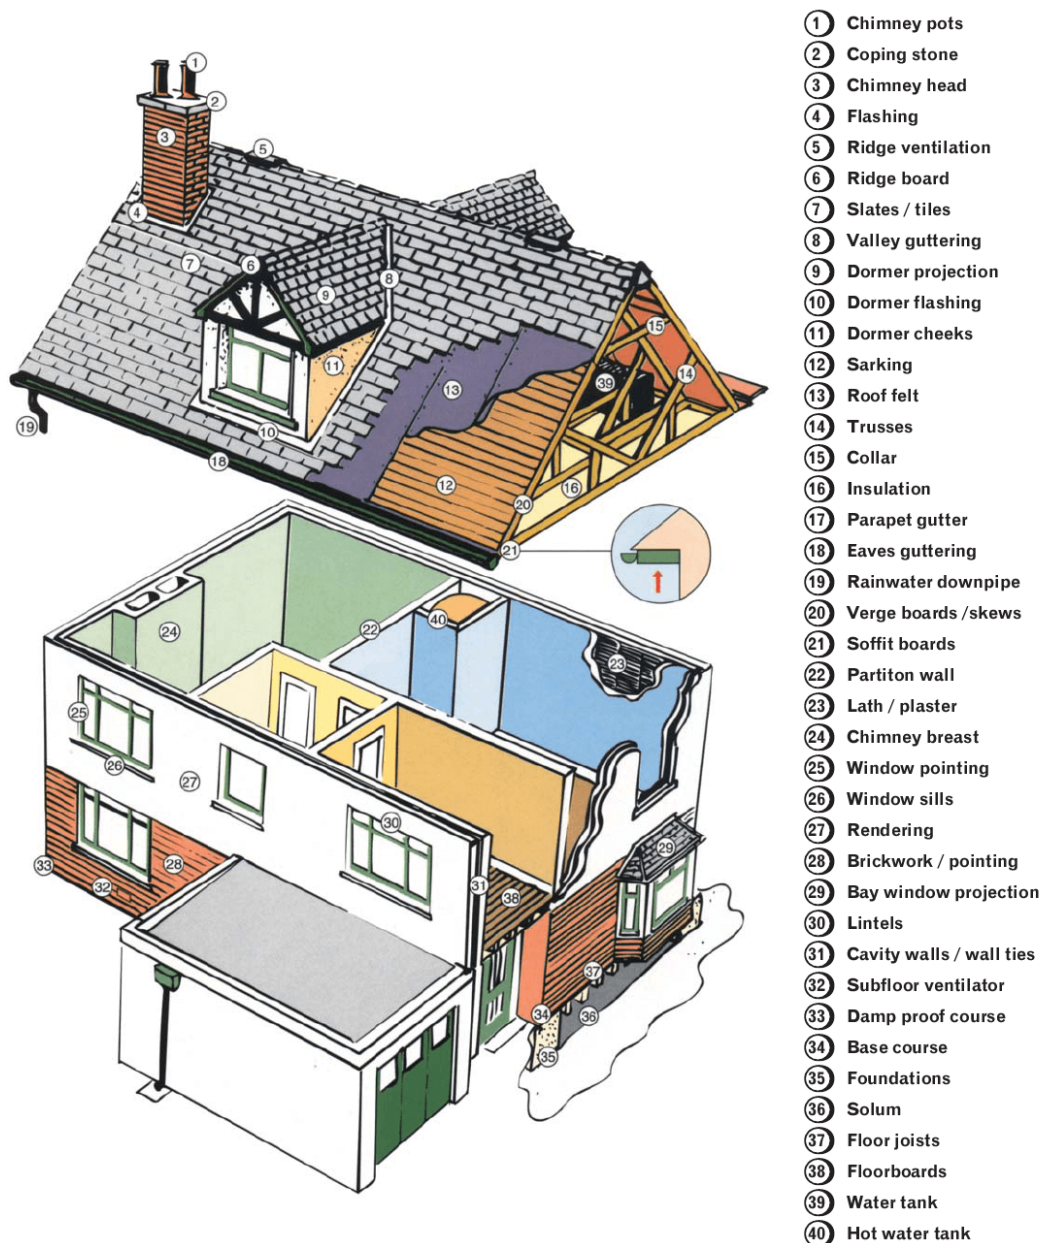
## Sectional Diagram showing elements of a typical house

Reference may be made in this report to some or all of the above component parts of the property. This diagram may assist you in locating and understanding these items.
