# Home Report

8 Hannah Wynd  
St. Quivox Ayr KA6 5HB

# Single Survey

| <b>Description</b> | The property comprises of a detached two storey villa. |

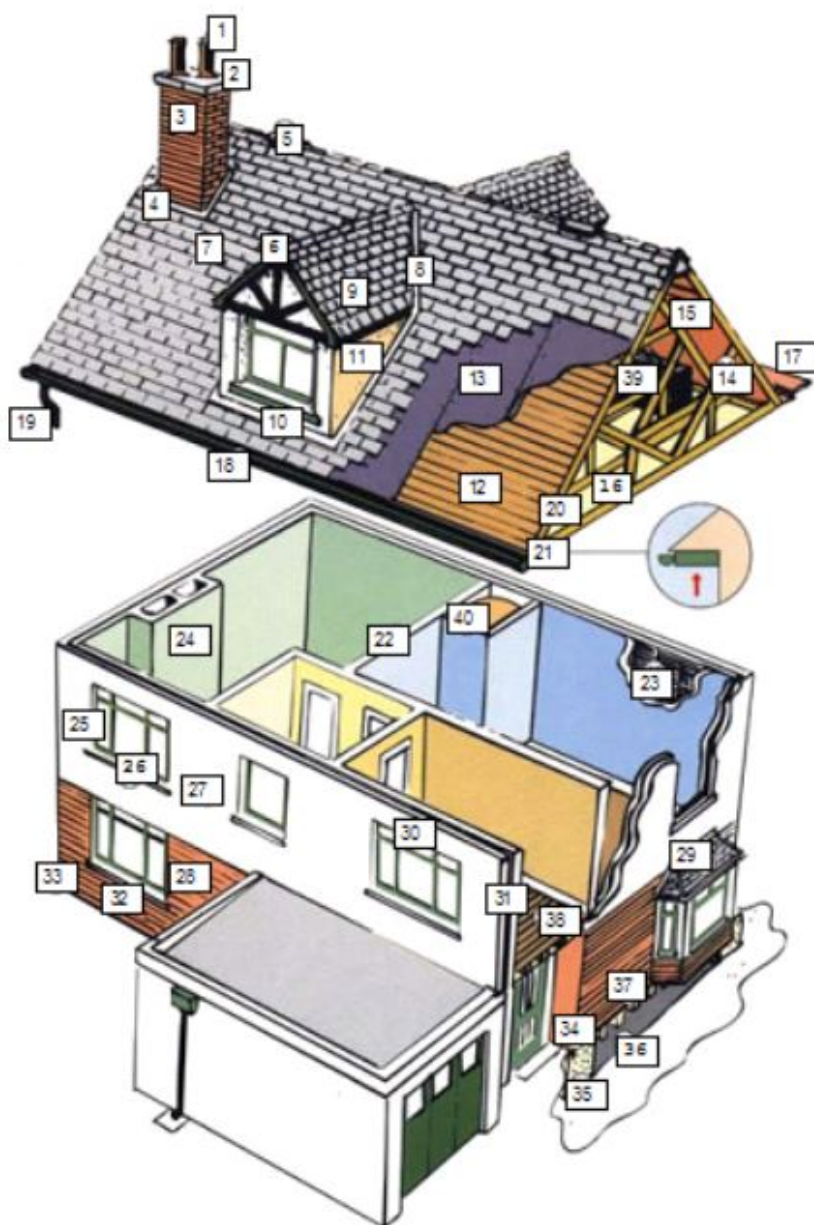
## Sectional diagram showing elements of a typical house

| 1 | Chimney pots |
| 2 | Coping stone |
| 35 | Foundations |
