Home Report

19 Eskfield View, Wallyford, EH21 8FB

Single Survey

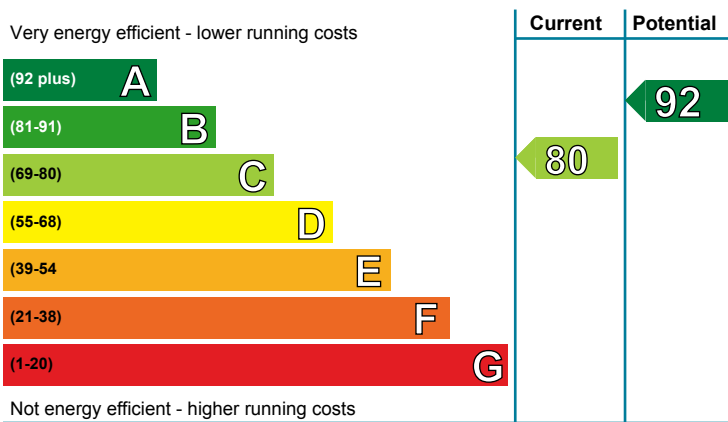
Energy Efficiency Rating

This graph shows the current efficiency of your home, taking into account both energy efficiency and fuel costs. The higher this rating, the lower your fuel bills are likely to be.

Your current rating is **band C (80)**. The average rating for EPCs in Scotland is **band D (61)**.

The potential rating shows the effect of undertaking all of the improvement measures listed within your recommendations report.

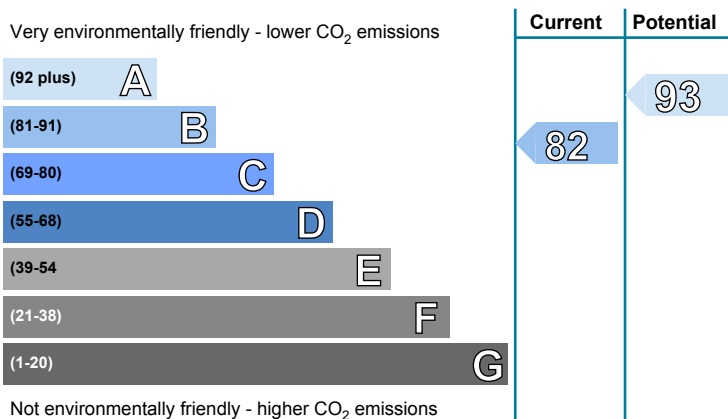
Environmental Impact (CO₂) Rating

This graph shows the effect of your home on the environment in terms of carbon dioxide (CO₂) emissions. The higher the rating, the less impact it has on the environment.

Your current rating is **band B (82)**. The average rating for EPCs in Scotland is **band D (59)**.

The potential rating shows the effect of undertaking all of the improvement measures listed within your recommendations report.
