Home Report

Property: **Rowanlea
Mill Road
Kingussie
Highland
PH21 1LF**

Energy Performance Certificate (EPC)

ROWANLEA, MILL ROAD, KINGUSSIE, PH21 1LF

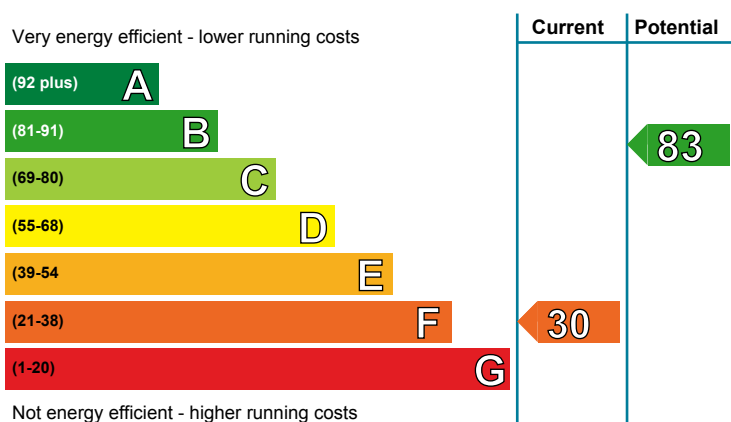
Energy Efficiency Rating

This graph shows the current efficiency of your home, taking into account both energy efficiency and fuel costs. The higher this rating, the lower your fuel bills are likely to be.

Your current rating is **band F (30)**. The average rating for EPCs in Scotland is **band D (61)**.

The potential rating shows the effect of undertaking all of the improvement measures listed within your recommendations report.

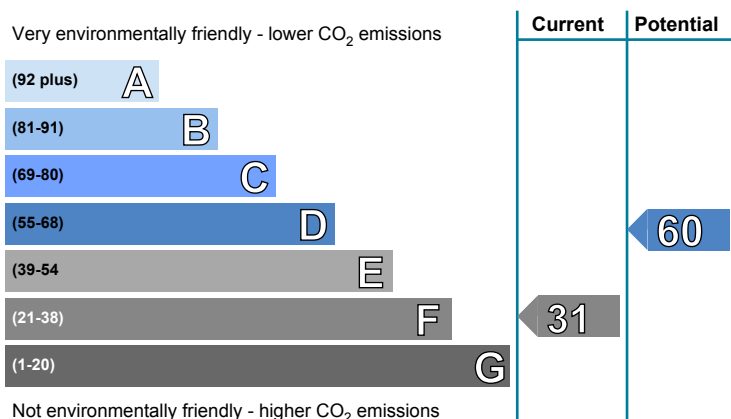
Environmental Impact (CO₂) Rating

This graph shows the effect of your home on the environment in terms of carbon dioxide (CO₂) emissions. The higher the rating, the less impact it has on the environment.

The potential rating shows the effect of undertaking all of the improvement measures listed within your recommendations report.

The average Scottish household produces about 6 tonnes of carbon dioxide every year. Based on this assessment, heating and lighting this home currently produces approximately 13 tonnes of carbon dioxide every year. Adopting recommendations in this report can reduce emissions and protect the environment. If you were to install all of these recommendations this could reduce emissions by 5.7 tonnes per year. You could reduce emissions even more by switching to renewable energy sources.
