single survey

Survey report on:

Property address	10 Earns Heugh Avenue
, ,	Cove
	Aberdeen
	AB12 3RH
Customer	Mr Jason McKown
Customer address	C/o Purple Bricks
Date of Inspection	13 th July 2017
Prepared by	David Adamson & Partners Limited
-	Chartered Surveyors
	7 Queens Gardens
	Aberdeen
	AB15 4YD
	Tel: +44(0)1224 586 795
	Email: valuations@davidadamsongroup.com

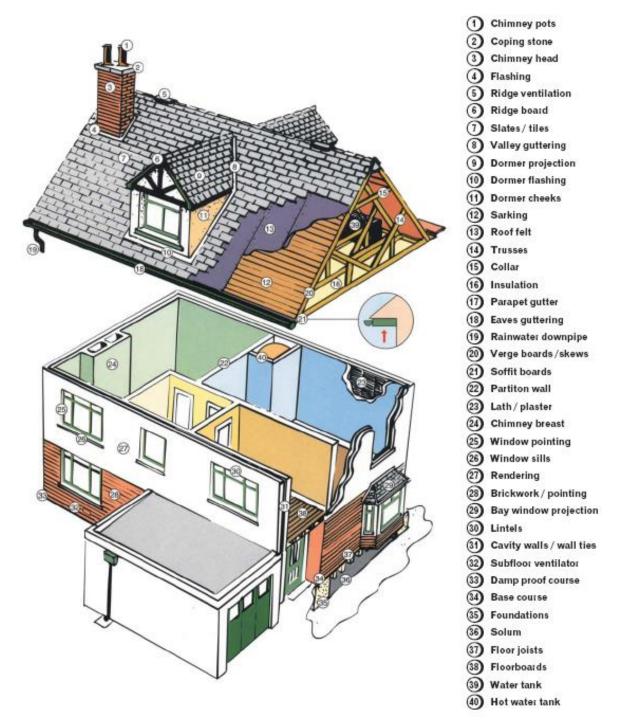
Sectional Diagram showing elements of a typical house

Reference may be made in this report to some or all of the above component parts of the property. This diagram may assist you in locating and understanding these items.
